Report Title: Haven Bridge Public House

Report to: Scrutiny

Great Yarmouth Borough Council (GYBC) appointed Technicus Consulting on 15th February 2024 to conduct a visual-only, non-invasive, external structural survey of the fire damaged Haven Bridge Public House (PH) on Bridge Road, Cobholm. The purpose of the survey is to report on the structural condition of the building, and the expected preliminary scope of structural repairs and remedial works needed to return the building to a wind and watertight condition. We understand this report will then be used to assess the likely remedial works costs to assist with valuing the property, following which GYBC may consider submitting a Compulsory Purchase Order (CPO) to acquire the dilapidated property.

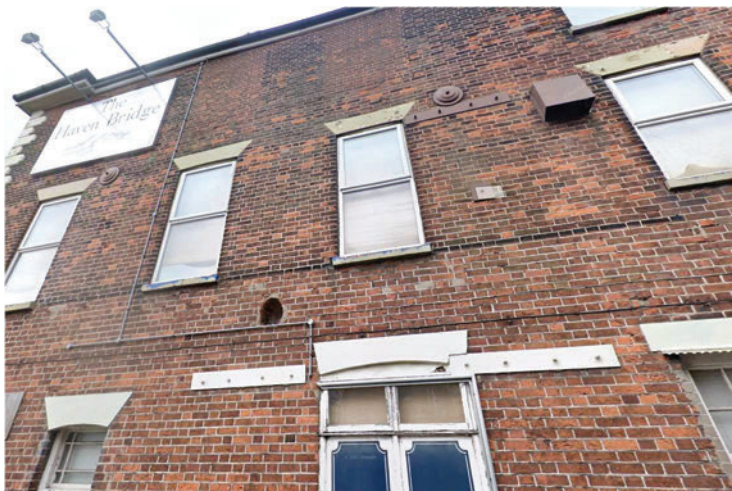
The building has also been subject to remedial works in the form of installation of lateral restraint tie rods and pattress / restraint plates to laterally restrain the east facing flank wall panel at first and second floor levels. These remedial works are visible from Steam Mill Lane and can be seen in Figure 3 below.

Figure 3 – East Facing Flank Wall of Haven Bridge PH showing Lateral Restraint Remedial Works Tie Rods and Pattress Plates at First Floor & Second Floor Levels

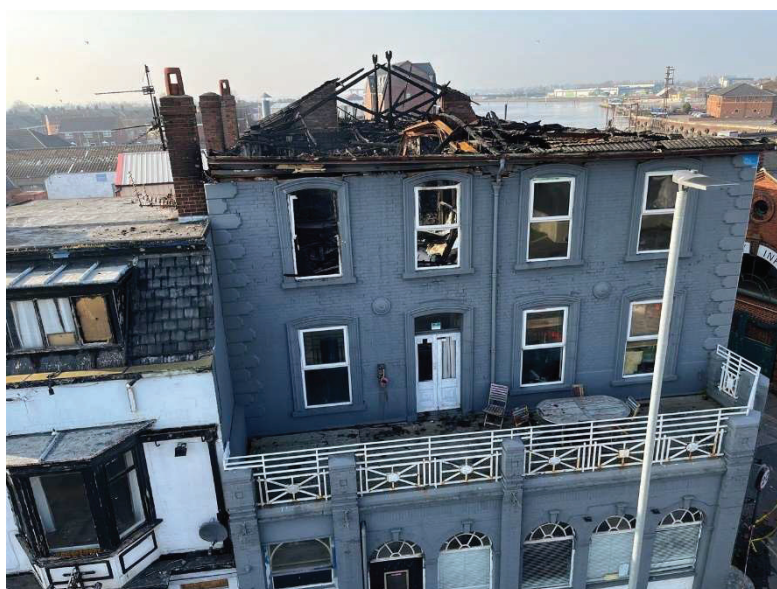
Figure 4 – Front Elevation View of Fire Damaged Building

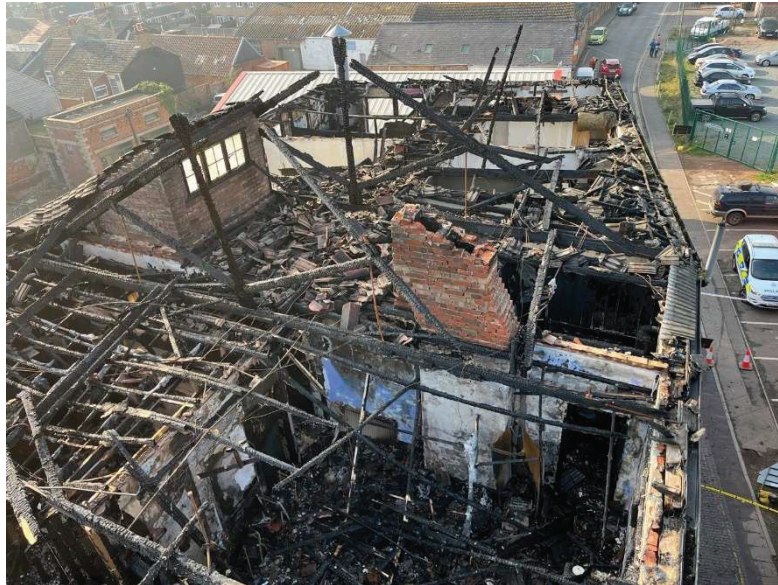
Figure 5 – High Level View of the Fire Damaged Central Roof & Second Floor Area Looking North

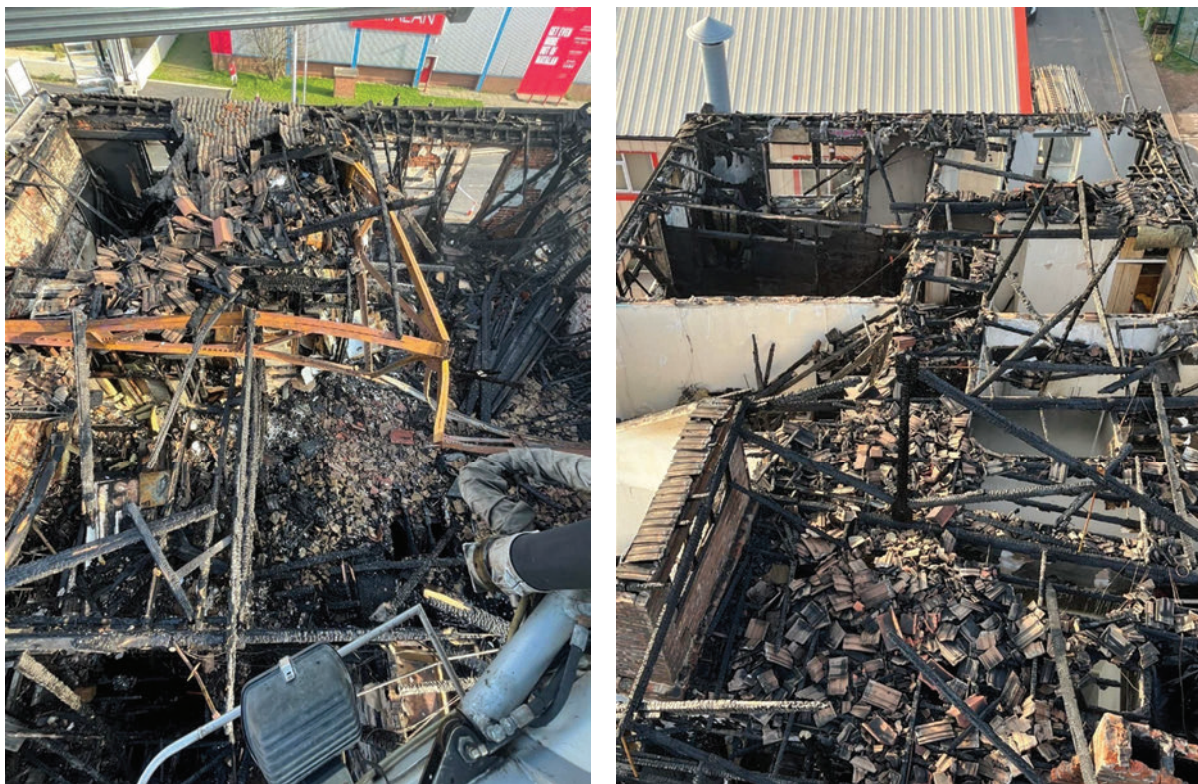
Figure 6 – High Level Views of the Fire Damaged Roof & Second Floor Looking South (left) and North (right)

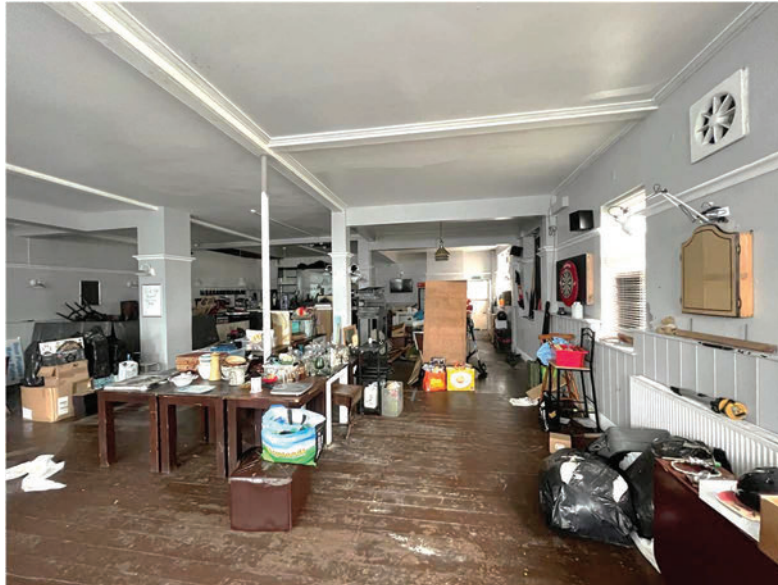
Figure 7 – Internal Ground Floor View from Front Entrance Door Looking North

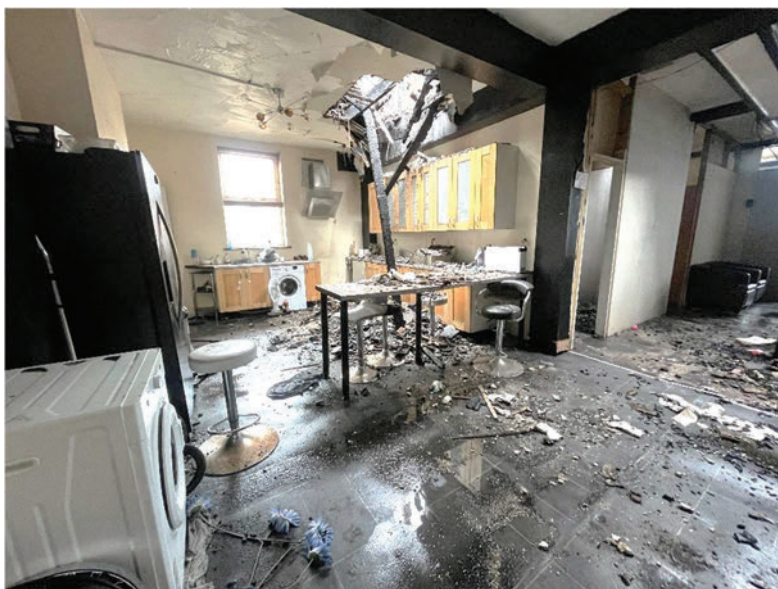
Figure 8 – Internal First Floor View Looking South-East from the Main Staircase

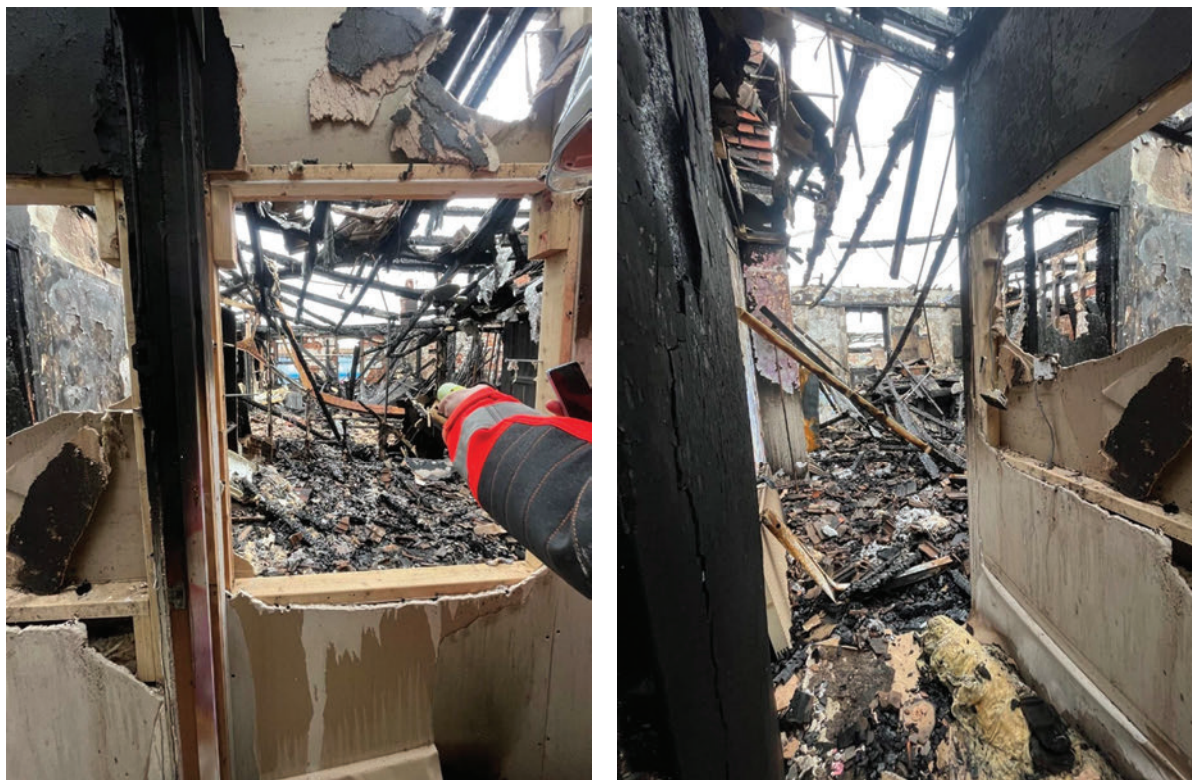
Figure 9 – Internal Second Floor Views Looking South (left) and North (right) from the Main Staircase

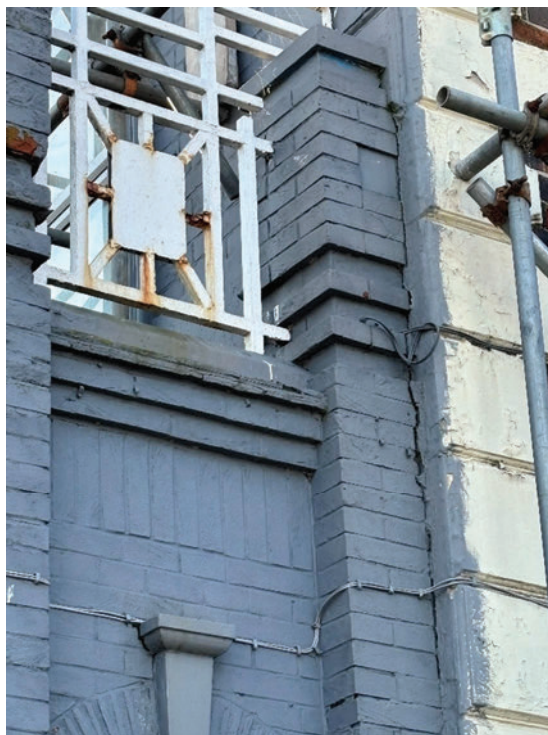
Long-term vertical tapered fracturing was observed at the junction of the brickwork piers to the single storey front projection and the main unit stone quoin courses in the eastern corner of the front elevation. Refer to Figure 10. This damage was present in March 2022, and does not appear to have worsened.

Figure 10 – Vertical Cracking at Junction of Single Storey Front Projection with Front Elevation of Main Unit

- a) Repair / locally rebuild damaged or defective areas of the external masonry wall panels to restore structural integrity and watertightness. Add tie rods, pattress plates, straps, etc. to ensure walls / floors are adequately restrained in accordance with current best practice construction guidance, structural design standards, and legislation.
- b) Undertake crack stitching repairs using stainless steel helical masonry reinforcement bars to any areas vertical or diagonal of crack damage to restore structural integrity.

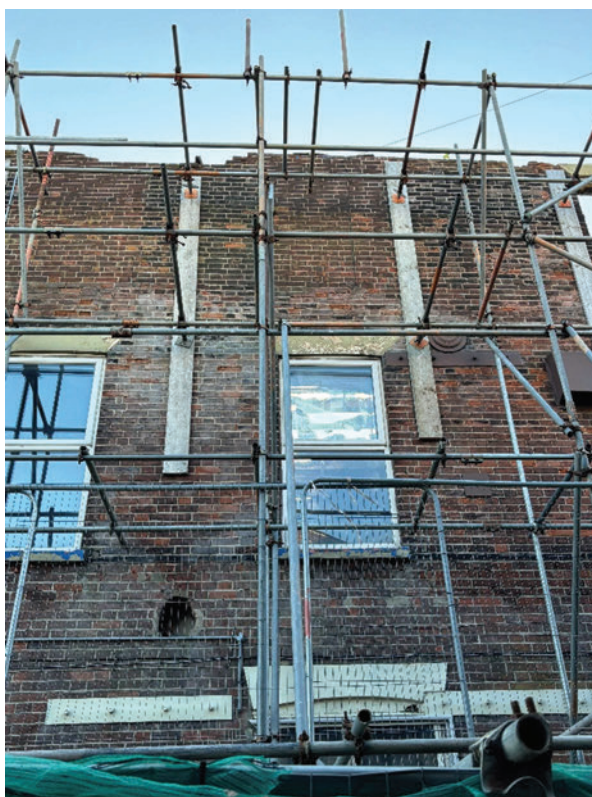
There is a loss of some localised sections of the side wall panel masonry at high level. This damage was caused by a combination of the of the roof structure collapsing, and subsequent removal of loose guttering and roof structure remnants by NFRS immediately following the fire. Refer to Figure 11. There does not appear to be any obvious signs of loose masonry falling to ground within the fenced-off area at the base of the side wall.

Six vertical scaffold boards are held against the vertical face of the side wall, each by two horizontal scaffold tubes and threaded scaffold jacking baseplates secured to the raking scaffold shoring system. These were installed to reduce the risk of outward movement of the wall panel following the fire damage. There are no internal lateral restraints or ties preventing inward movement of the external side wall panel as it was not possible to install internal ties during the fire event.

Figure 11 – View of Side Wall Showing Lateral Restraint Temporary Scaffold System and Localised Loss of Masonry at High Level

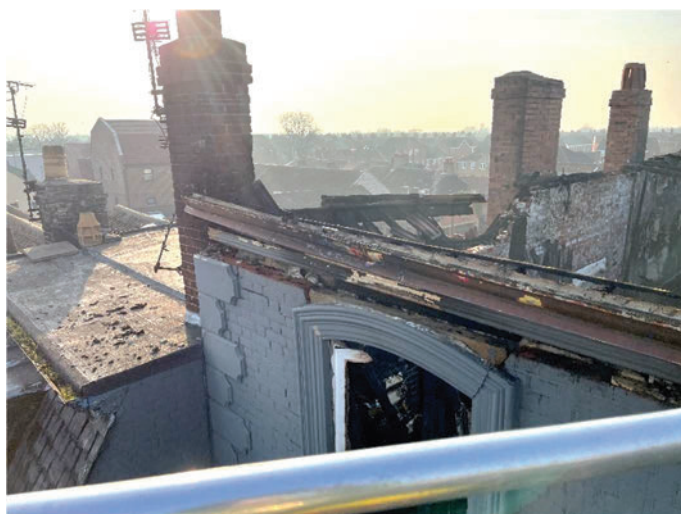
Three chimney stacks are present towards the front of the property on the party wall line with no. 6 Bridge Road. Based on their alignment (Refer to Figure's 12 & 13) it is believed that these chimneys serve no. 6 Bridge Road, not Haven Bridge PH. From our ground level visual inspection, the chimney stacks appear to be in reasonable condition, with no obvious signs of excessive distortion or structural movement.

Figure 12 – High Level View of Chimney Stacks on Party Wall Line
(Photo taken on 24th March 2022)

- a) Repoint, repair masonry stacks to ensure structural integrity.

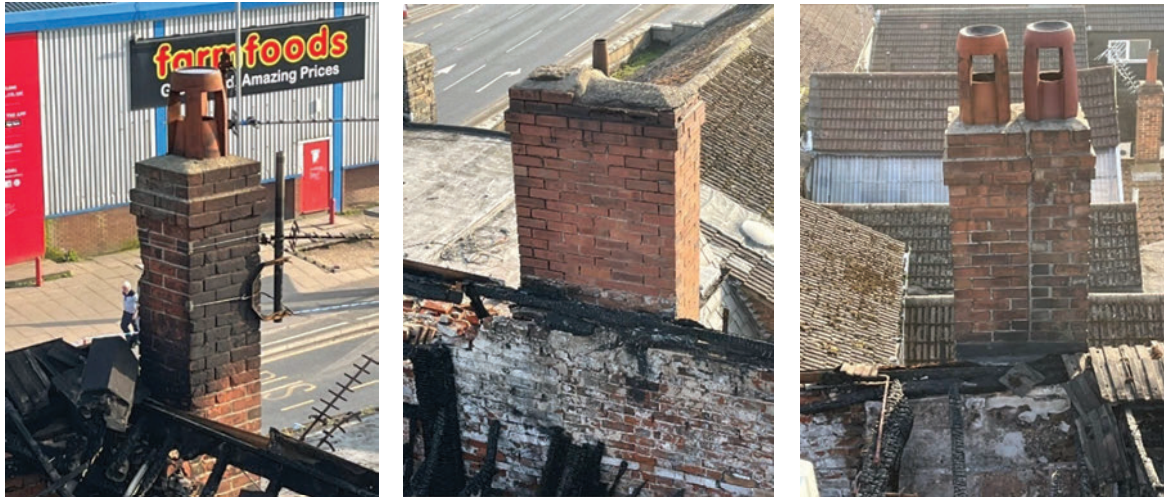
Figure 13 – High Level Close-up Views of Chimney Stacks on Party Wall Line
(Photos taken on 24th March 2022)
