Subject: South Denes Seawall High Level Assessment

Report to: Executive Leadership Team – 6th July 2022

Report by: Senior Coastal Advisor and Coastal Manager, Coastal Partnership East

5210393-REP-001

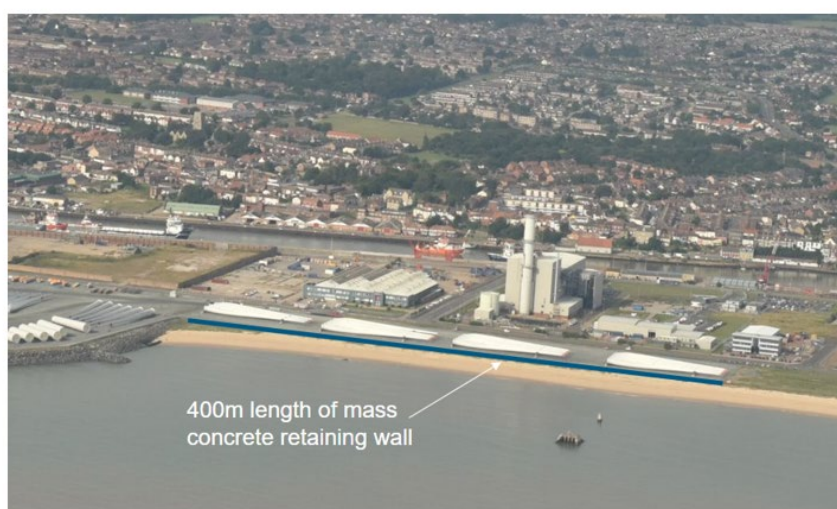
Figure 1-3 - Extent of the South Denes seawall under investigation

1.4 At the southern extent of the frontage at South Denes, Great Yarmouth, a seawall is the primary defence structure, as the beach is not expected to provide ample protection to the area and is likely to narrow and steepen as sea levels rise. The seawall is a mass concrete wall with local reinforcement at the connection to the coping and connections to ancillary items e.g., access steps and ramp. Figure 1-3 below shows the extent of the of the South Denes seawall under investigation.

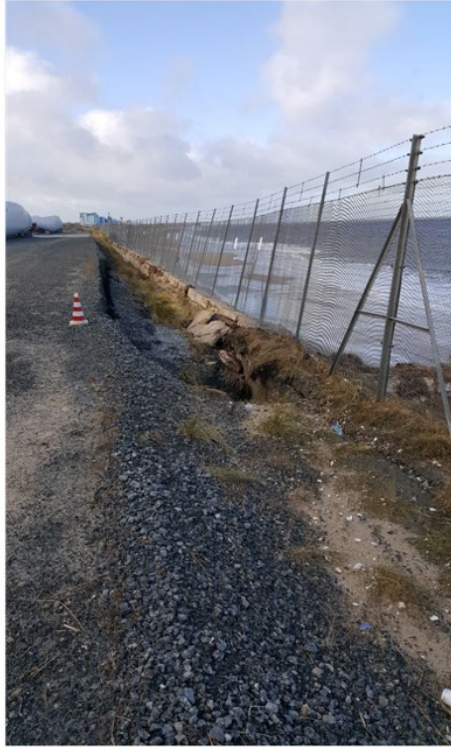
Figure 1-5 - Rotation of the wall (06/04/2020)

1.5 Following several storm events in early 2020, beach levels significantly reduced such that a section of the sea wall at South Denes, Great Yarmouth, was undermined, rotated forwards and a number of cracks formed. These are shown in Figures 1-5 and 1-6.

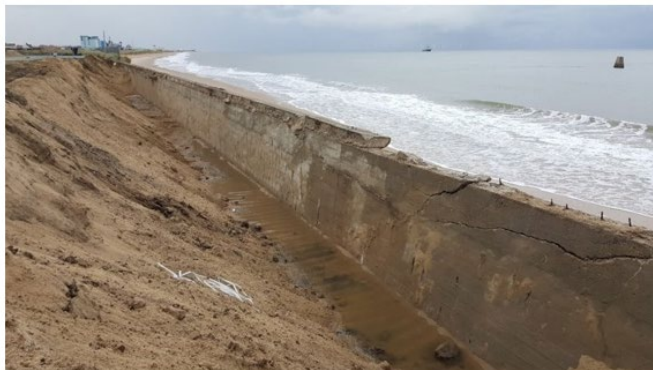
Figure 1-7 - Remedial works to relieve pressure on the landward side of the wall (23/09/2020)

- 1.6 Emergency works were completed in this location to reduce the forces acting behind the wall through temporary removal of materials, as shown in Figure 1-7.

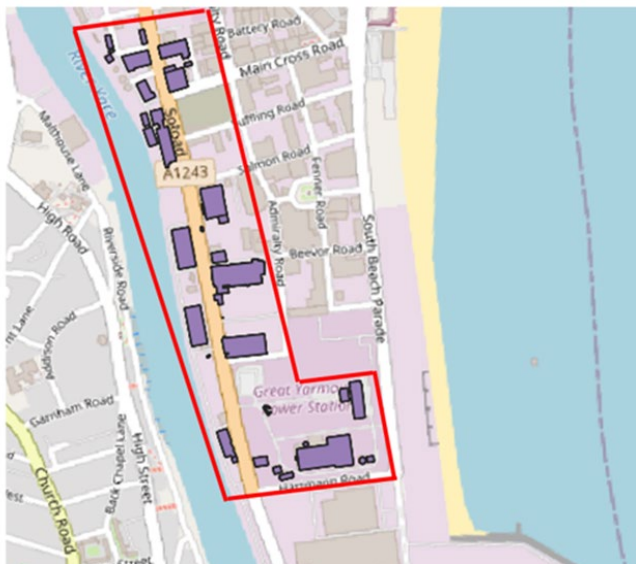
- 3.3 Below identifies the properties included in the flood damage scenario for the South Denes high-level economic assessment. Local topography has been assessed with professional judgement to derive a plausible flood route. The overtopping flood water moves from higher to lower ground, first in a westerly direction across the South Denes peninsula and north to lower ground. The scenario assumes that overtopping flood water is prevented from entering the river due to the presence of the flood defence. Property damages were assessed using the Multi Colour Manual (MCM) methodology. The MCM methodology provides a nationally recognised approach for assessment techniques of flood risk management benefits, including damage to property, indirect damages accounting for loss of the infrastructure due to a flood event and costs associated with emergency services responding to flood events.

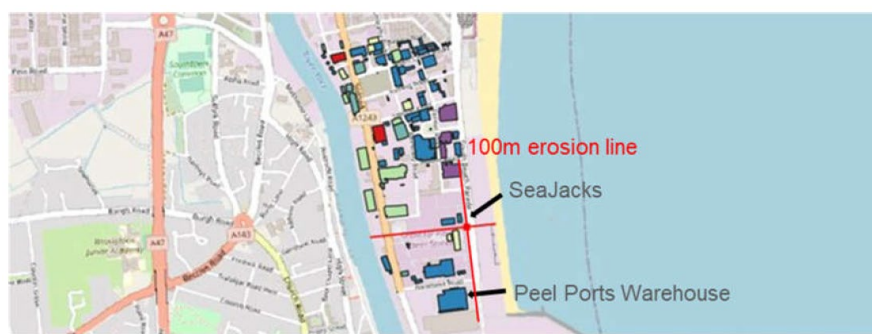
- 3.4 An extract from the report shows the properties included in the coastal erosion scenario for the South Denes high-level economic assessment. An erosion rate of 2.8 metres per year has been used to identify properties and assets which may be at risk to loss due to coastal erosion as part of the 'Do Nothing' scenario. These are businesses potentially being lost after 30-35 years, following approximately 100m of erosion assuming immediate failure of the wall at the present point in time.

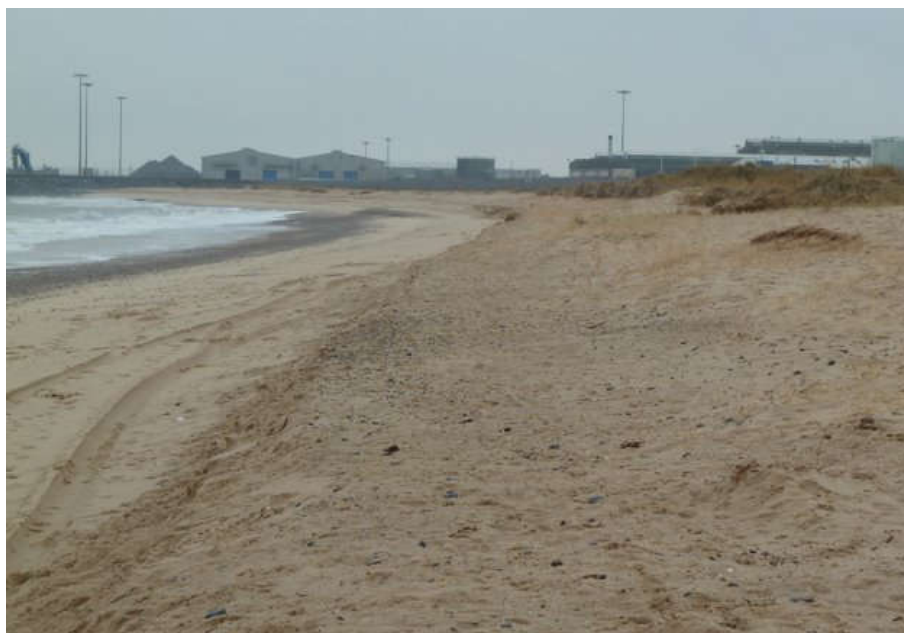
Figure 1-2 - South Denes beach (15/01/2014)

Great Yarmouth is a major area of industry and commerce and has also recently seen the construction of the Great Yarmouth Outer Harbour (GYOH) in 2007/2008. Except for the northern and southern extents of the town, defence is primarily provided by the wide beach, which has been fed by sediment derived from cliff erosion in north-east Norfolk. Figure 1-2 below shows the South Denes beach with relatively healthy beach levels.

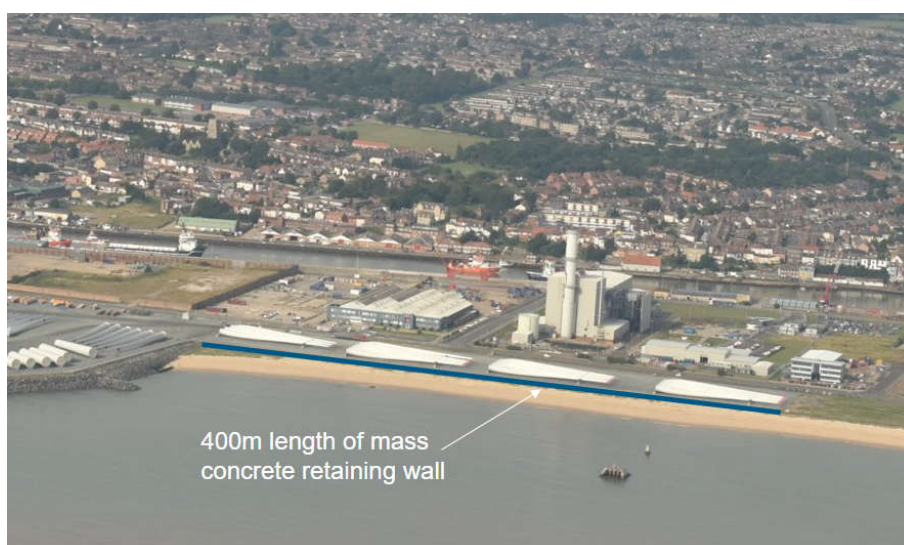
Figure 1-3 - Extent of the South Denes seawall under investigation

The Shoreline Management Plan policy for South Denes notes that the beach is expected to continue to provide ample protection without the need for any intervention, other than at the extremities, provided that a sediment supply is maintained. This should be assessed in the medium to long term. At the southern extent of the frontage at South Denes, a seawall is the primary defence structure, as the beach is not expected to provide ample protection to the area and is likely to narrow and steepen as sea levels rise. The seawall is a mass concrete wall with local reinforcement at the connection to the coping and connections to ancillary items e.g., access steps and ramp. Figure 1-3 below shows the extent of the of the South Denes seawall under investigation.

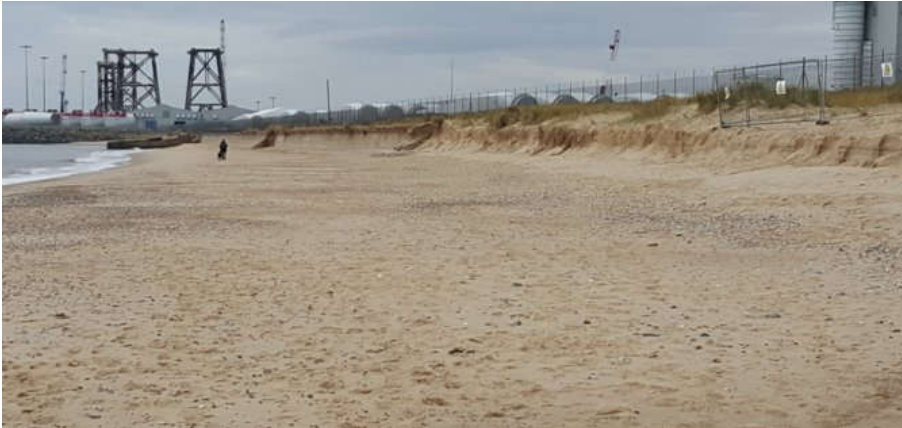
Figure 1-4 - South Denes beach with sea wall exposed (06/04/2020)

Following several storm events in early 2020, beach levels significantly reduced such that the wall was undermined, rotated forwards and a number of cracks formed (see Figure 1-4, Figure 1-5 and Figure 1-6 below).

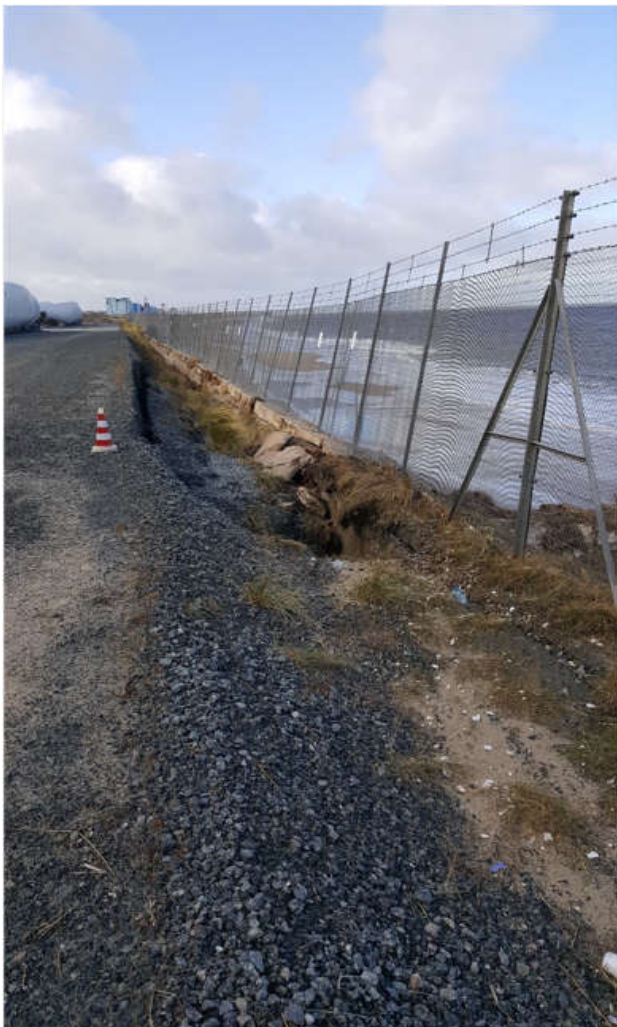
Figure 1-5 - Rotation of the wall (06/04/2020)

The undermining and deteriorating stability of the wall since early 2020 are a result of a combination of factors: depleted winter beach profile; wave reflection due to the vertical wall; and the severity and close timing of the storms which occurred at the start of 2020.

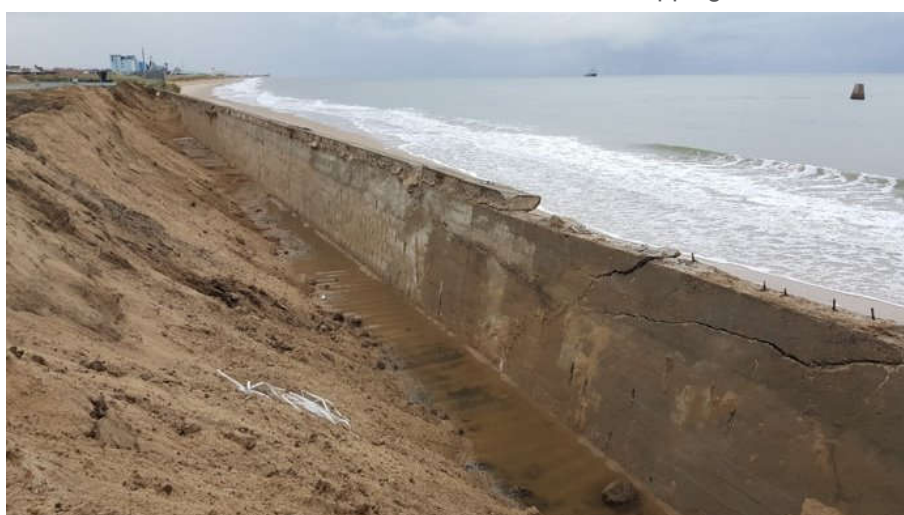
Figure 1-7 - Remedial works to relieve pressure on the landward side of the wall (23/09/2020)

Emergency works were completed in this location to reduce the forces acting behind the wall through temporary removal of materials (see Figure 1-7). However, further works are still required to repair or upgrade the seawall to reduce the risk of erosion and limit overtopping.

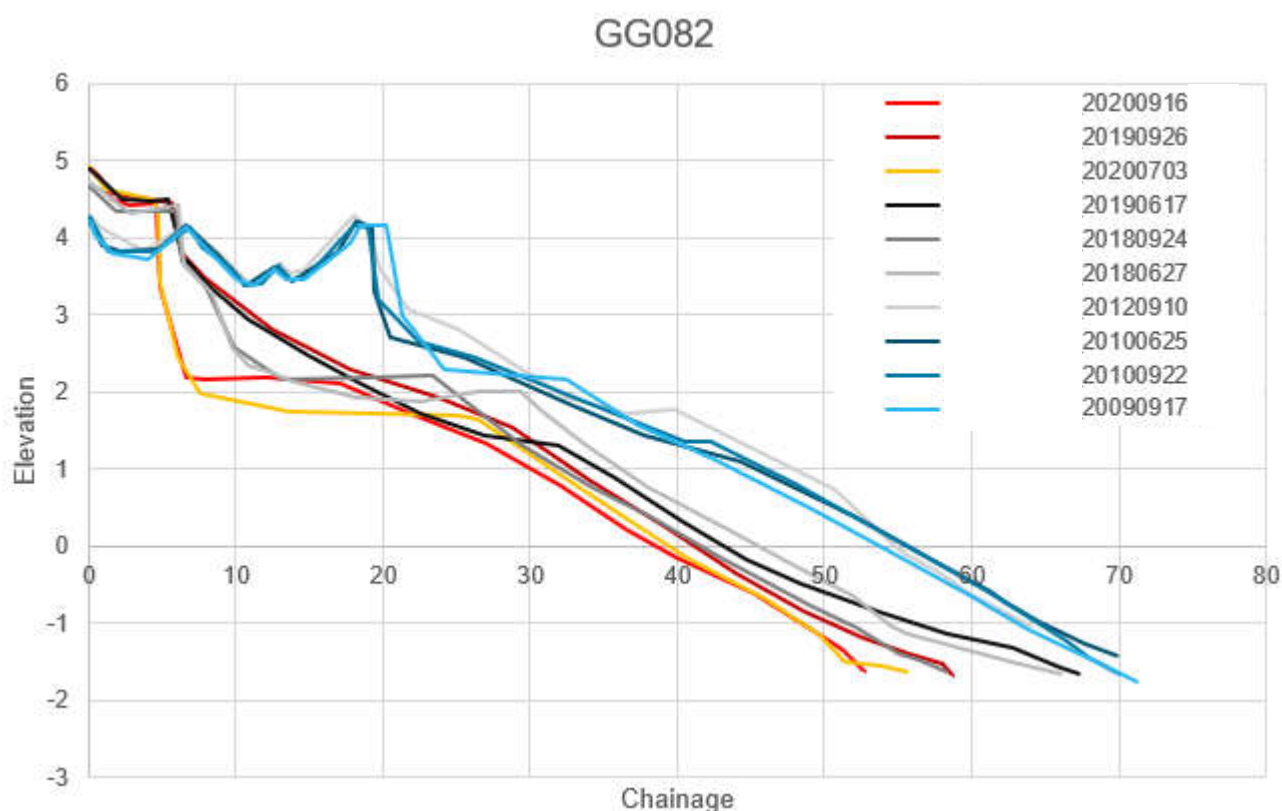
Figure 3-2 - Beach profiles from 2009 to 2020

Using the data from the National Network of Regional Coastal Monitoring Programmes [7], an assessment has been undertaken on the coastal retreat from recent years (2009 to 2020), see Figure 3-2. Figure 1-1 shows a series of beach profiles surveyed between 2009 and 2020. The analysis has considered all available profiles relevant to the study area.

Beach levels remained relatively stable until 2012 for both winter and summer profiles. Beach profiles vary but comparisons of data from 2020 and 2012 do show erosion rates of up to 3m per year over this period (e.g. 20120910 [Chainage 30m] and 20200916 [Chainage 6m] at +2.25mAOD), see Figure 3-3. This is consistent with Cefas's Shoreline Variability Report [5], which examines this same region between 1991 to 2010, and with the erosion trends mentioned in the reports assessed in the previous sections. Therefore, an erosion rate of 2.8m/year has been adopted for the purposes of the coastal erosion assessment.

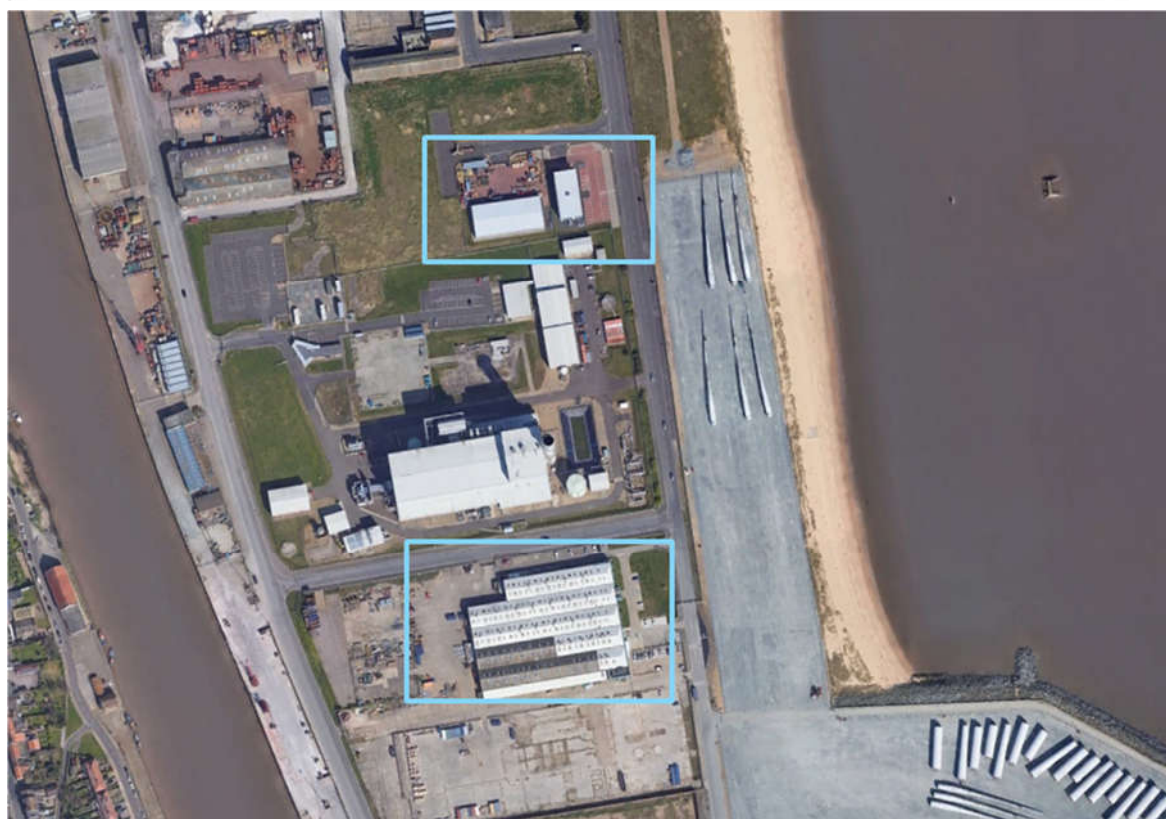
Figure 4-3 - Properties at risk due to erosion following immediate failure of the wall

Erosion rates have been used to identify non-residential properties which may be lost to coastal erosion during the appraisal period. These are non-residential properties being lost after 30-35 years, following approximately 100m of erosion, assuming immediate failure of the wall and erosion of approximately 3m per year. The damages associated with the loss of these properties has been included in the Do Nothing damages. Damages have been estimated according to the property capping value, flood area and discount factor for the year of loss (Year 33 in this case), see Figure 4-3.

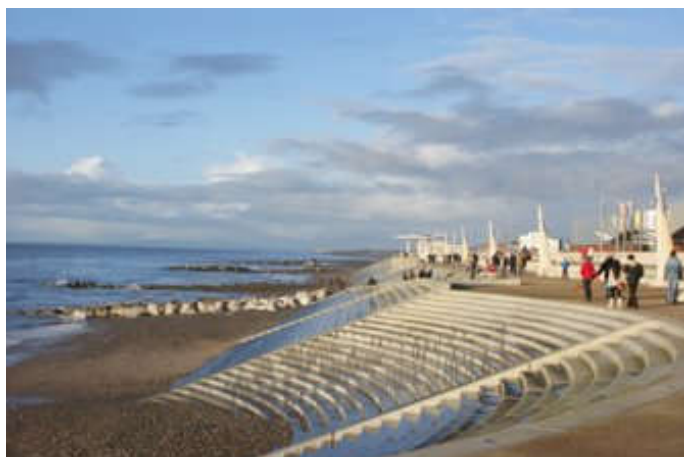
Figure 5-2 - Indicative stepped revetment structure [10]

Advantages: Efficient, accurate and high quality construction with prefabricated components. It is noted that this option may require a sheet piled toe for stability.

Disadvantages; adverse visual impact, loss of amenity (beach space), relatively expensive when compared with a rock option, stability issues with energetic wave climates (e.g. where $H_s > 2\text{m}$).

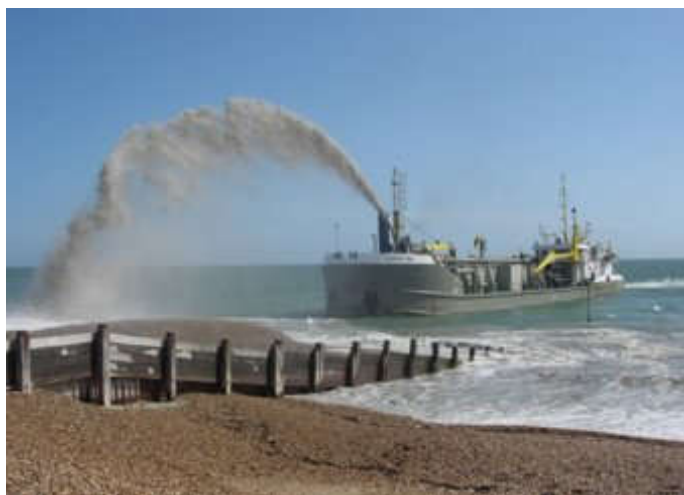
Figure 5-6 - Beach nourishment at Hayling Island [12]

This option involves significant beach recharge to minimise maintenance/replacement of the seawall as shown in Figure 5-6.

Advantages: ease of solution, import “X” m³ of material every “Y” years, Widens the beach, protects structures behind beach, environmentally friendly, helps stabilize tidal flats.

Disadvantages: material will wash off or move under the influence of storms, not a “one off solution”. It is noted that this option will have to be adopted along with one of the previous beach control structures.
