URN: 22-093

Subject: Scratby Damaged Gabions, Options and Recommendations

Report to: Environment Committee, Tuesday 13th September 2022

Report by: Colin Bye, Senior Coastal Advisor, Coastal Partnership East

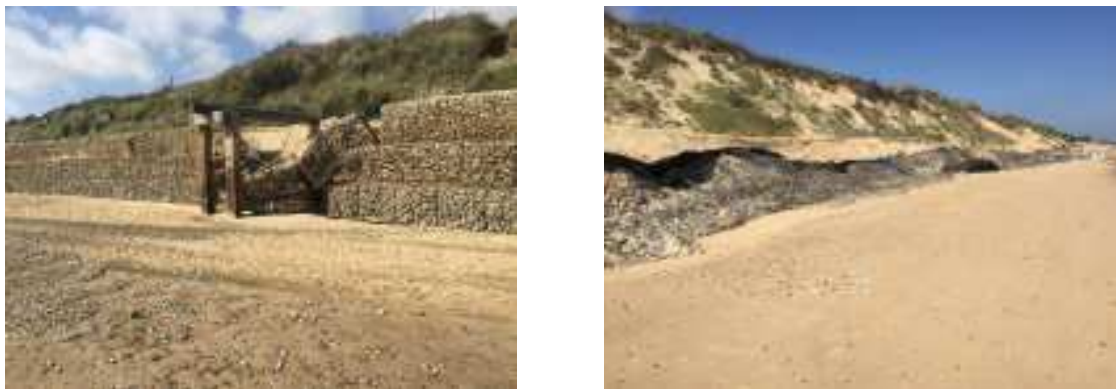
In 2018 significant damage was done to the north-western section of the gabion structure as a result of the storm conditions in late winter/early Spring known as the ‘Beast from the East’, resulting in a further investment of £420,000 to repair this storm damage. Figure 1 shows the damage to the gabion structure in 2018.

Figure 1 Previous damage to Scratby Gabions following the Spring 2018 ‘Beast from the East’

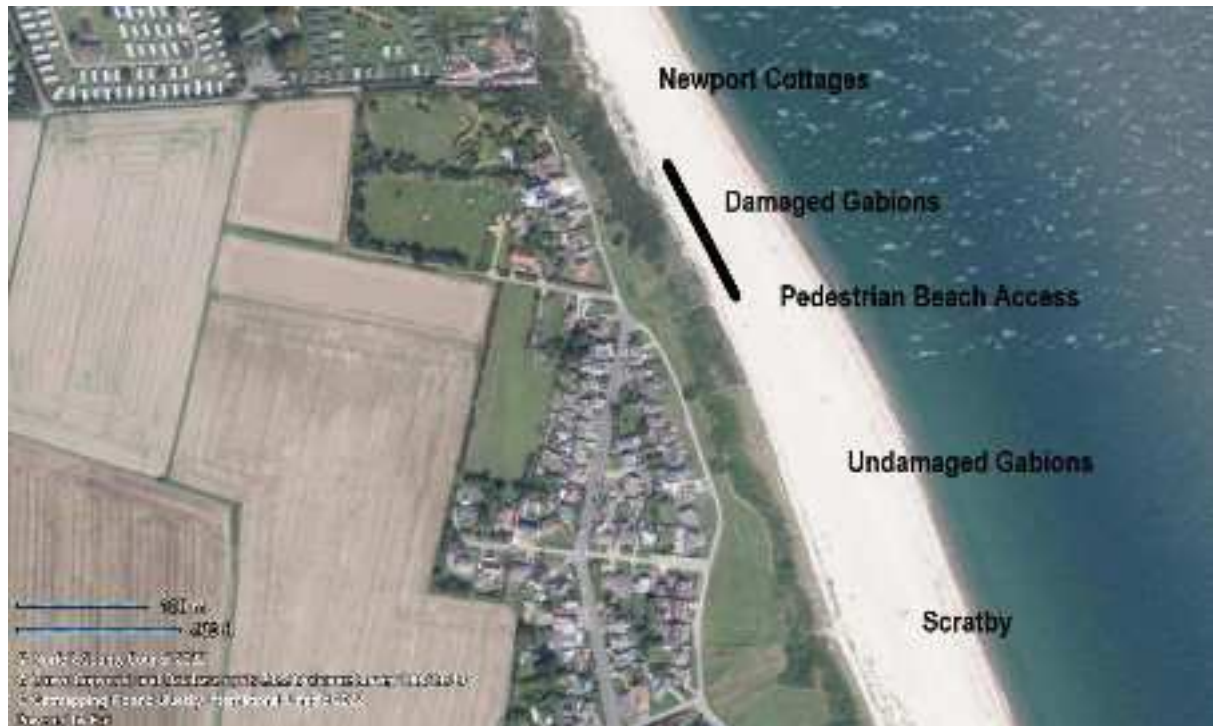
On the evening of 31st March and 1st April 2022, storm conditions led to significant beach lowering along the north-western extremity of the Scratby gabions. The base of the gabion structure was exposed by the lowered beach, causing collapse of the gabion structure in the immediate vicinity of the pedestrian beach access and a forward rotation of the gabion structure immediately to the north-west of this access. Figure 2 shows the location of the gabion structure which was damaged in the storm event of the evening of 31st March and 1st April 2022, with Table 1 summarising the timeline for construction work/activities and storm events/damage along the Scratby gabions frontage between 2015 and 2022. Figure 3 shows changes along this length of coast before and after the storm event of 31st March and 1st April 2022. These include a significant drop in beach levels, loss of the gabion

Figure 2 Location of damaged Scratby Gabions following the storm event of the evening of 31st March and 1st April 2022

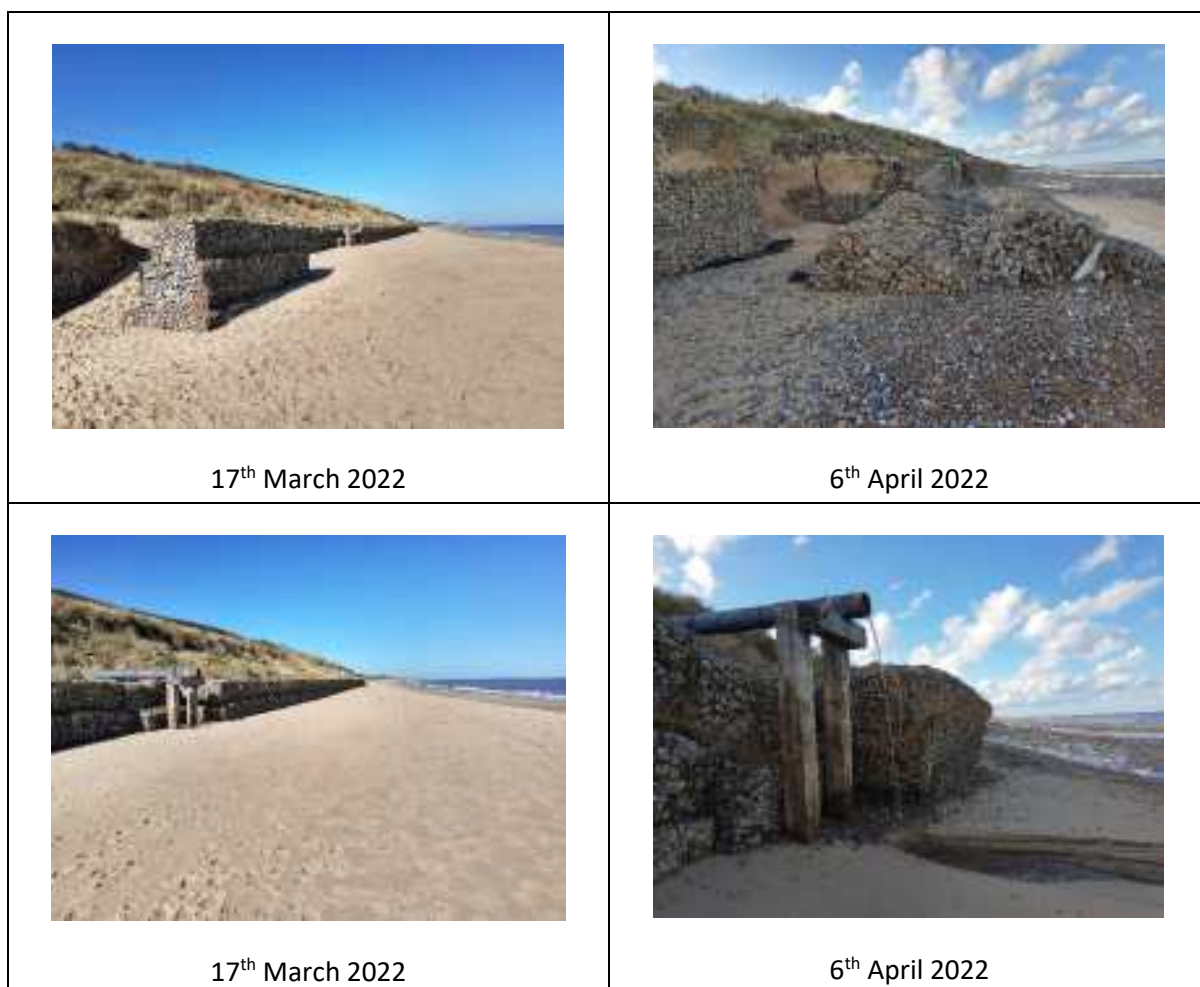
structure in the immediate vicinity of the pedestrian beach access and forward rotation of the longer gabion structure. Figure 4 gives additional views of the forward rotation of the Scratby gabion structure.

Figure 3 Lowering of beach levels and subsequent damage to Scratby gabion structure, March 2022 to April 2022

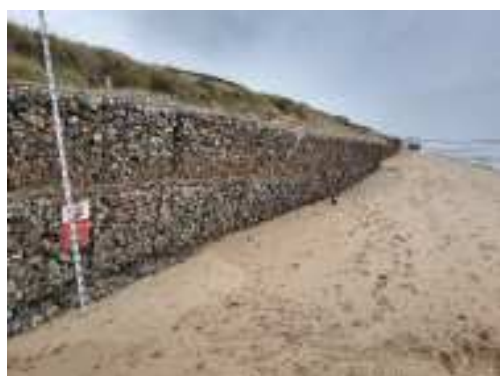
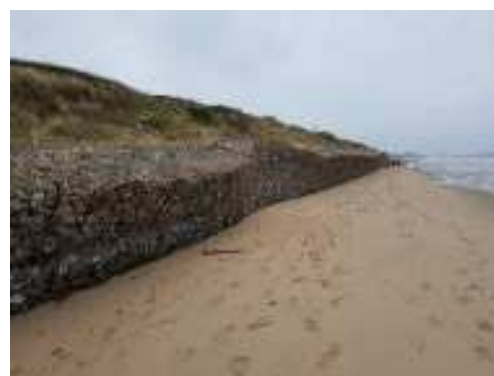
4th May 2022

Figure 4 Forward rotation of the Scratby gabion structure, following the storm event of the evening of 31st March and 1st April 2022.

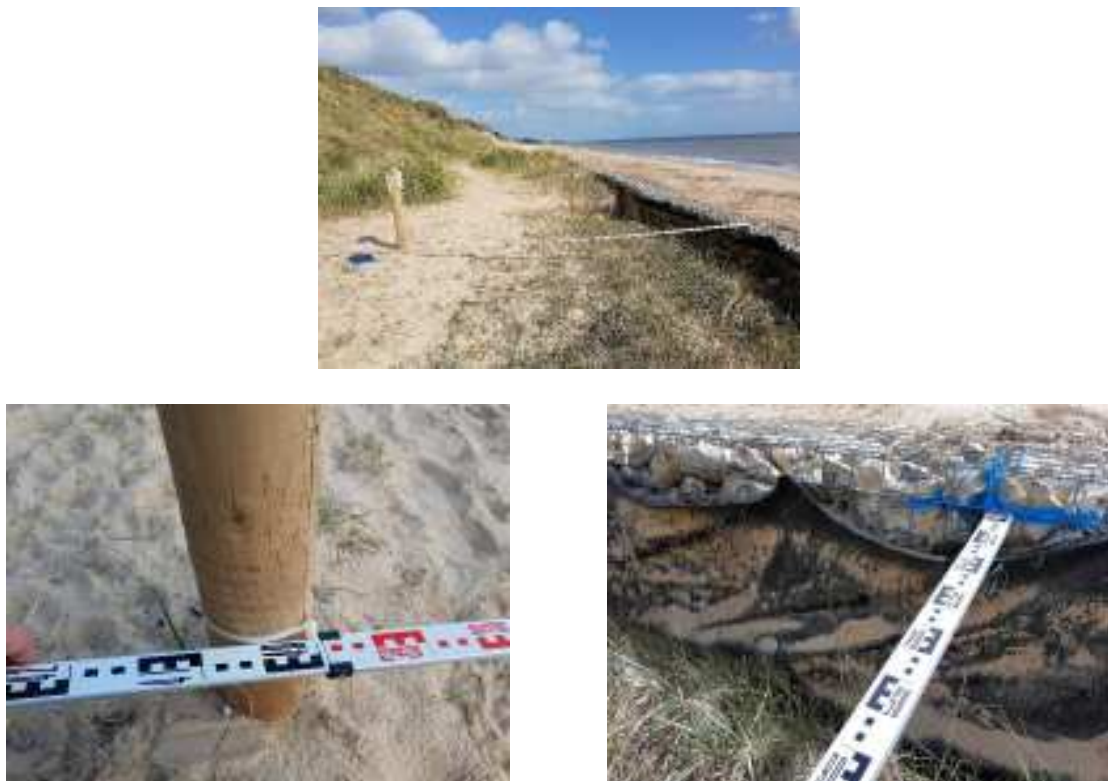
Since the damage to the gabion structure following the storm event of the evening of 31st March and 1st April 2022, the area behind the gabions has been fenced to restrict public access and warning signs have been placed on site. Regular monitoring has been completed by the Coastal Partnership East team, with measurements being taken from fixed points located on wooden posts to the rear of the line of damaged gabions to the crest of the gabion structure. The process of taking measurements from the fixed monitoring points is shown in Figure 5. This monitoring has shown no movement of the crest of the damage gabions.

Figure 5 Monitoring of damaged Scratby gabions

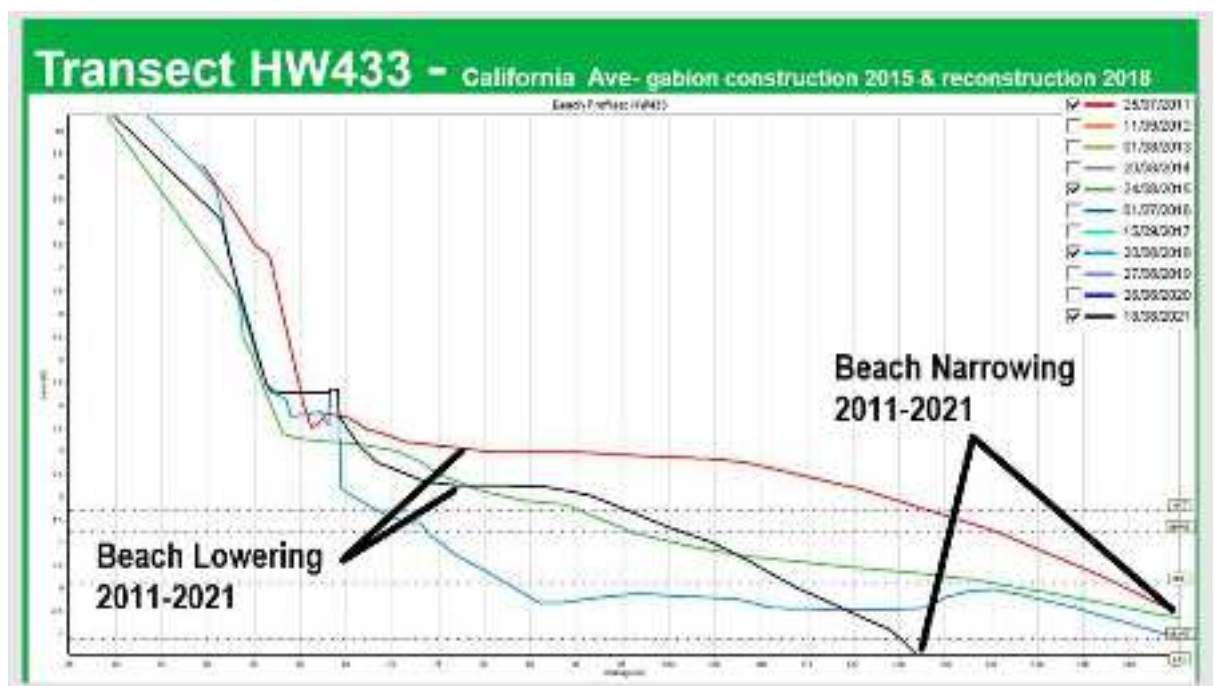
Figure 6 shows survey data for a beach profile cross section location at the northern extremity of California Avenue, Scratby, provided by the Environment Agency through the Anglian Coastal Monitoring Programme. This is in the immediate vicinity of the damaged Scratby gabions. The 2021 survey shows that the beach is lower and narrower than that

surveyed at this same location in 2011. This survey data also shows the beach height at this same location being lower in the 2018 survey compared to the 2015 survey, with 2015 being the year of initial construction of the gabions and 2018 being the year of reconstruction of the damaged gabions following the 'Beast From The East' storm. Lowering of beach levels increases the instability and potential for wave impacts to the Scratby gabion structure. Higher beach levels provide more support to the Scratby gabion structure. It must be emphasised that significant lowering/building up of the beach can take place over a period of a few weeks following a storm event.

Figure 6 Anglian Coastal Monitoring Programme Beach Level Data, 2011, 2015, 2018 and 2021, for transect HW433 in the immediate vicinity of the Scratby damaged gabions

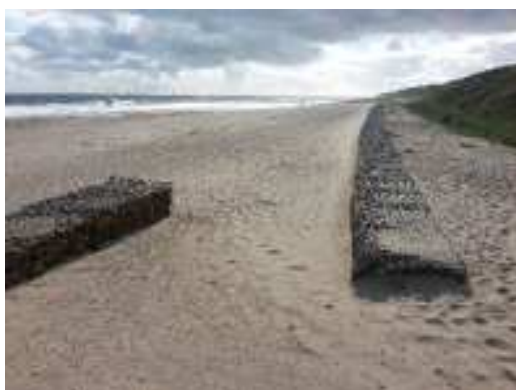
Beach Access, 2016

Figure 7 provides photographic evidence of the lowering in beach levels in front of the gabion structure at the site of the Scratby damaged gabions, which have occurred between 2016/2019 and 2022. Figure 8 shows recent beach levels, to the immediate north-west and south-east of the site of the damaged Scratby gabions. These photographs show the presence of a relatively shallower and narrower beach and exposure of the gabion structure at the north-western extremity of the damaged Scratby gabion structure, with a relatively higher and wider beach to the south-east with the gabion structure being buried beneath sand deposits in the upper beach.

Figure 7 Longer term changes in beach height at the site of the Scratby damaged gabions

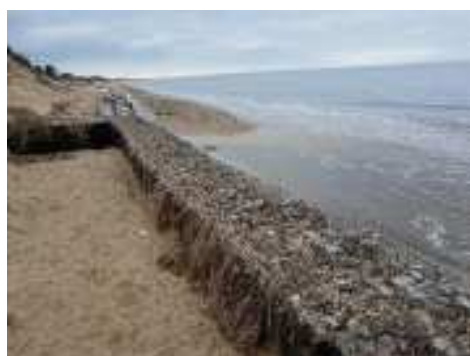
North-West of Damaged Gabions
19th May 2022

Figure 8 Recent beach levels to the immediate north-west and the south-east of the site of the Scratby damaged gabions
