GREAT YARMOUTH
BOROUGH COUNCIL

Environment Committee

Venue: Supper Room

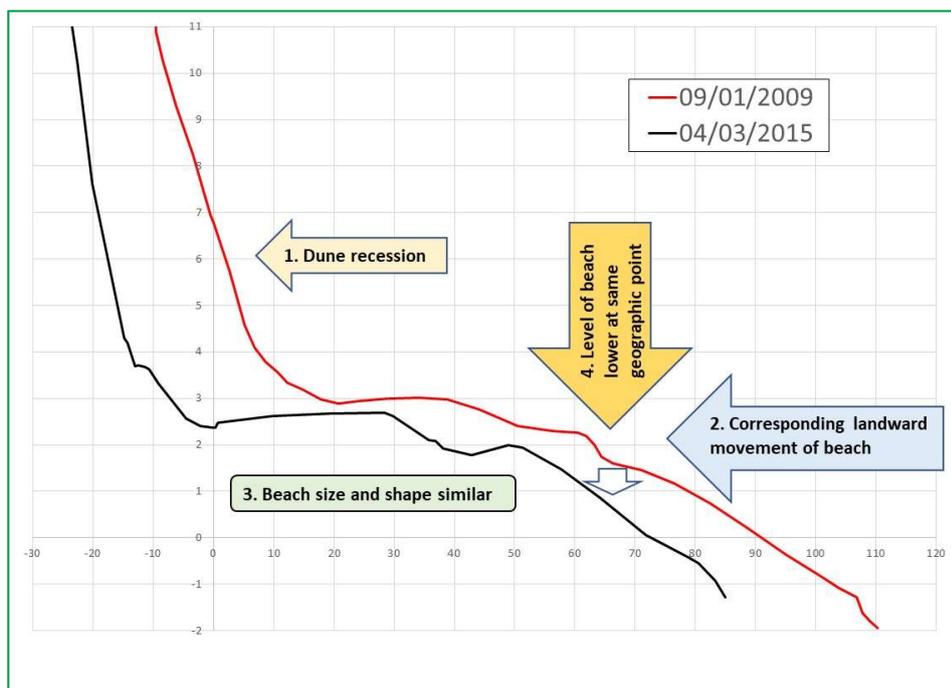
To the naked eye the beach may look similar now to in the recent past, but its position has changed and with this the depth of water over the place that beach previous occupied has increased. To illustrate this point, Figure 3.1 compares two profiles from 2009 and 2015, and shows that although the size and shape and size of the beach is similar, because of the ongoing natural transgression, the whole profile has shifted landward. This means that although the distance between the toe of the dune and high water is similar, the point where high water was in 2009 is more than a metre lower by 2015.

Figure 3.1 Illustration of beach transgression at Hemsby.

system resulting from continued landward movement of the nearshore channel. That translates to an ongoing lowering at the point where the defences were installed, which would lead to them being undermined and failing, if not bedded deep enough into the beach. This process has already been observed at Hemsby, with undermining of the HexiBlocks and gabion wall. This is independent of any beach scouring that might also arise from wave reflections off the new structure.

In the above example, the defence would have needed to have been founded at least 2 m lower, to accommodate beach changes over just a 5-year period, and remain stable. Although that is perhaps an extreme example, this same process will continue and any structures built now would also need to accommodate such changes and more, to address the continuation of this process, if they are to provide many years of protection. Another consequence of this process is that the accommodation space in which sediment can accumulate is being squeezed even further and there is no means to hold material moving along that stretch of shoreline. Ultimately, that may mean there would no beach in front of the structures.

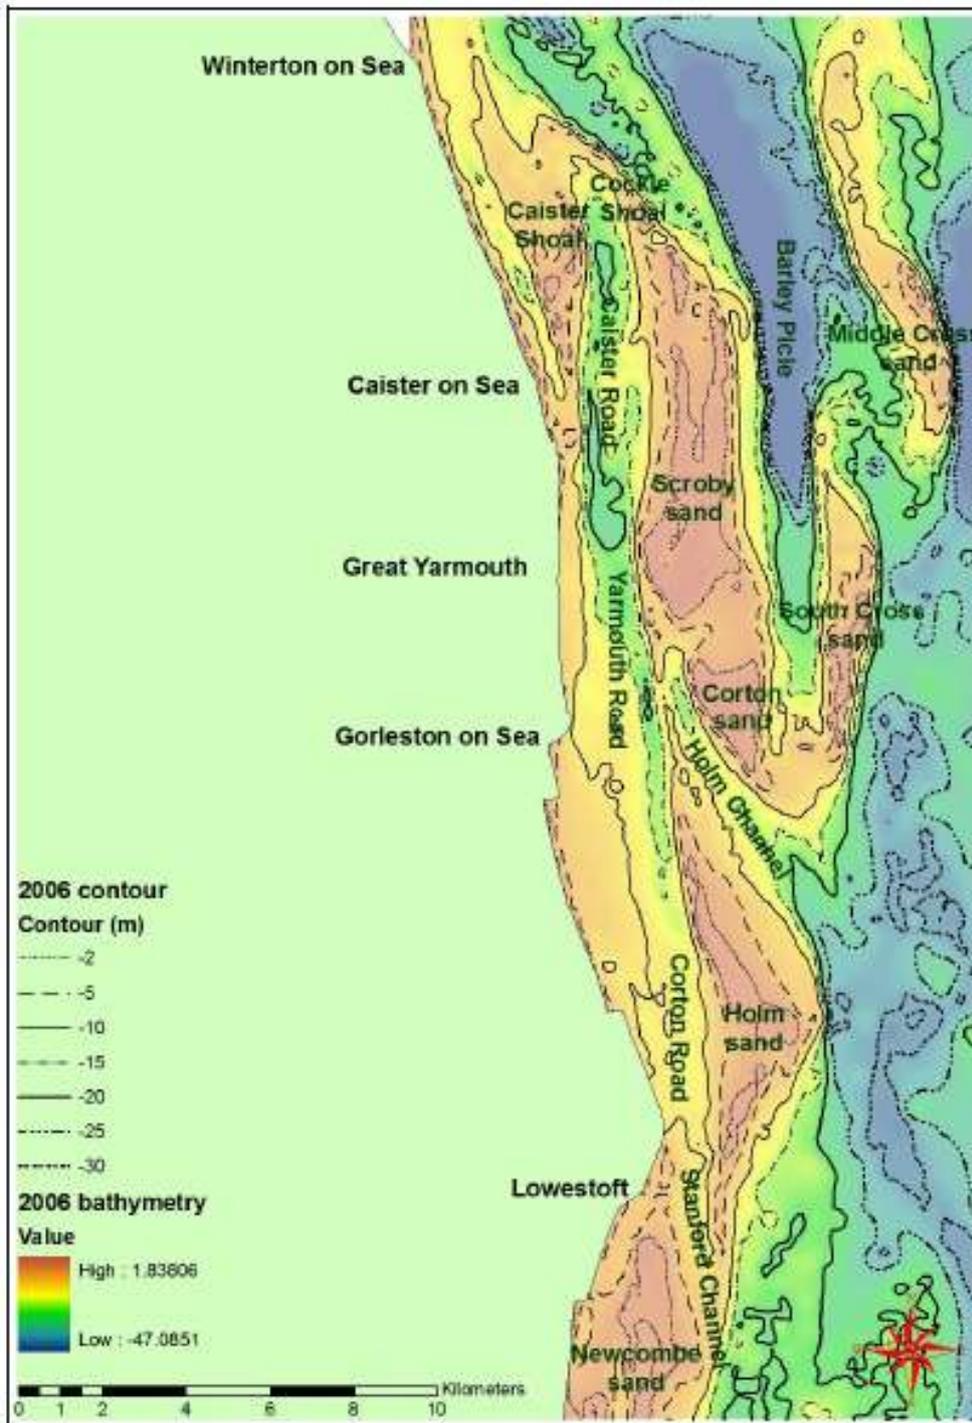
The banks are a significant sink for sand in the Southern North Sea (Cooper et al., 2008) and they are estimated to be around 620 million m³ in volume. The banks roughly follow the shoreline and are interlaced with flood and ebb channels (Robinson, 1966) at fairly regular intervals.

Figure 3 Sandbanks and channel features of Great Yarmouth Banks (taken from Bakare et al., 2010; based on 2006 bathymetry)

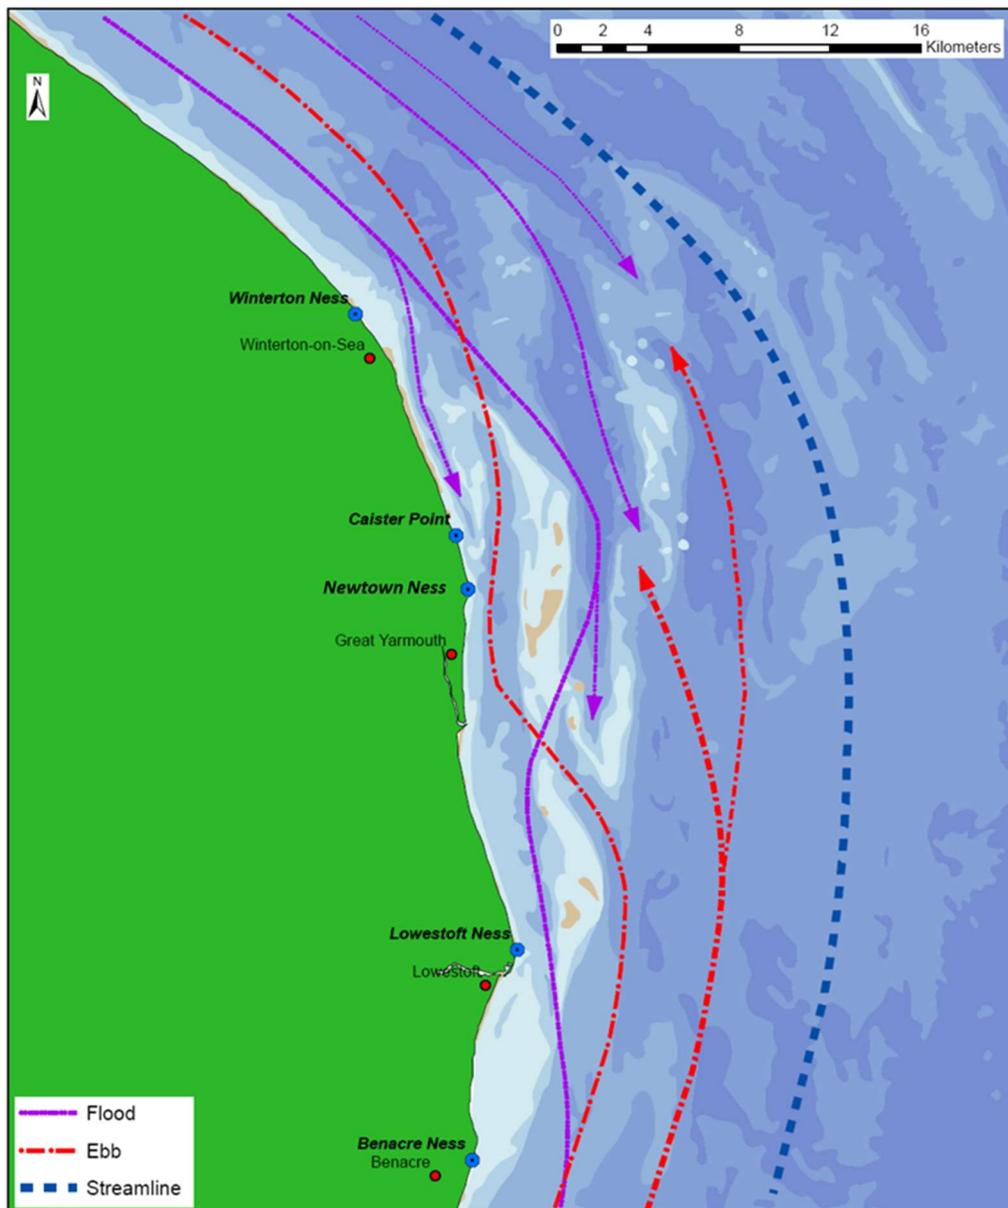
Figure 7 Patterns of flood and ebb flow through the bank system. Taken from Barber (2016, modified from Cooper et al. (2008)).

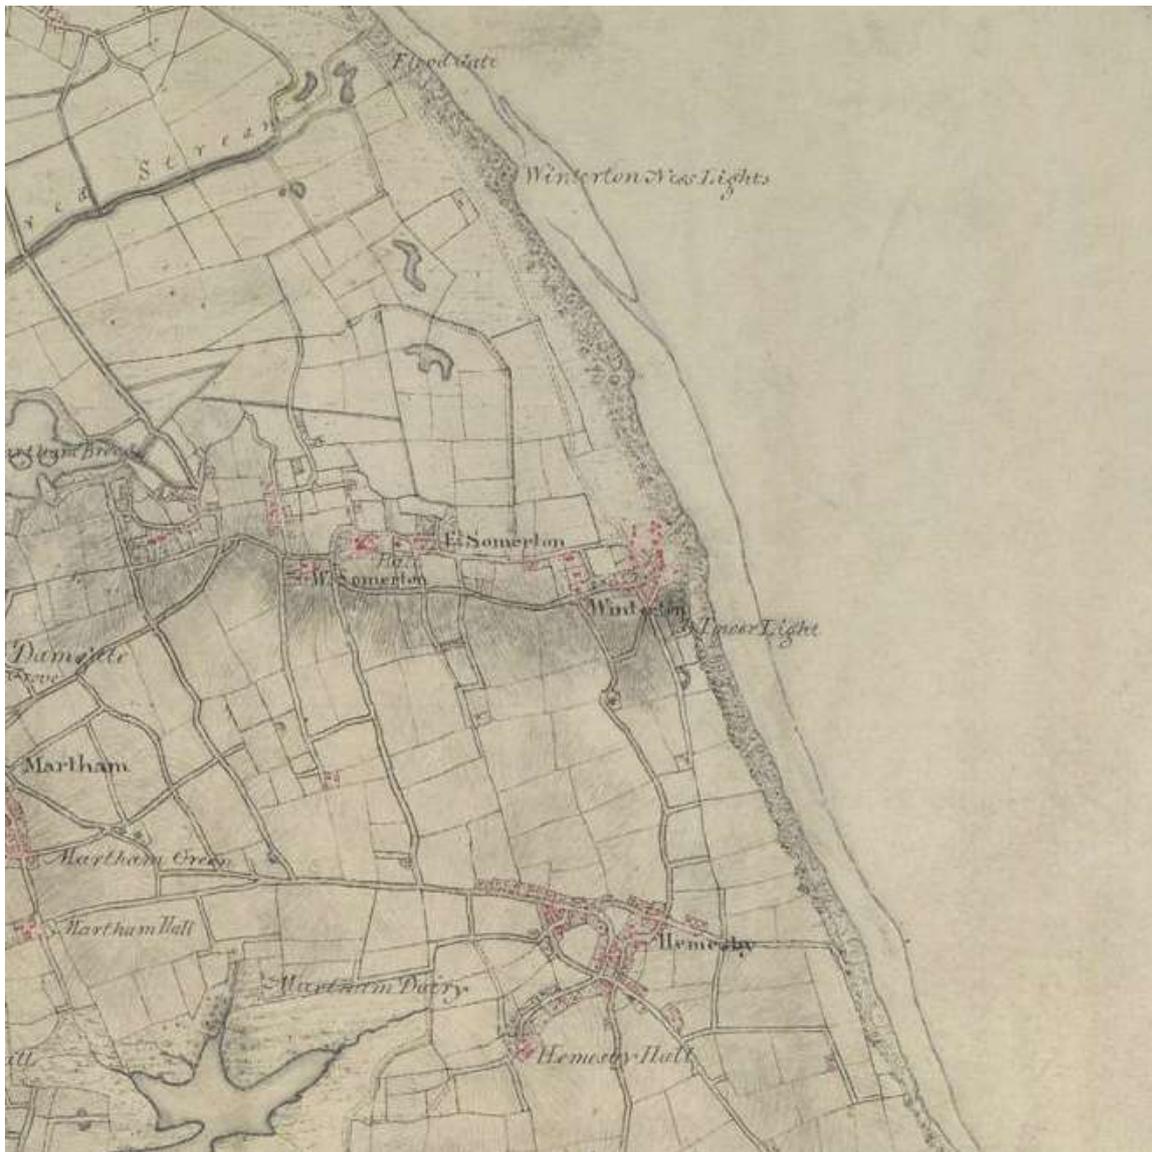
Figure 8 Early drawing of the coastline, assumed to date from 1817, by Charles Budgen (available from British Library online catalogue; www.bl.uk/onlinegallery/)

A later, more detailed, map is available from the early 1800s (possibly 1817), by Charles Budgen (Figure 8). This also shows the three distinct nesses in the region of the current Winterton Ness, the shape of which suggest a southward movement of material. Based on the field boundaries, there is evidence that erosion of the cliffs had subsequently occurred along the Hemsby frontage. It is not clear whether there are dunes along the frontage at this time, but the maps do indicate a vegetated or scrub area, which roughly corresponds to the location of The Valley.

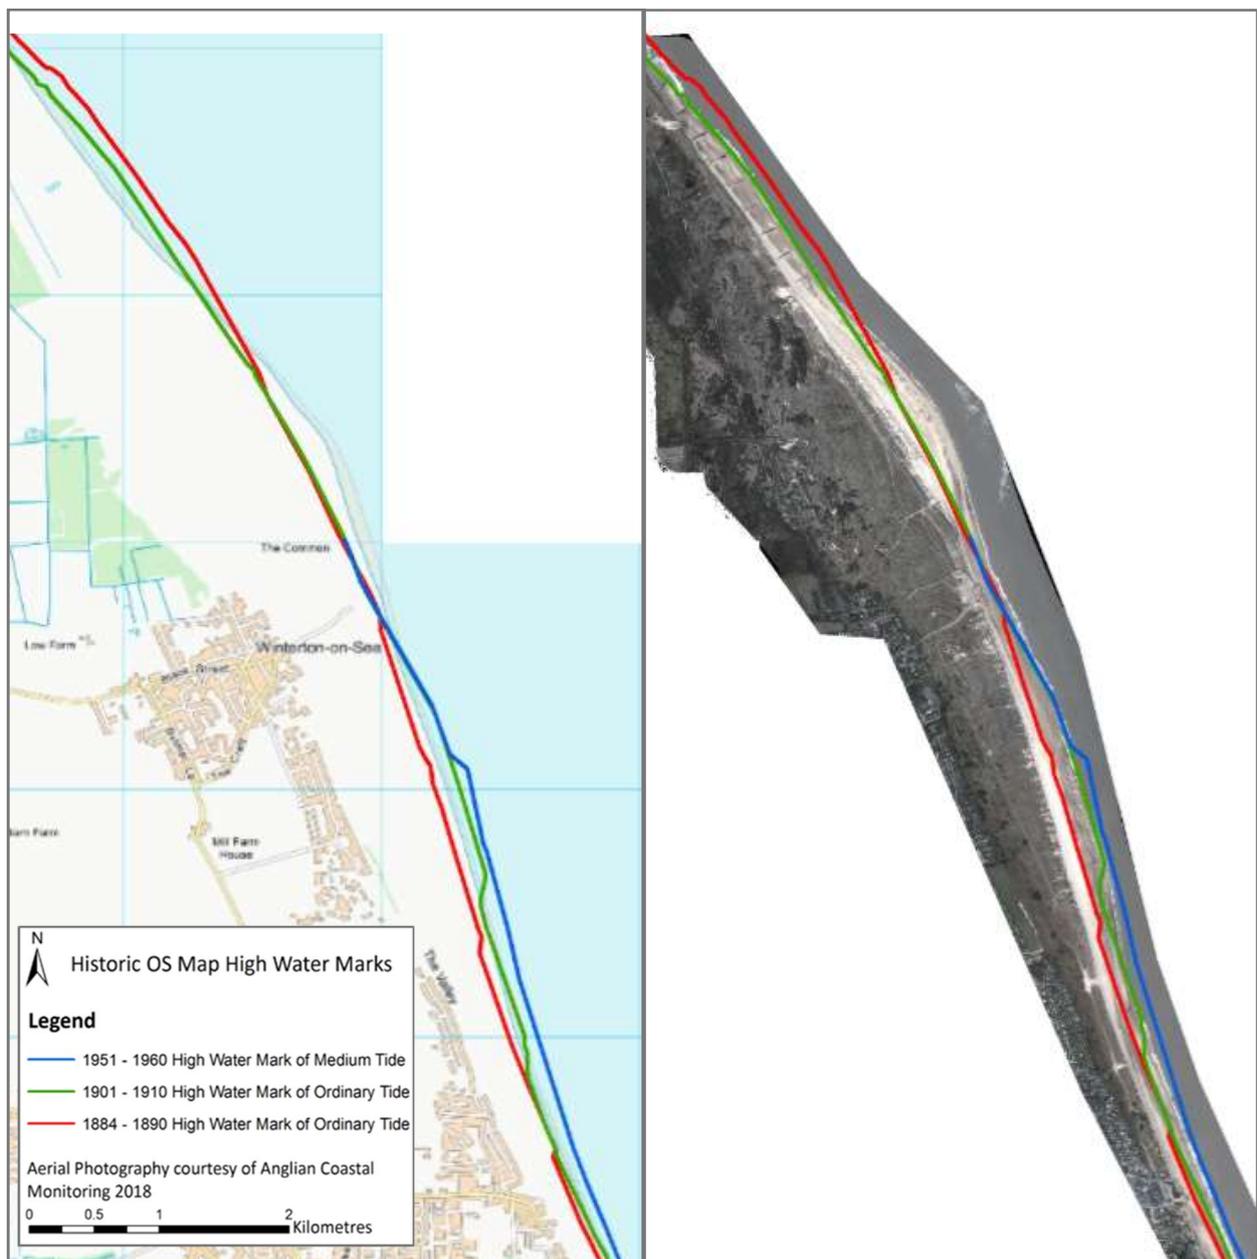
From the historical Ordnance Survey maps, the mapped position of high water mark has been extracted. These are shown in Figure 9 below, with (a) the latest OS mapping and (b) the 2018 aerial photograph used as backgrounds. The figure shows that there has been a large-scale realignment of the shoreline over the past 130 years. To the north of the ness there has been net retreat, whilst to the south of the ness, there was a period of growth followed by net retreat. The ness itself has distinctly changed in form from a more elongate configuration to a distinct peaked form. This pattern of change also concurs with earlier maps, for example Budgen’s 1817 edition (see Figure 8) which showed the ness formerly consisted of a more elongate feature with a number of protrusions, rather than a single pronounced point.

Figure 9 Changes in the position of mean high water, derived from historical Ordnance Survey mapping. Note that the definition of the mapped line changed between the 1901/1910 and 1950/60 map editions, but it is assumed that they can be taken to mean the same i.e. the tide lines half-way between neaps and springs; however, the limitations of the data sets should be recognised.

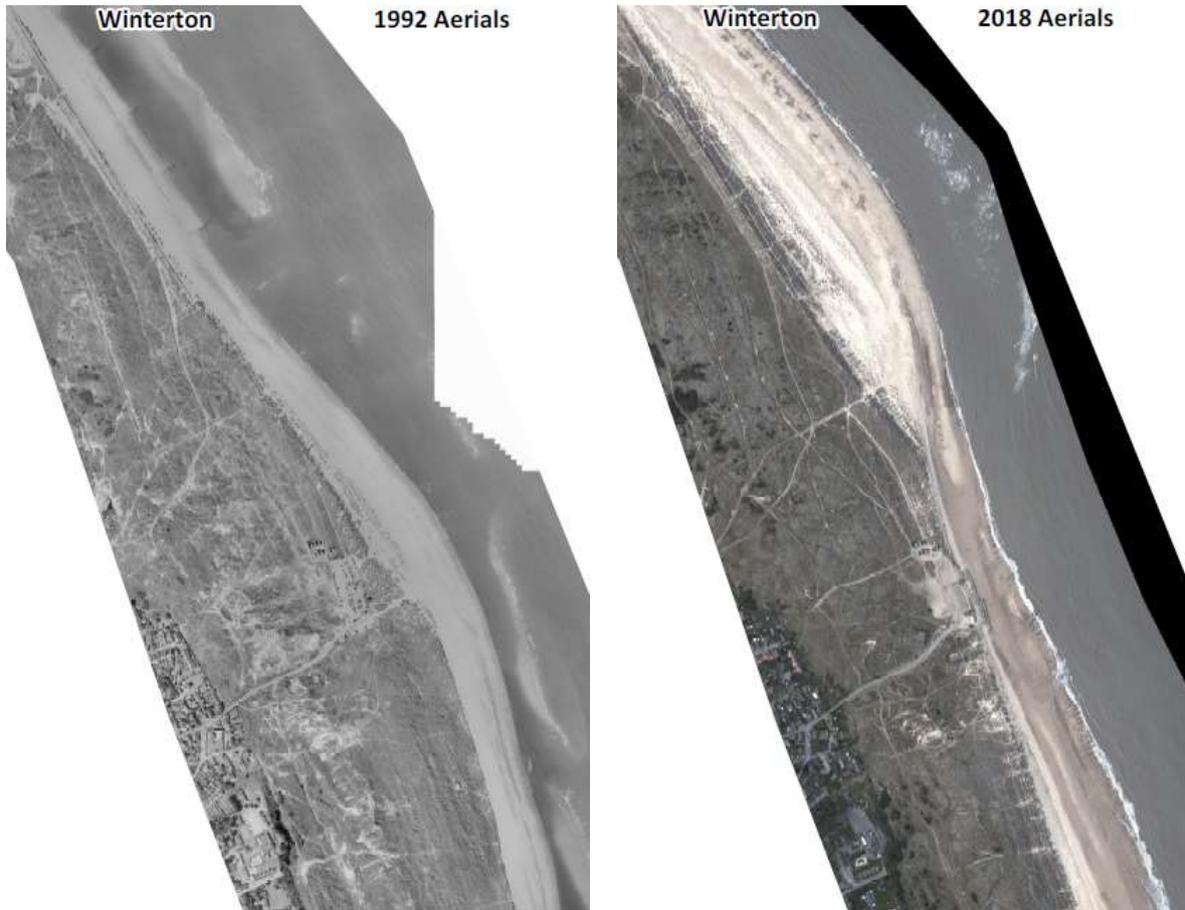
Figure 10 Comparison of 1992 and 2018 aerial, showing the northward movement of the ness over this time.

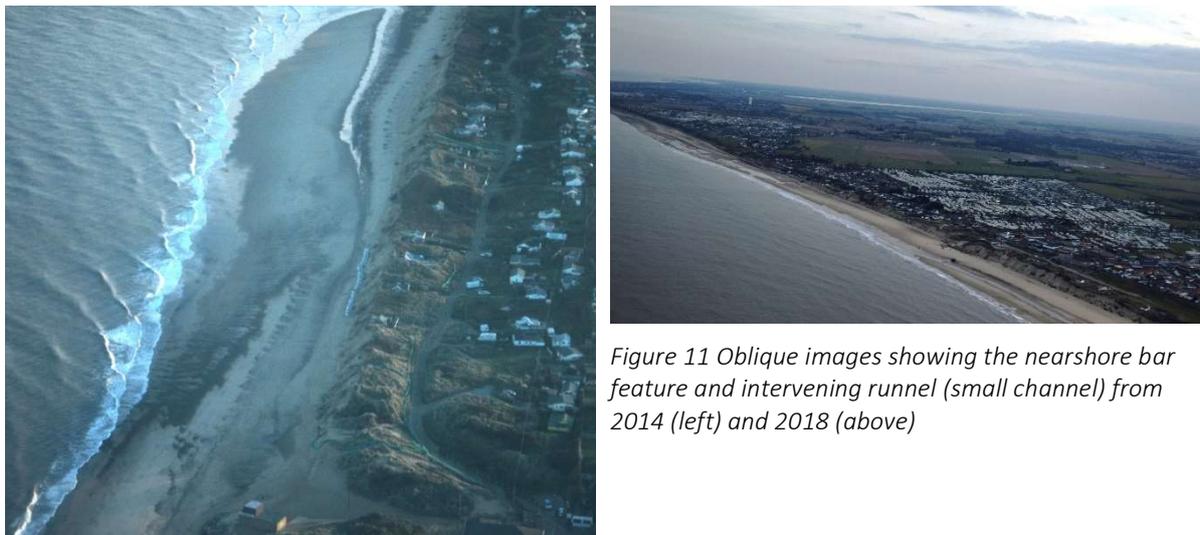
Figure 11 Oblique images showing the nearshore bar feature and intervening runnel (small channel) from 2014 (left) and 2018 (above)

A key feature of interest shown by the aerials is a bar which extends southwards from Winterton Ness (see Figure 11). Due to the aerials being taken at variable states of the tide it is difficult to consistently compare between years; however, from the sequence of photographs this feature appears to be semi-permanent in form. At times it appears to become welded onto the shoreline, creating a wider beach, at other times it is a distinct ridge feature, separated from the main beach by a channel (runnel).

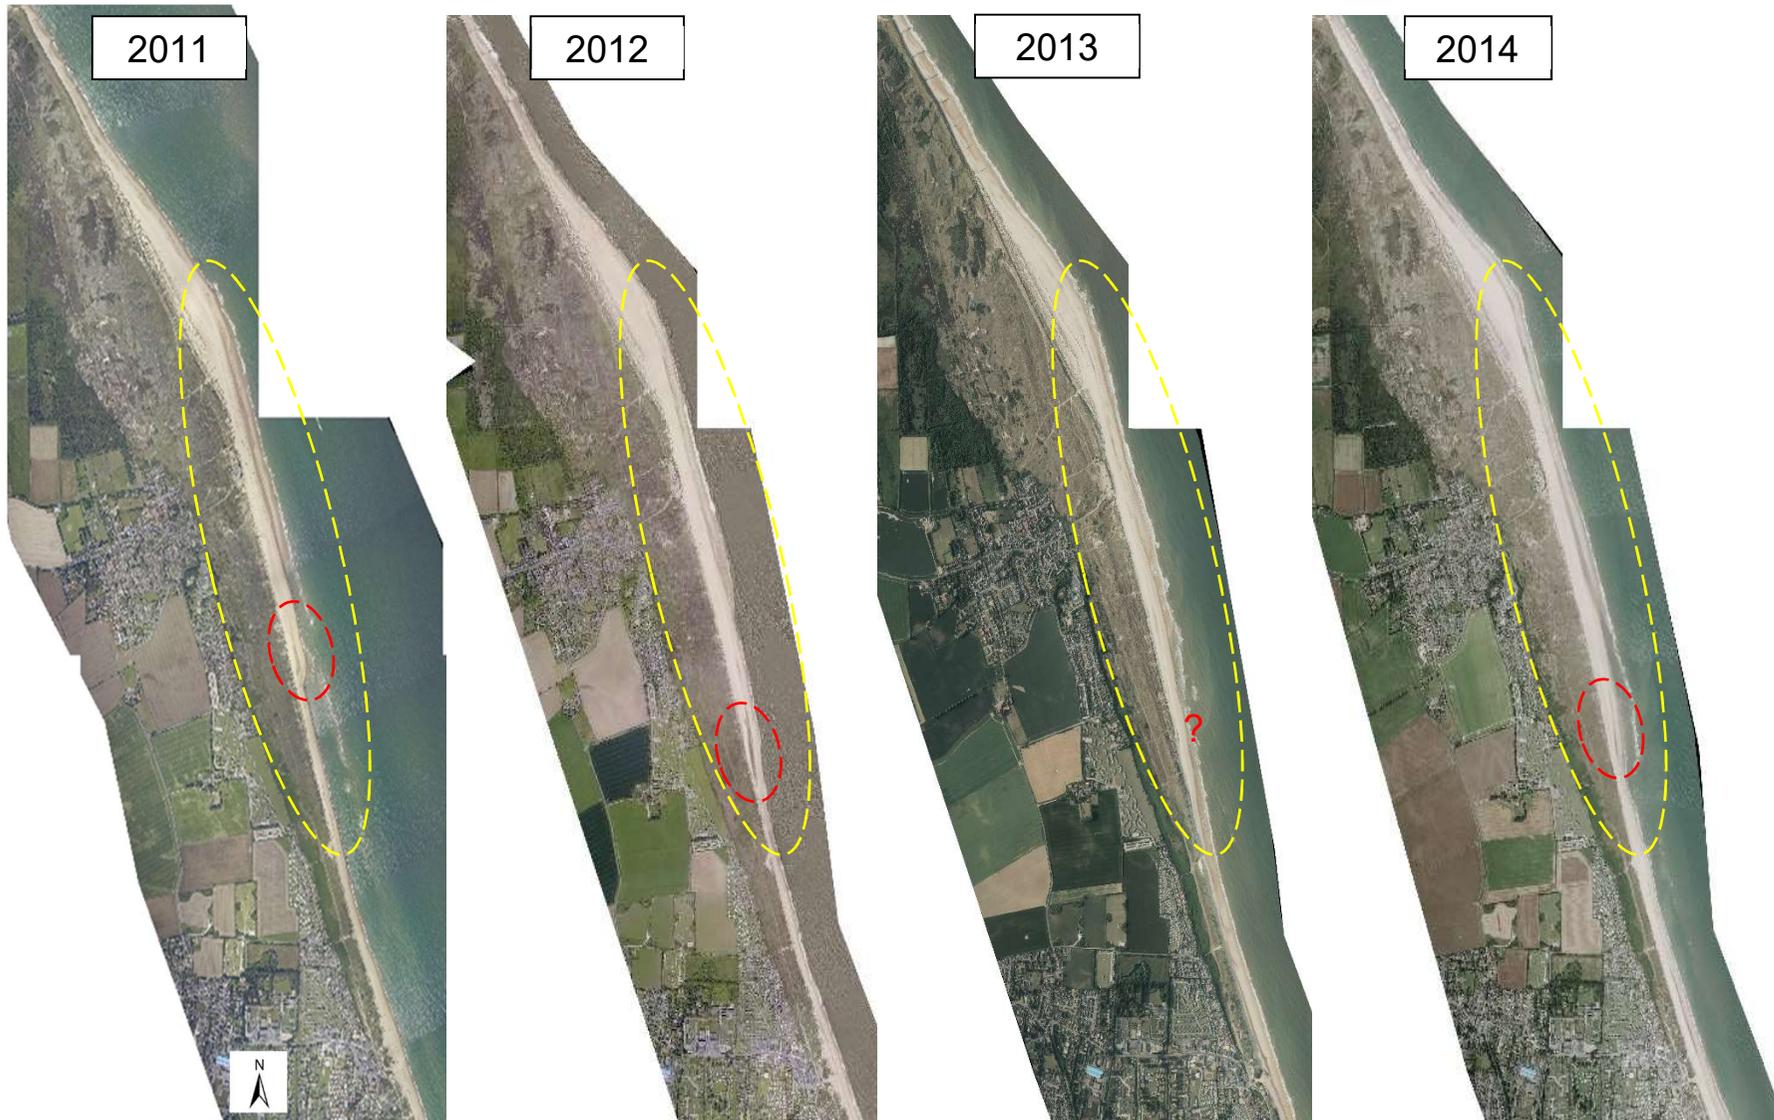
Figure 12 Aerial sequence from 2011 – 2014. Images © Anglian Coastal Monitoring. The yellow circle indicates the same position on each photograph, whilst the red circles show the terminal end of a bar/spit feature protruding from the ness.

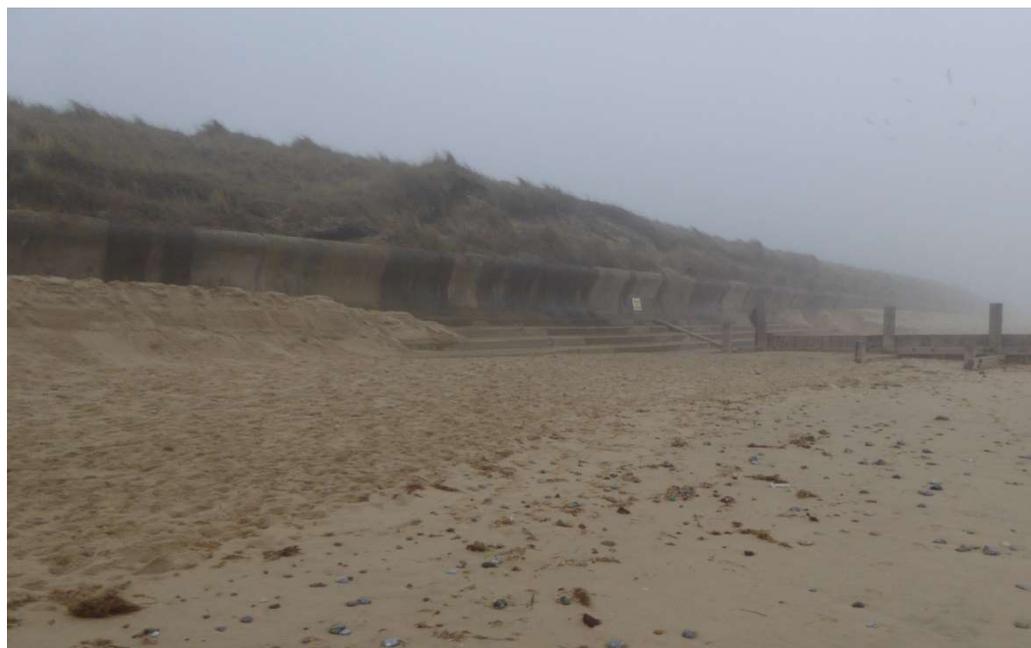
Along this stretch the backshore position is defined by a seawall, which continues northward towards Happisburgh (Figure 13). There has therefore been no change in this shoreline position over time. Beach levels in front of the seawall fluctuate and can change by over 2.5 m between surveys, indicating extremely volatile beach conditions. There is no net trend of either accretion or erosion evident from the data sets and for much of the frontage, the latest data from 2017 lies within the range of beach levels observed previously.

Figure 13 North of Winterton Ness, along the groyned section of beach. Photograph taken during site visit April 2018.

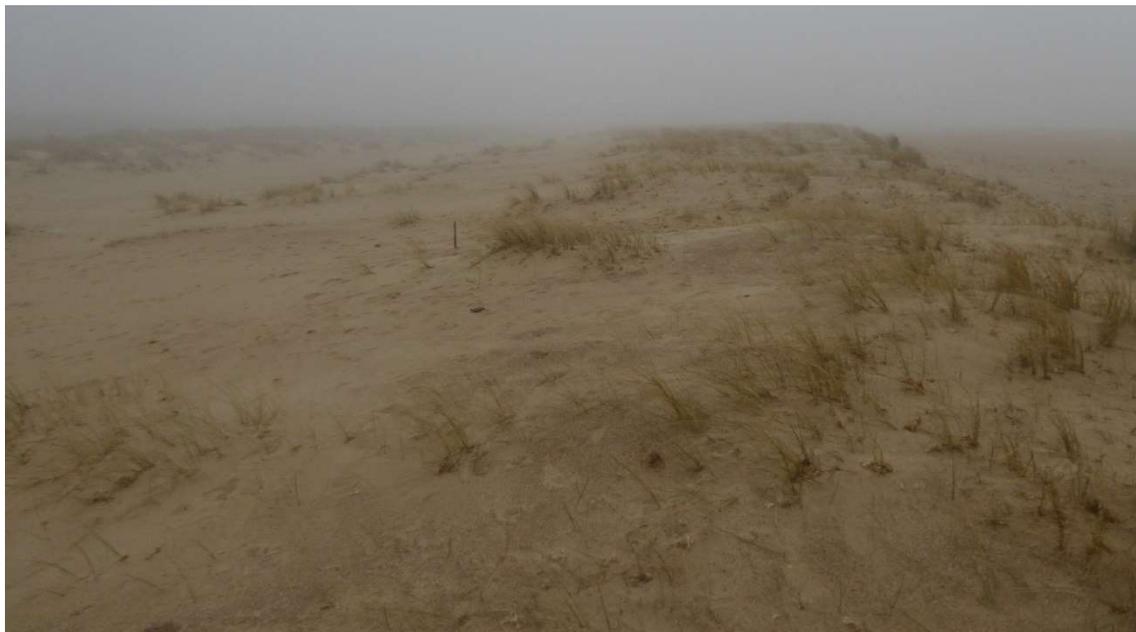
Figure 15 Embryo dune development along Winterton Ness, showing how a series of new ridges are being created. Photograph taken during site visit April 2018.

The beach transects indicate a change in behaviour to the north and south of the current apex of the ness, around profile HW348. To the north there has been net accretion, resulting in an increase in beach width. The longest data set available, for profile N093, shows that since 1992 the upper beach (above mean sea level) has increased in width by around 120 m (Figure 14). As the beach zone has increased, this has enabled the development of 'embryo' dune ridges (see Figure 15), due to windblown transport of sand landwards.

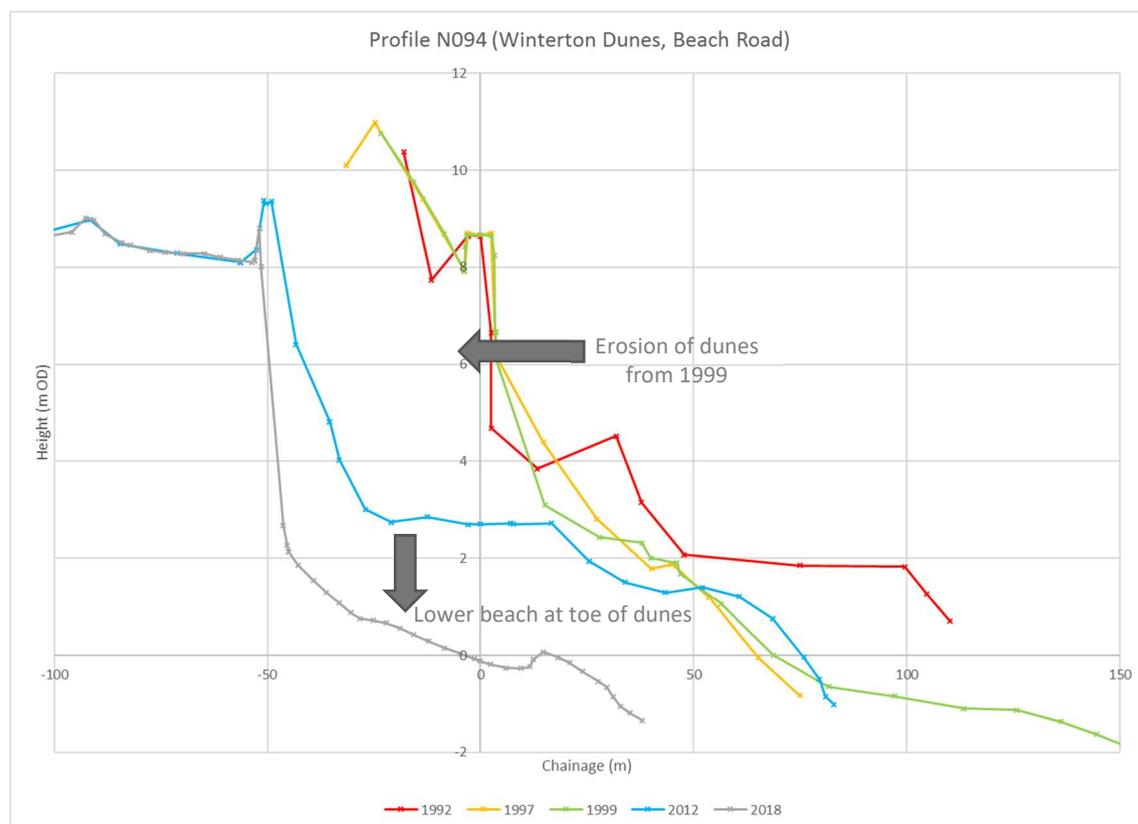
Figure 16 Beach transect at Winterton Beach Road (N094), showing net erosion and dune retreat over time.

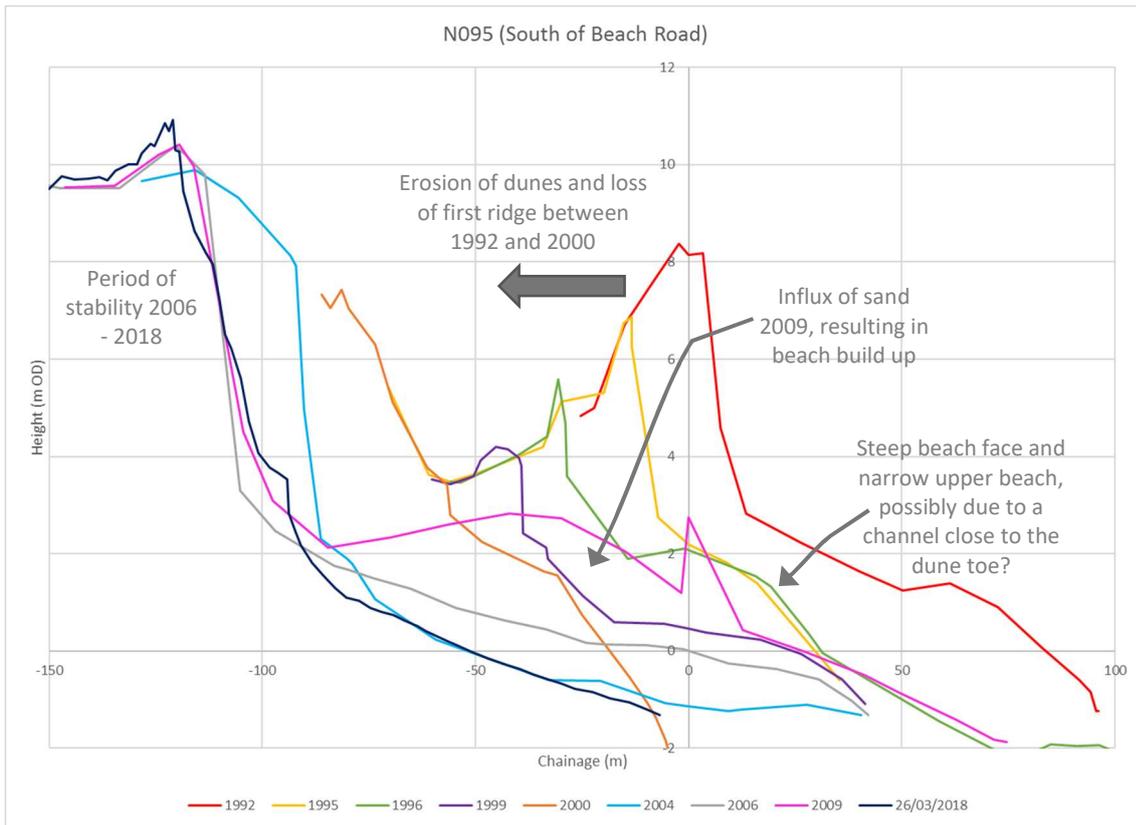
Figure 17 Beach profile N095, south of Winterton Beach Road.

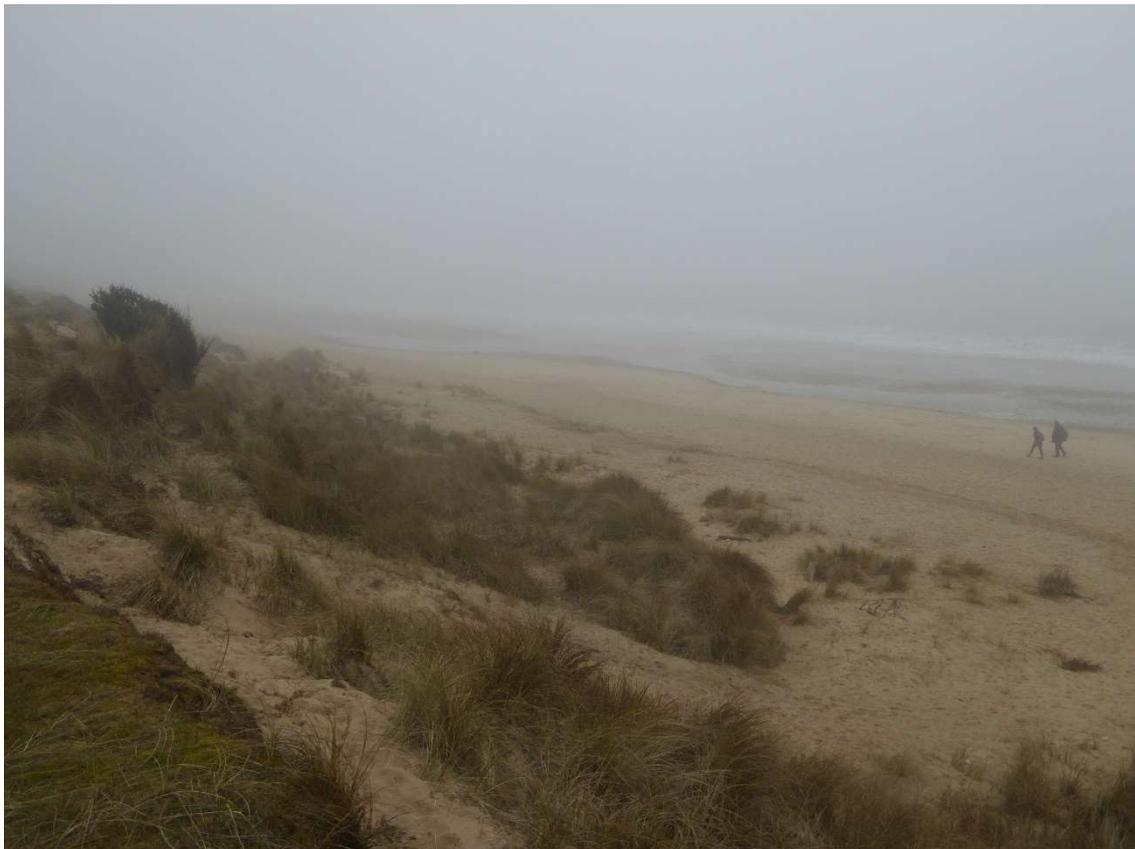
Currently the dunes south of Winterton Beach Road are fairly well vegetated (Figure 18), but there are signs of previous dune erosion and subsequent recovery, suggesting that this frontage has received sand in recent years, allowing some dune recovery.

Figure 18 South of Winterton Beach Road, dunes indicate past periods of erosion but also some subsequent build up and dune growth. Photograph taken during site visit April 2018.

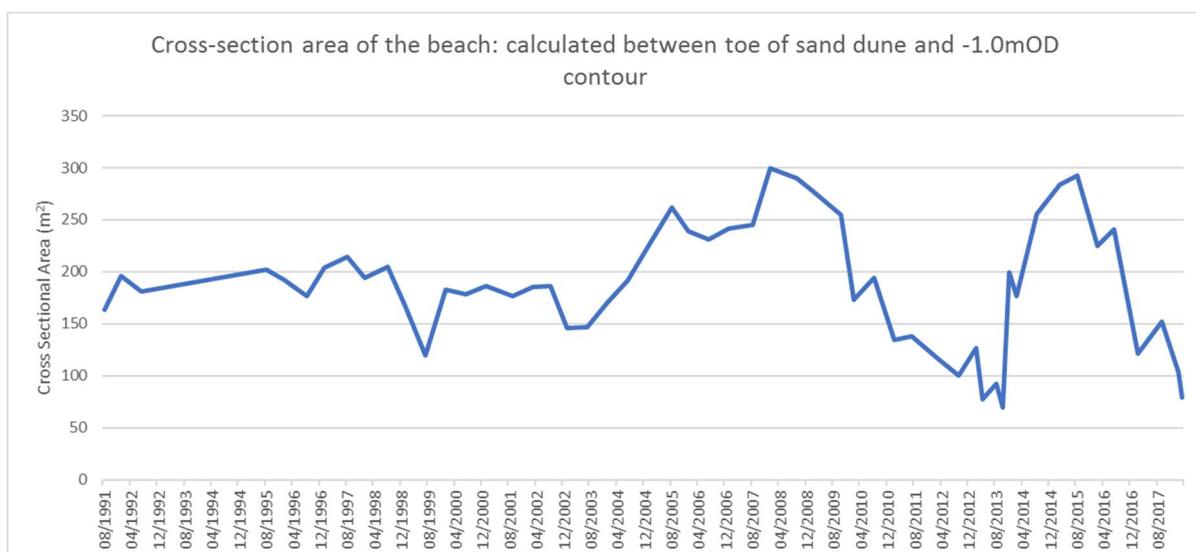
Figure 24 Changes in cross sectional area of the fronting beach at N098, south of Hemsby Gap, over time.

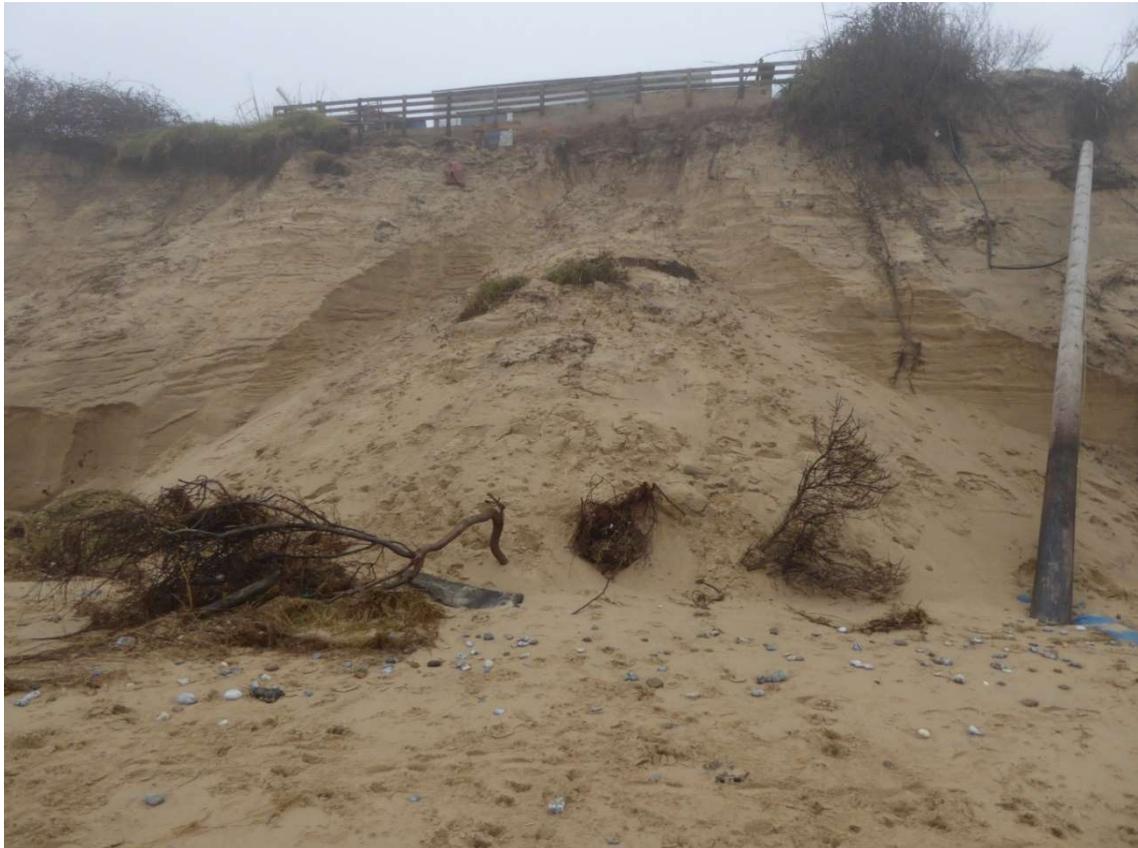
The beach transect data show very little variation in dune steepness over time. From the site visit and available photographs, it is evident that failure is through undercutting followed by slab failure. Subsequent avalanching can occur along the steep scarp face, but the overall slope of the face remains steep (see Figure 25). Given time, further slumping could occur allowing the dune face to reach a more stable slope.

Figure 25 Erosion of the dunes at Hemsby.

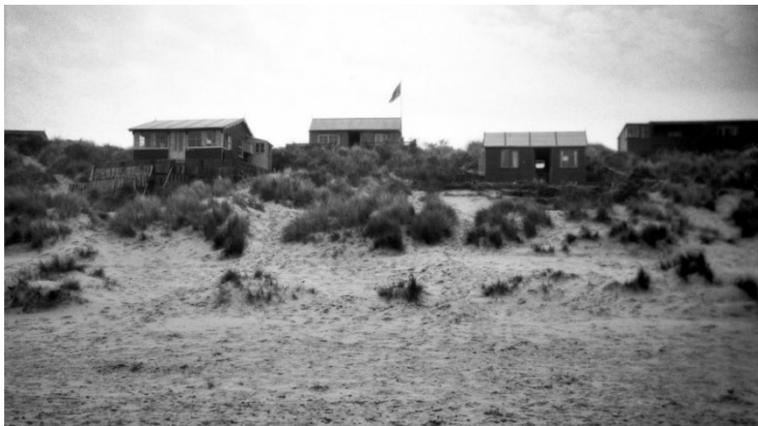
Figure 27 Hemsby beach bungalows, believed to date from the 1930s. There is little vegetation along the dunes, but this may be evidence of erosion or due to trampling damage

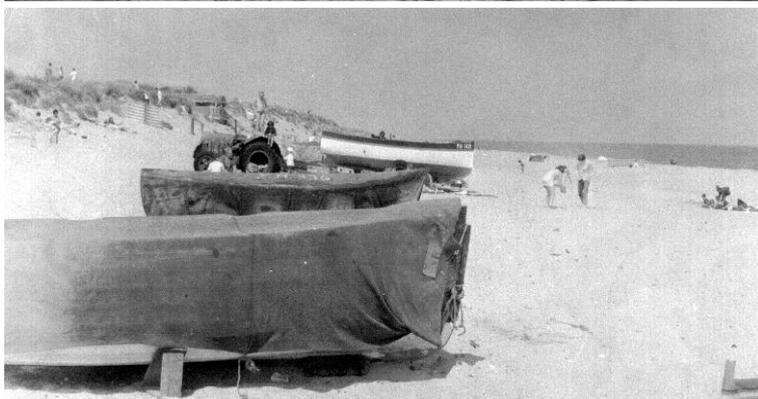
Figure 28 Winterton beach, possibly from the 1970s/1980s. In the foreground the dunes do not show signs of cliffing, but are sparsely vegetated, those in the background appear steeper and possibly cliffing

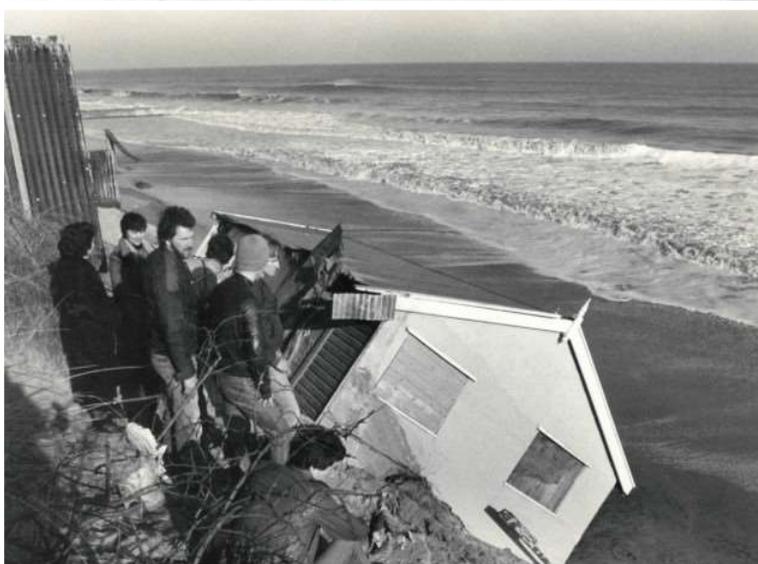
Figure 29 Erosion of the dunes in 1983 caused the loss of beach chalets. It is uncertain where exactly this photograph was taken.

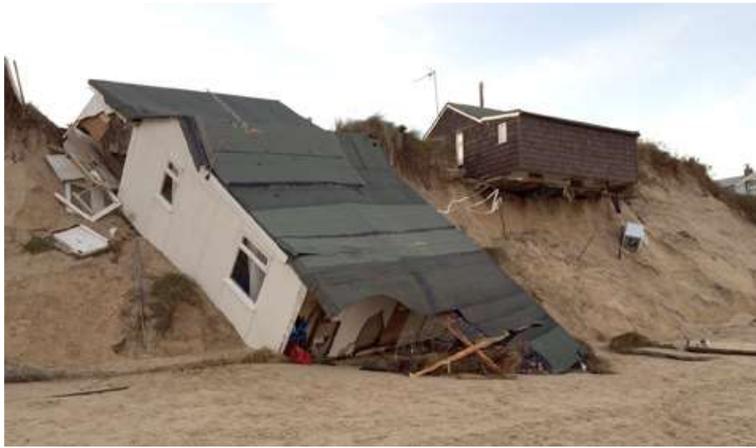
Figure 9 More recent erosion (2013) has caused further loss of properties. Near-vertical dune faces have formed during the storm events, undermining the chalets.

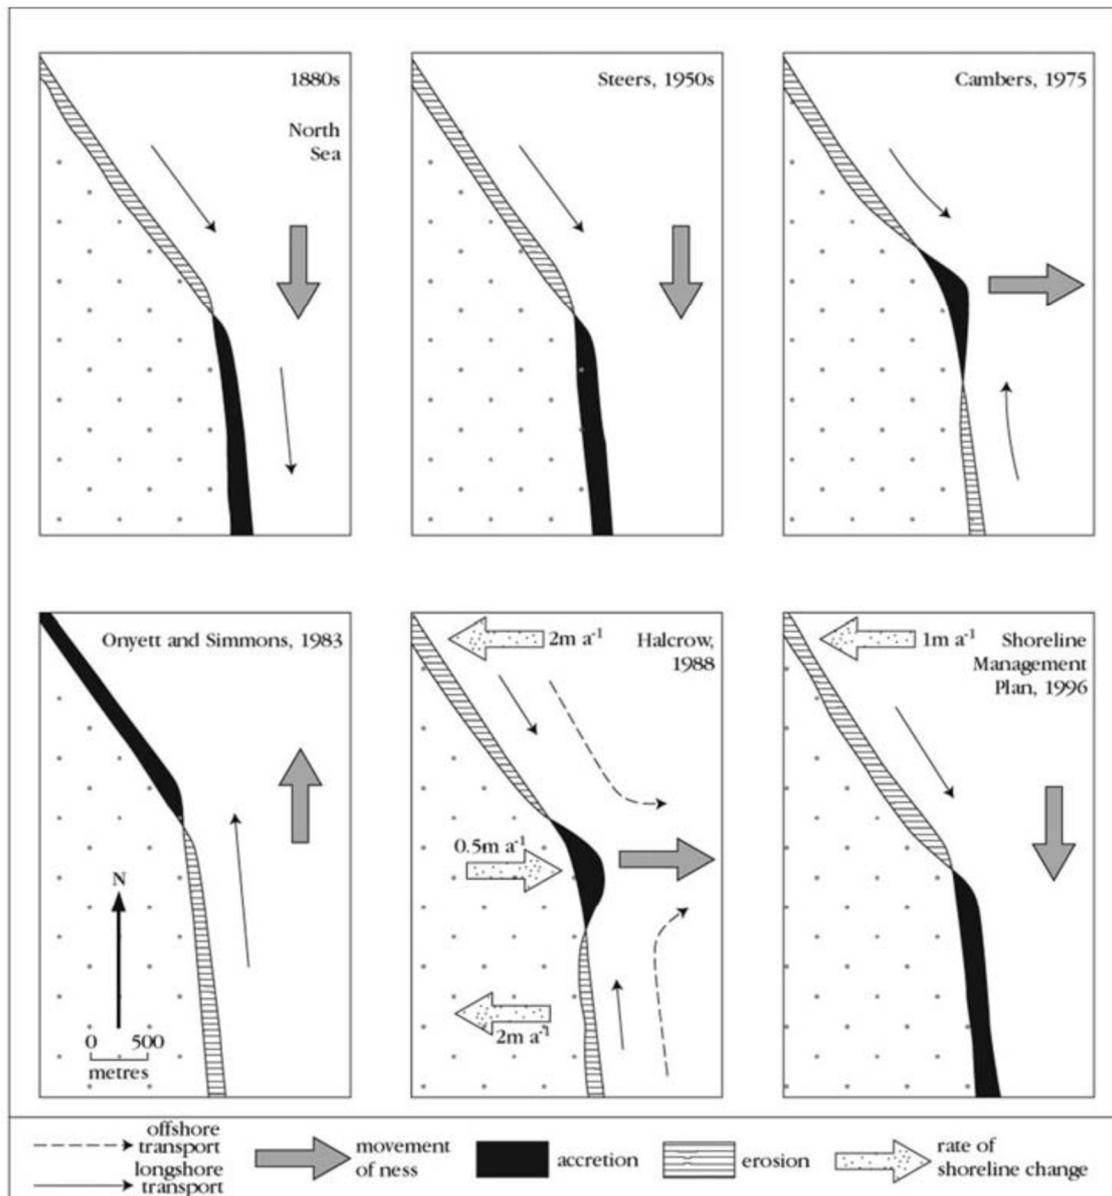
Figure 30 Different interpretations of the sediment transfers at Winterton Ness, taken from May (2003). In the 1880s, according to Steers (1964a) and the Shoreline Management Plan (North Norfolk District Council et al., 1996), net sediment transport was southwards and the ness moved in the same direction. Others have suggested that transport is from the south, and Cambers (1975) and Halcrow (1988) agree on transport from both south and north with a transfer offshore and the ness extending seawards.

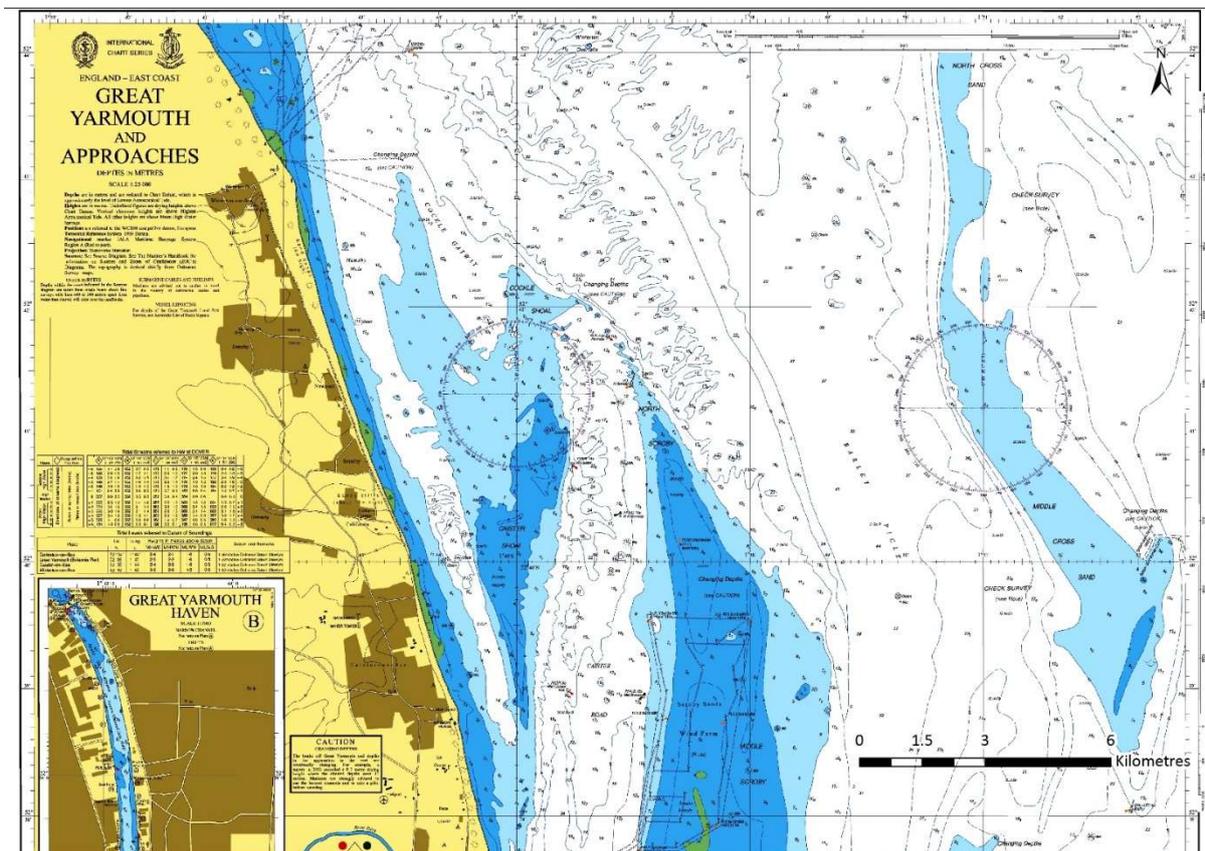
- Scroby Sands – This lies offshore of Caister Shoal and is made up of South, Middle and North Scroby Sands, which are connected at the 5 m contour below Chart Datum.

Figure 31 2018 Hydrographic Chart showing the nearshore banks and channels. © Crown Copyright and/or database rights. Reproduced by permission of the Controller of Her Majesty's Stationery Office and the UK Hydrographic Office (www.GOV.uk/UKHO).
