GREAT YARMOUTH
BOROUGH COUNCIL

Environment Committee

Venue: Supper Room

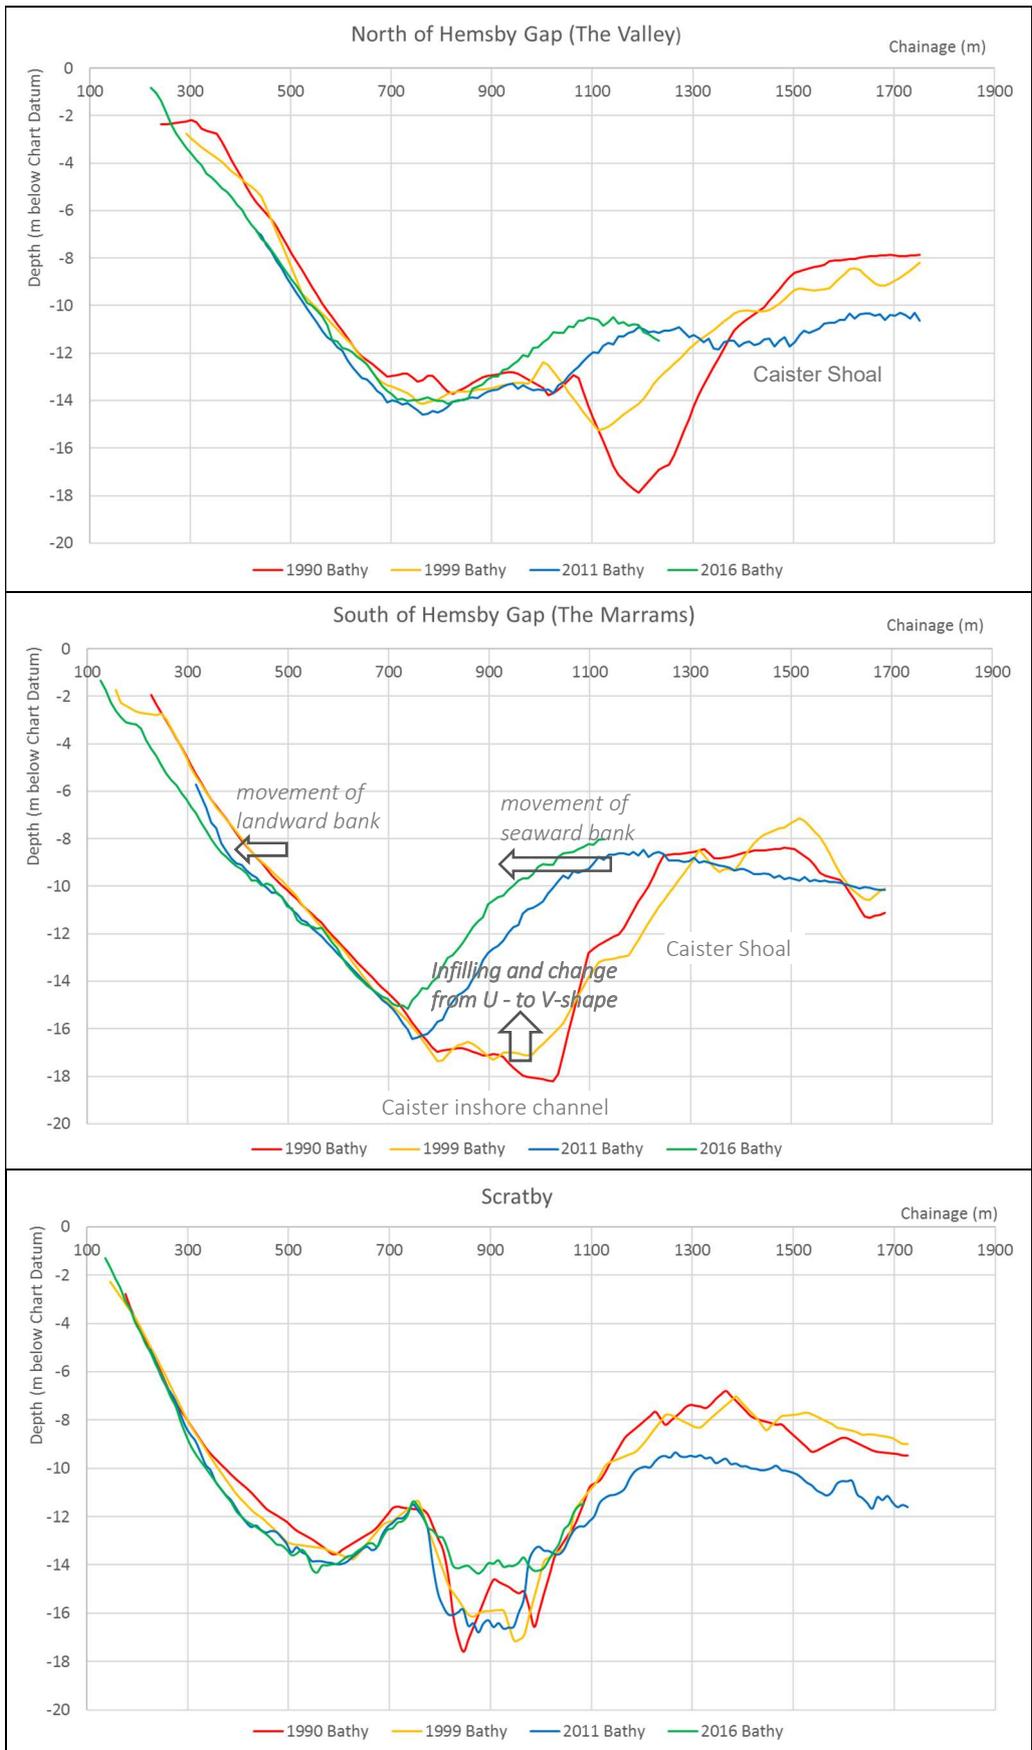
Figure 33 Transects through the bathymetric data showing changes in nearshore bed levels: years 1990 (red), 1999 (yellow), 2011 (blue) and 2016 (green).

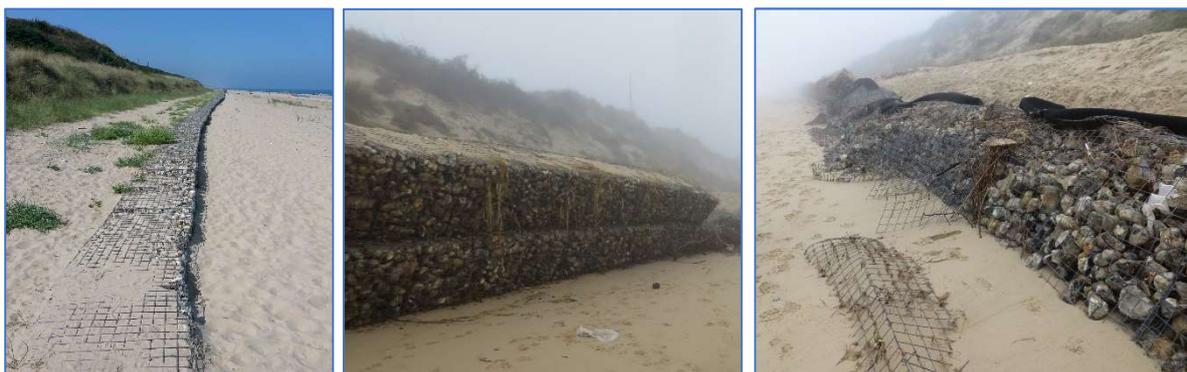
These have already been used at the southern end of Hemsby and along the Scratby frontage, built in the form of a near vertical wall.

As can be seen in the second photo, beach lowering (as a result of 2018 storms) has led to their undermining and consequential overturning, illustrating one of the main issues with any type of linear defence along this coast unless a suitably deep and robust foundation/toe is provided. Other issues with gabions, namely stretching and splitting apart, are illustrated by the third photo.

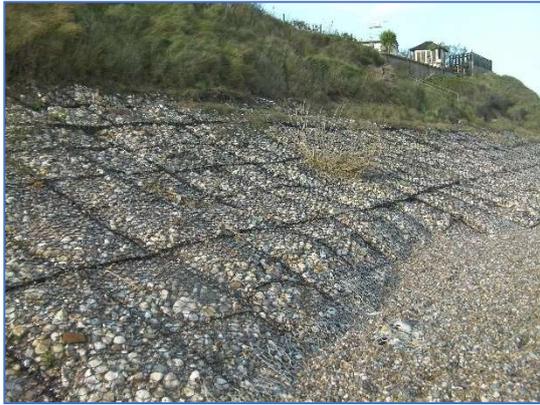
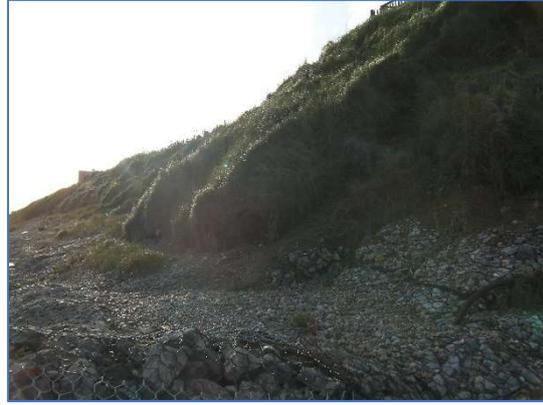
Another application on a similar coastline is at Thorpeness (Suffolk) where they have been laid on the slope at the base of an eroding soft cliff. As can be seen in the second photo, they have helped protect the toe but there has still been some slumping of the upper cliff.

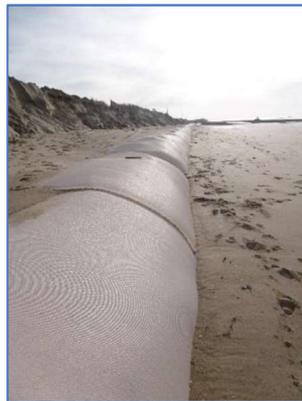
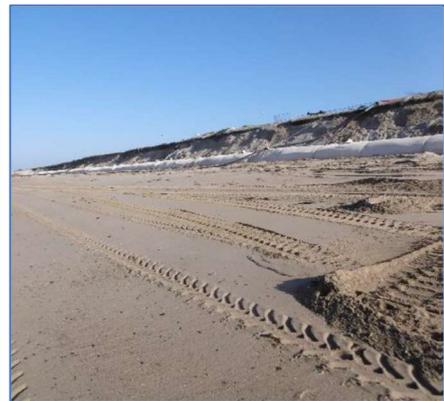
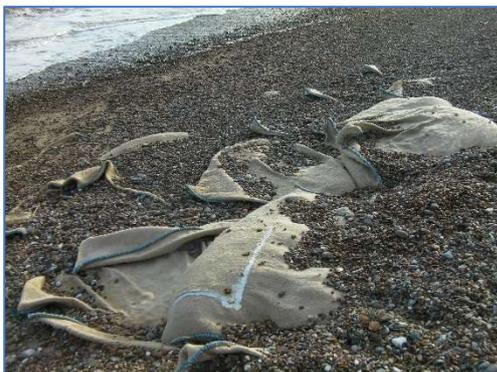
There are numerous examples from around the world, including in Australia, USA, Asia and Europe. The photographs to the right are an example of a geotube scheme on the Atlantic coast in Portugal (*reproduced with permission of Tencate Geosynthetics*).

Problems occur where the products are poor, not vandal-proof, filled with shingle or placed on shingle beaches, where abrasion or tearing of the bags can occur. The experience at Thorpeness, Suffolk (left) is an example of such problems, illustrating how quickly some installations can be ineffective if they are not the right system and product or not installed by a specialist with the right equipment and skills.

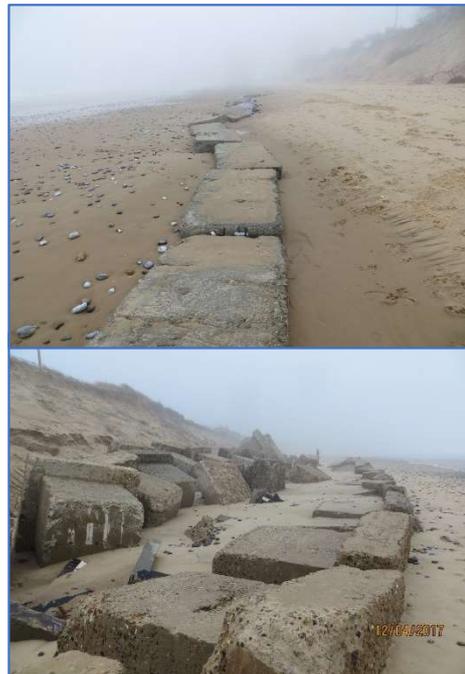
An example of this approach already exists on Hemsby beach, with the novel idea of using large aggregate bags as forms into which concrete has been poured. These still remain in place, although they are now at a lower level as the beach levels dropped and the scouring by waves have probably further induced their settlement. Crucially, they have not prevented erosion of the dune face behind.

Further north, at Winterton car park, large blocks have fallen onto the beach, but in a random and disconnected array. This illustrates that even where the blocks themselves are massive, the individuality of the open array significantly compromises their effectiveness with little if any difference in the beach level landward of them after a storm, and active erosion taking place behind them.

The lack of effectiveness of this type of approach at Hemsby is already demonstrated by the well-intentioned but ultimately unsuccessful application of concrete filled bags over two short lengths, as well as the limited effect of the larger blocks that have fallen onto the beach at Winterton.

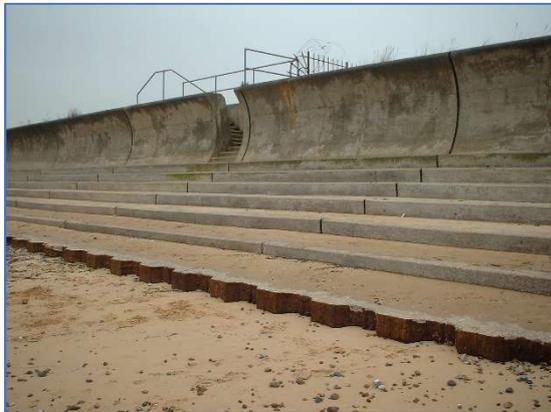
There are numerous examples of seawalls around the UK, in a range of different forms, although one of the most common is that with a recurve wave wall at the rear, as seen in this example at Southwold.

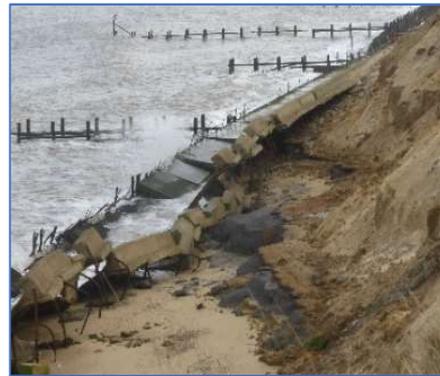
In contrast, south of Hopton on the Norfolk Suffolk boundary, the consequences of a seawall failure where such adaptation was not undertaken can be seen here. This is a stark illustration of the longer-term vulnerability of these structures on a coastline where there are similar issues with an eroding beach and transgressive shoreline, which the seawall alone will not address.

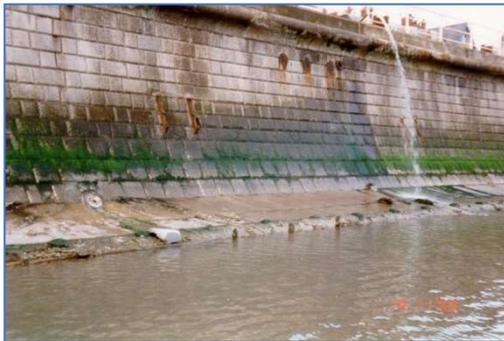
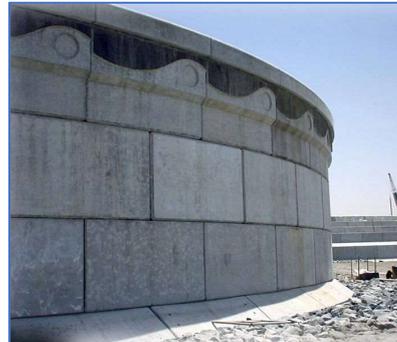
A traditional blockwork seawall in the UK is shown to the left, with a recent blockwall wall construction in the Gulf shown to the right.

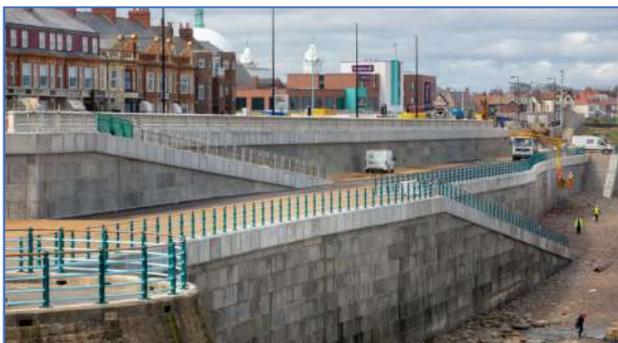
The only known application of the T-Block is in North West England at Whitley Bay.

Image courtesy of Poundfield Products and Hall Construction Services.

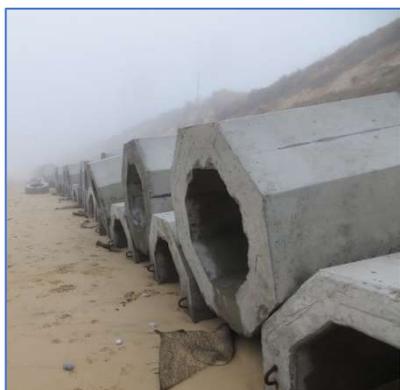
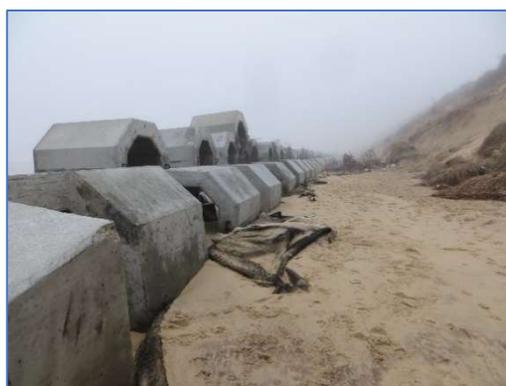
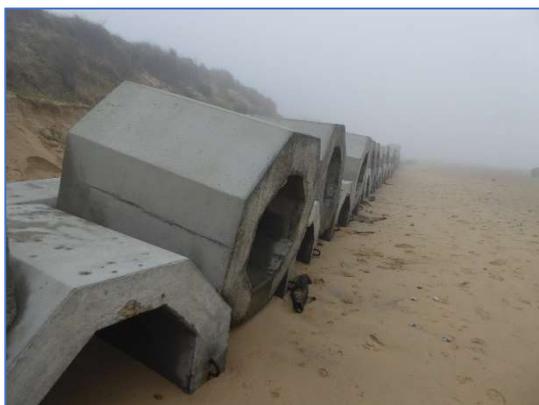
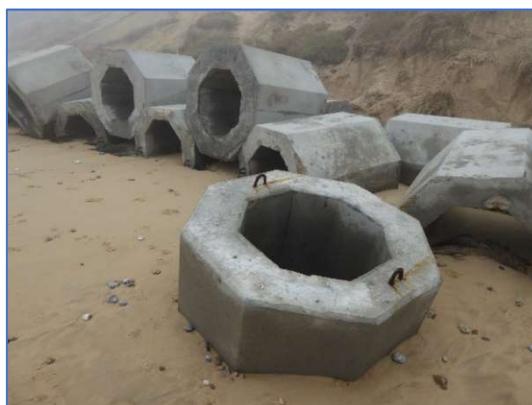
Following the 2018 storm damage, the condition of the HexiBlock wall at Hemsby was inspected. As the photographs below illustrate, there had been considerable displacement of units and clear signs of undercutting and scouring beneath the units in the absence of any foundation, evidenced by them pitching seaward. Although these may have reduced the extent of erosion at the dune face, compared to adjacent stretches, there was still very clear and notable active erosion and loss of dune. In the context of assessment criteria used to categorise the condition of defences, this wall would be considered to have failed.

In considering the effectiveness of HexiBlocks at Hemsby, it must be acknowledged that the existing wall was just a trial, from which lessons are inevitably going to be learned. It must also be recognised that the trial structure was somewhat different to what the designers intended. Assessment on effectiveness is therefore made on what the full wall would comprise, although the outcome of the trial has provided some useful detail to inform that.

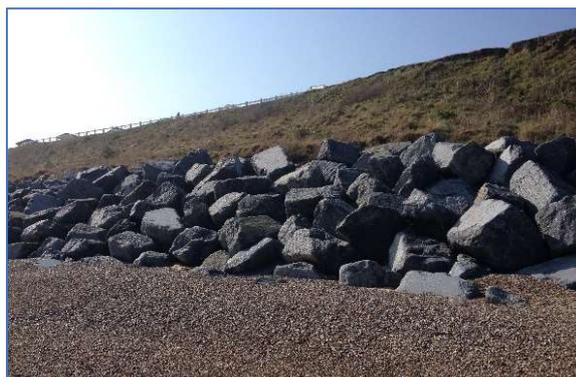
One local example is at Hopton (right). This is part of a broader scheme which also includes some beach control structures

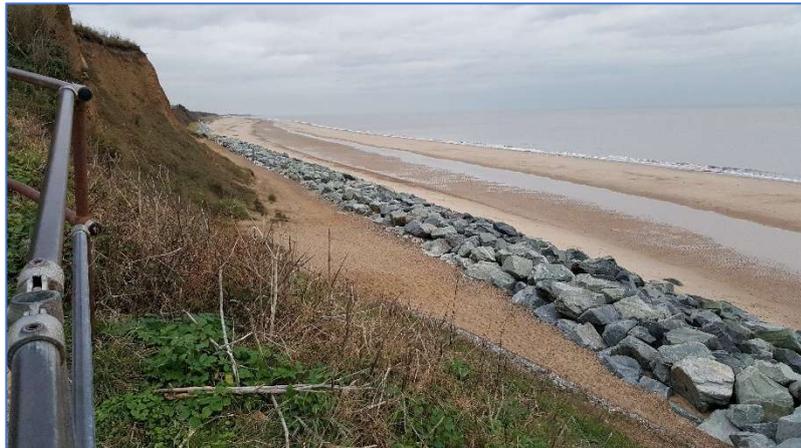
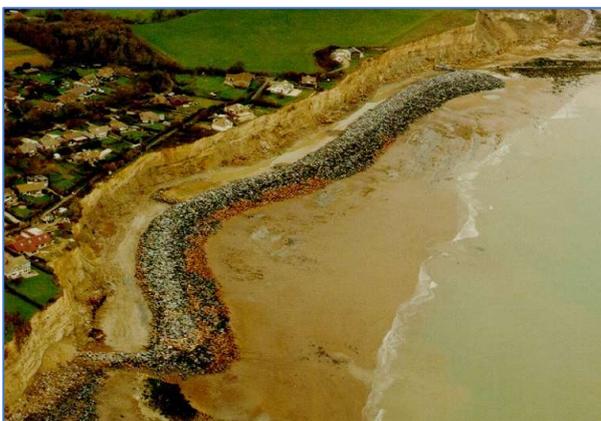
An example of this type of structure can be found a short distance along the coast at California.

The rock berm there appears to be working very effectively and as intended. Some limited erosion does still take place, but the structure remains stable, and there is a small beach along much of the frontage in front of the berm, although that beach is also in part due to the works implemented at the northern end of Caister.

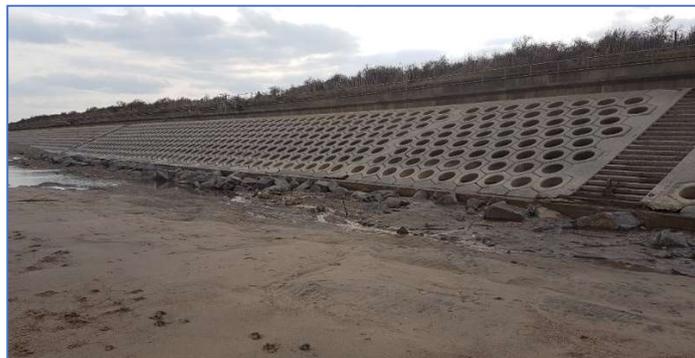
Seabees used on section of sea defences to north of Skegness along Lincolnshire coast.

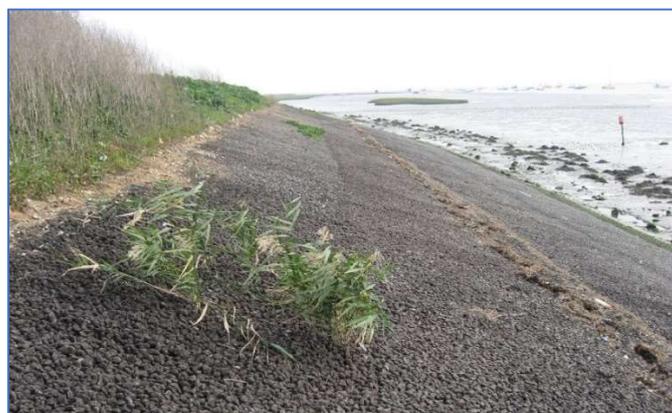
Use of Open Stone Asphalt (OSA) in Thames Estuary near Southend.

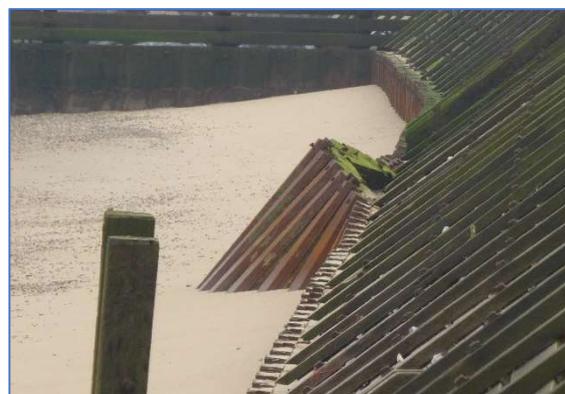
The photos below from just below Gorleston shows this working well, but a short distance further south, the commencement of failure is evident. Beach levels have lowered to expose the piling, and wave reflections have led to scouring at the toe, which will ultimately lead to the onset of failure.

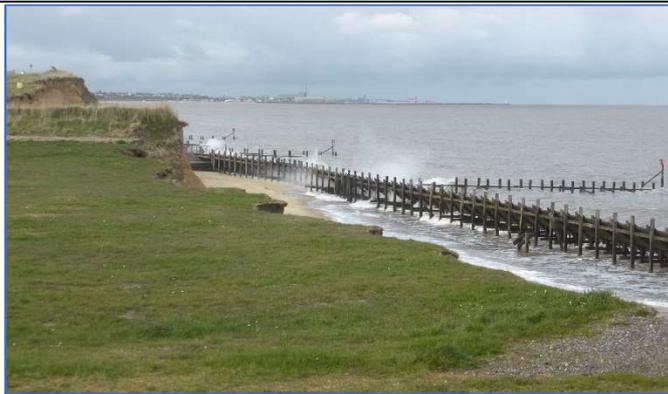
Just north of Corton in Suffolk, longer piles have left the heavily damaged timber revetment standing, but not prevented the erosion of the beach seaward, due to similar processes as being observed at Hemsby, leaving that stretch of shoreline unusable to the public due to the safety risks that now exist.

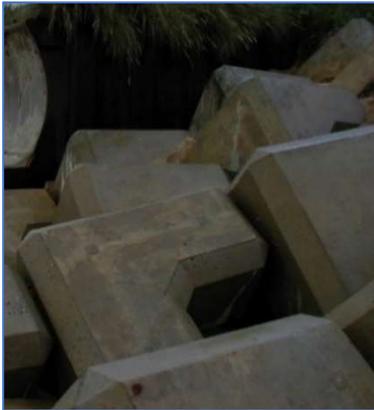
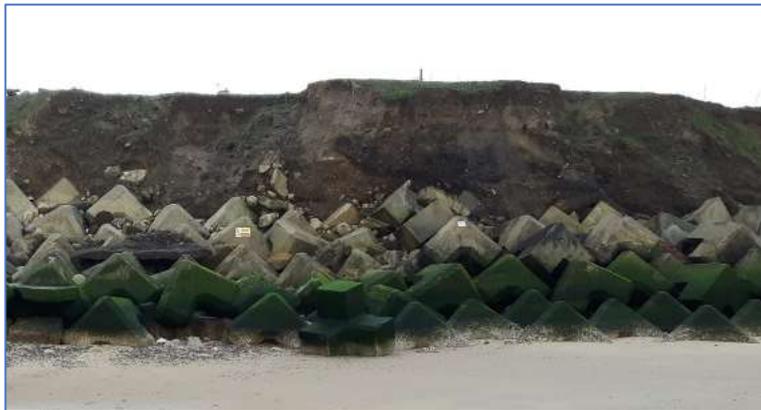
Concrete armour units do also include much simpler shapes such as the Tripod, basically half a cube, which have been used for cliff protection at Southwold.

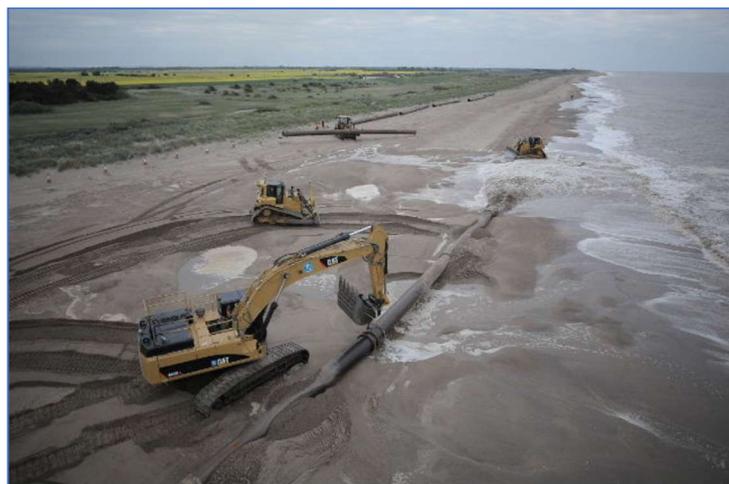
There are many examples of application around the UK. One of the largest has been on the Lincolnshire coast, where over 20 km of seawall has been protected by an annual renourishment operation since the mid 1990s. This scheme involves no control structures to restrict movement and the annual programme involves up to 500,000 m³ of sand each year.

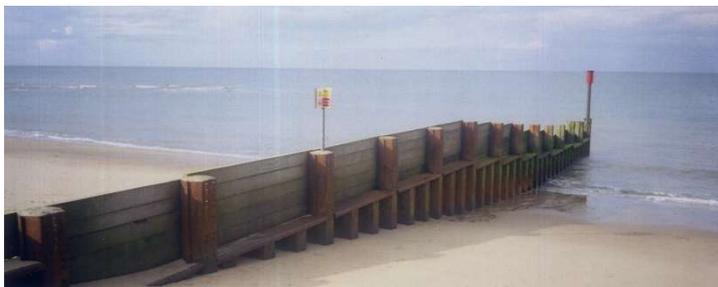
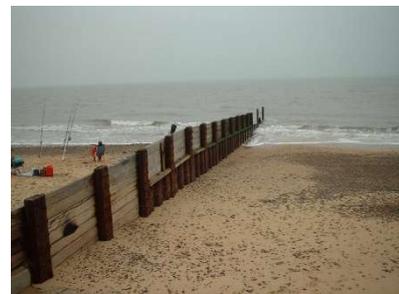
Local examples of timber groynes can be seen very close by, along the frontage managed by the Environment Agency just north of Winterton (left) and at Southwold (right).

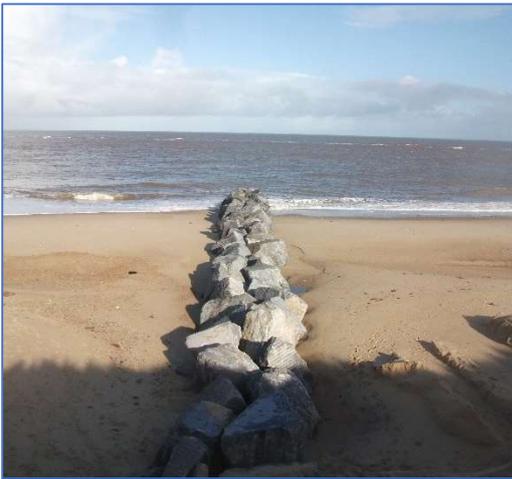
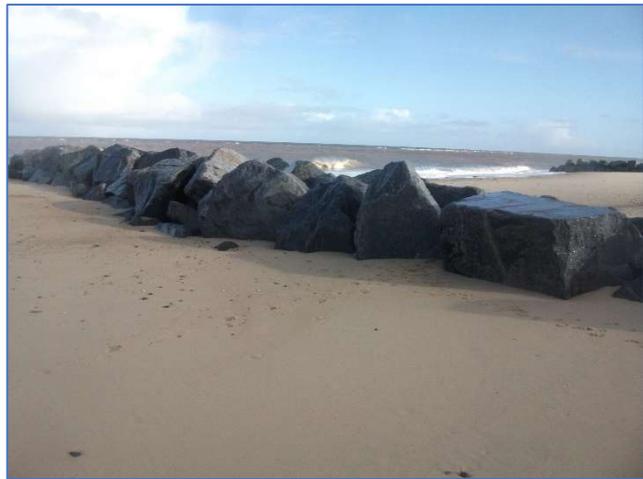
Examples of rock groynes can also be seen at these locations, with examples from north of Winterton shown below.

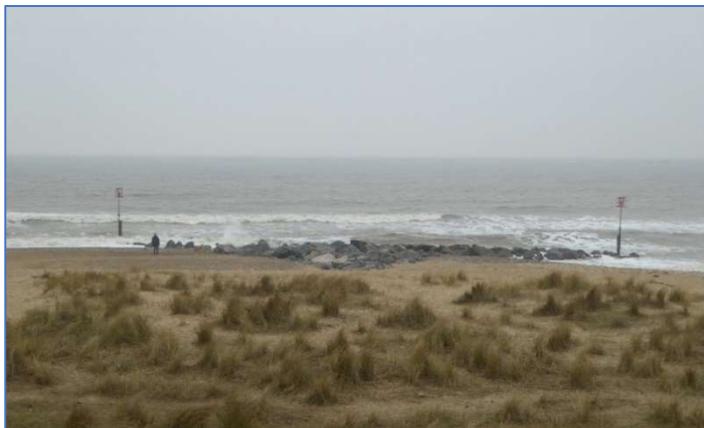
An example of Y-shape groynes can also be seen locally, at the northern end of Caister where these were introduced to help hold a beach that would extend northwards along the California frontage.

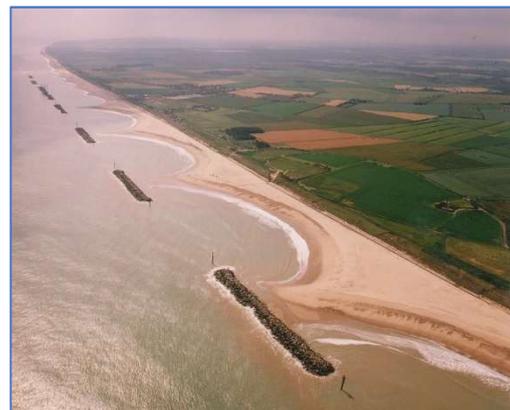
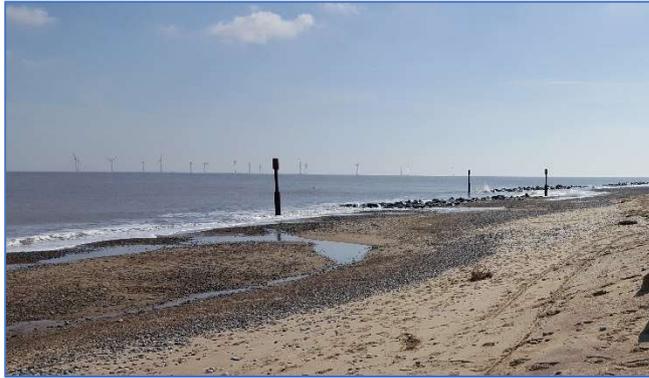
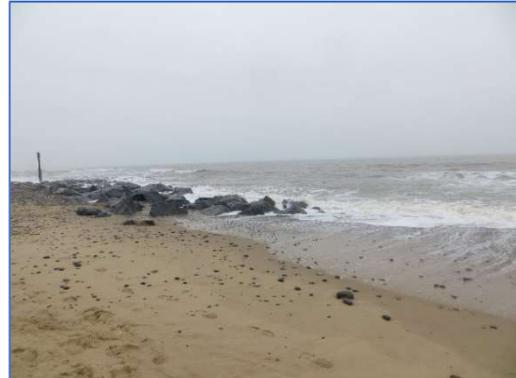
Two geographically close applications of this approach can be found to the north at Sea Palling (to the right) and south at Caister (below).

These two examples illustrate the contrast in beach response. This is partly due to the difference in coastal setting and processes operating at each location, but also reflects the fact that the breakwaters have been also designed to have a different effect.

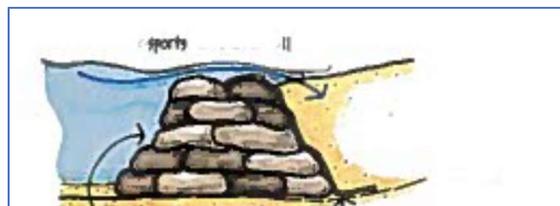
Below is an illustration of the concept (reproduced from 'Low Cost Shore Protection, USACE, 1981).

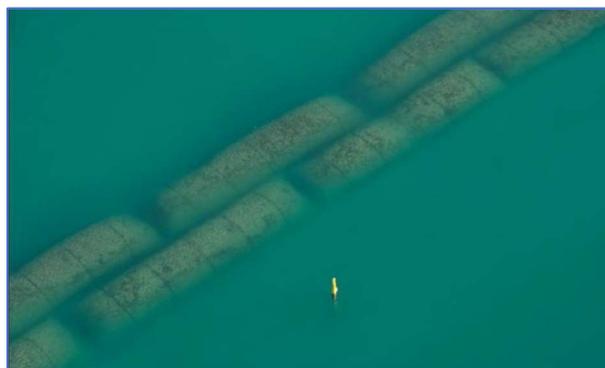
No examples have been identified of an application to perch a beach in an environment that might be considered similar to Hemsby, although there are locations where geotubes have been used as submerged structures to help build beaches or reclaim land.

Below example of geotubes placed as a submerged structure (reproduced by permission of Tencate Geosynthetics).

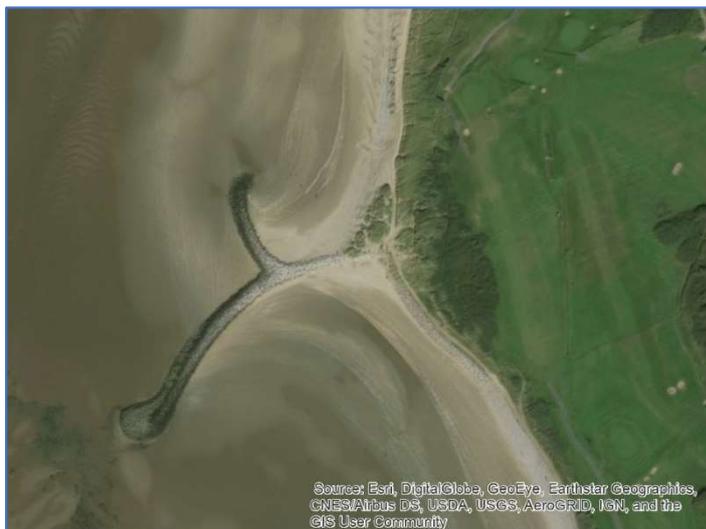
The design and construction of coastal defences along the Wirral Coast (1972-1987), the Morecambe seafront (1983-2010), Llandudno (1990-1996) and Llanelli (1991-2000) all have strong tidal currents running parallel to the shoreline and these schemes all employed structures to hold the tidal currents at a fixed distance away from the shoreline to allow the location of the shoreline to become effectively fixed behind a stable beach.

Google Earth image showing the headland structure at Llandudno.

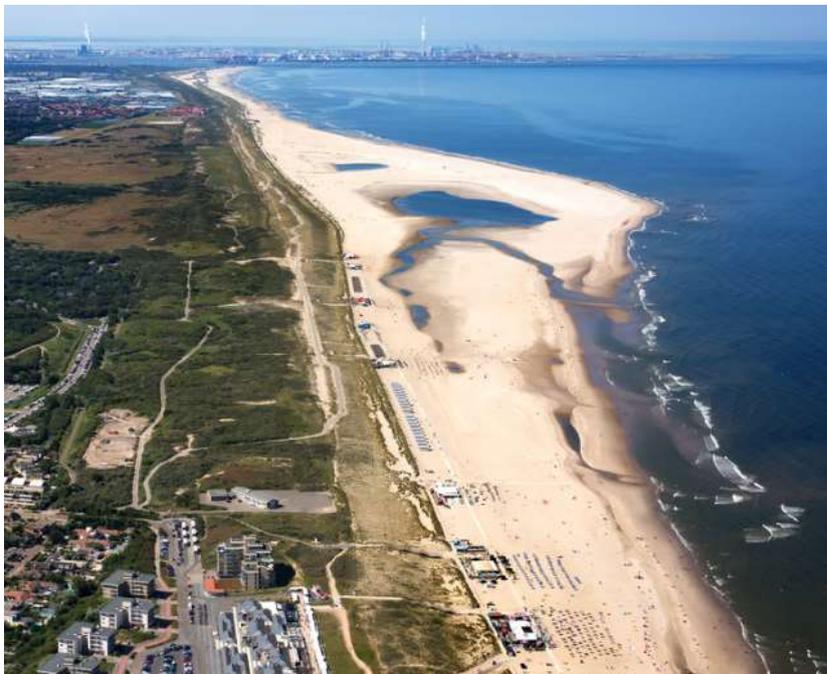
Although sites for trialing this in the UK are still being investigated, there is currently only one example of an application which is in the Netherlands, shown below. This was itself a trial and is still the subject of many ongoing research projects to gain improved understanding from its behaviour.

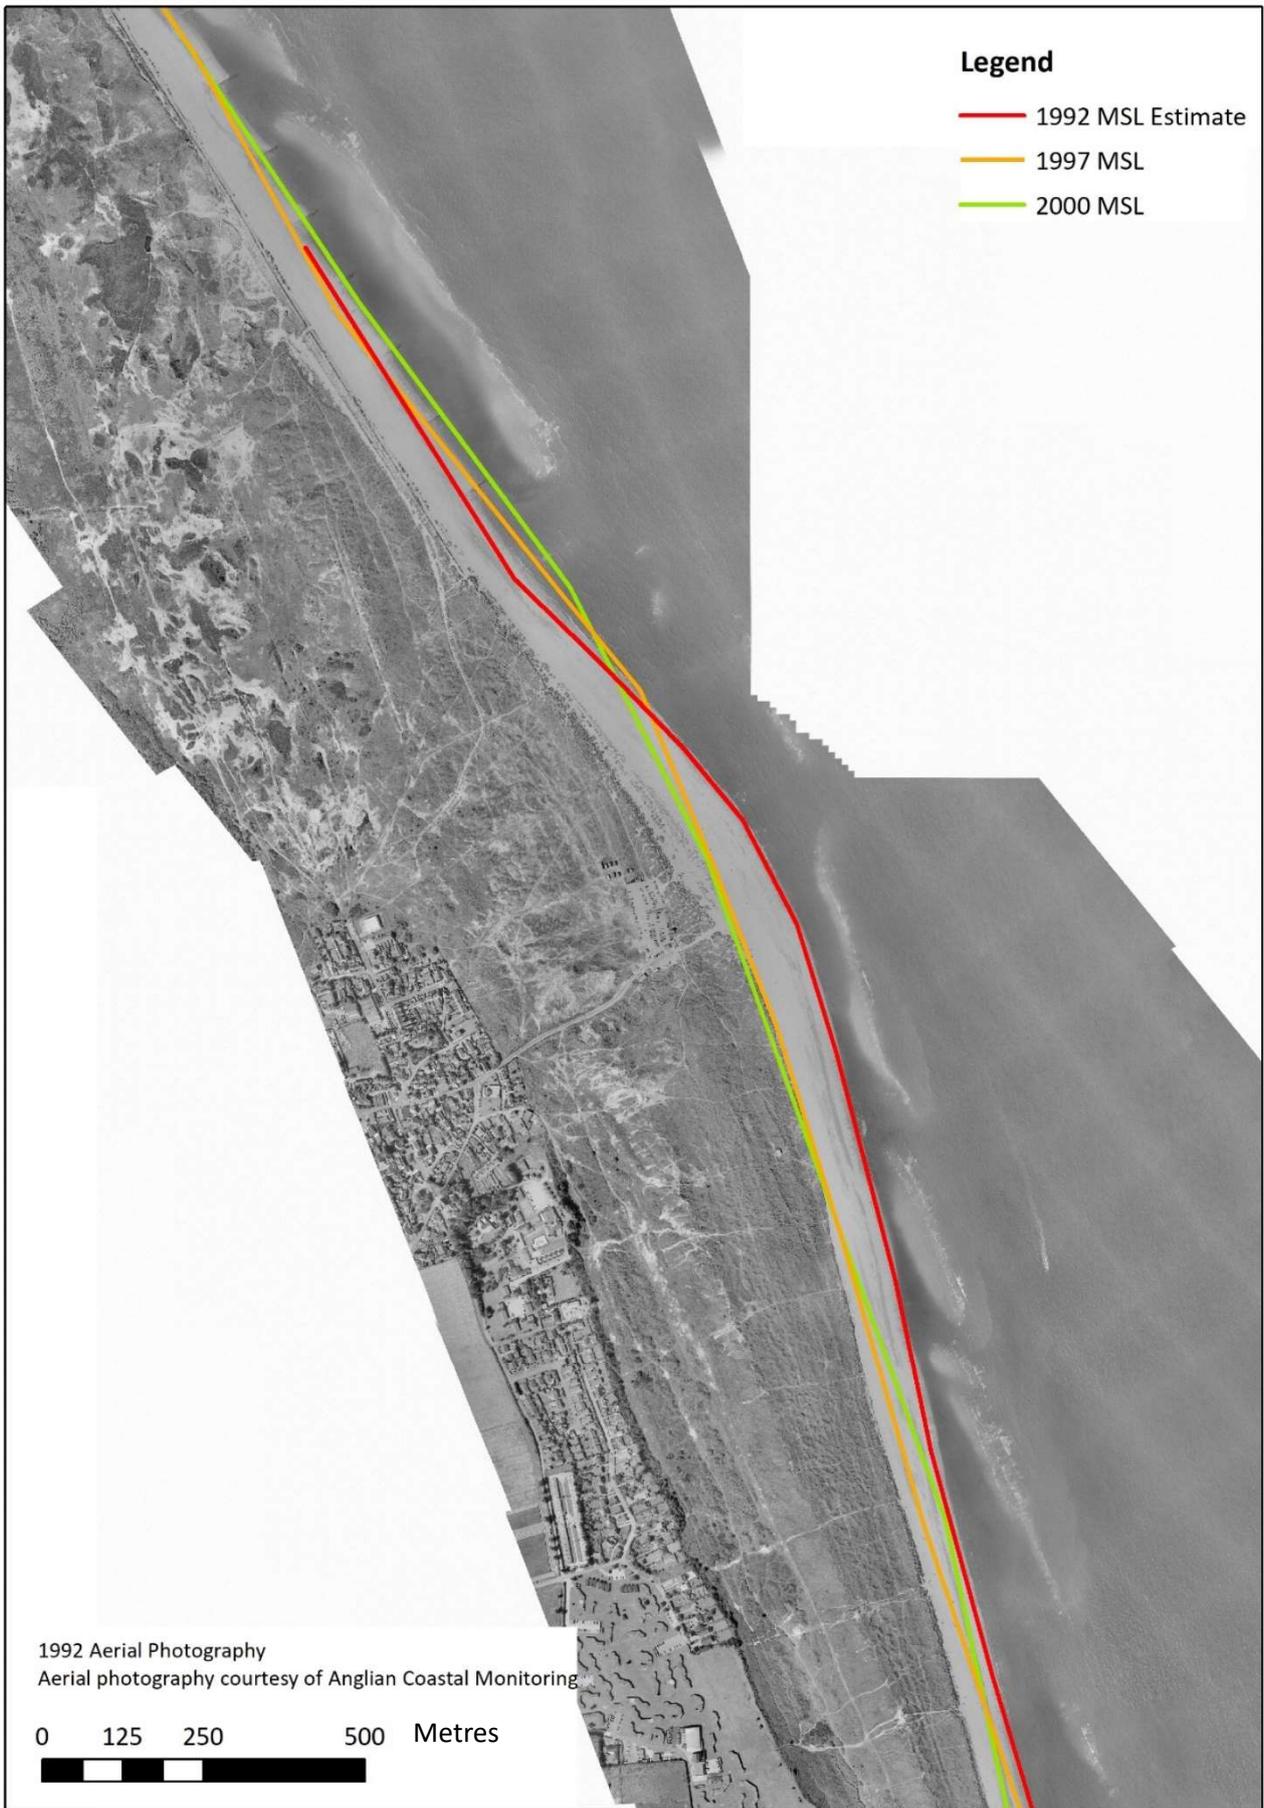
Figure 2 Extracted MSL points and interpolated lines for years 1997 – 2000. N.B. the 1992 line is based upon the aerial photography and whilst this gives a good indication of the shape may not truly reflect the MSL position.

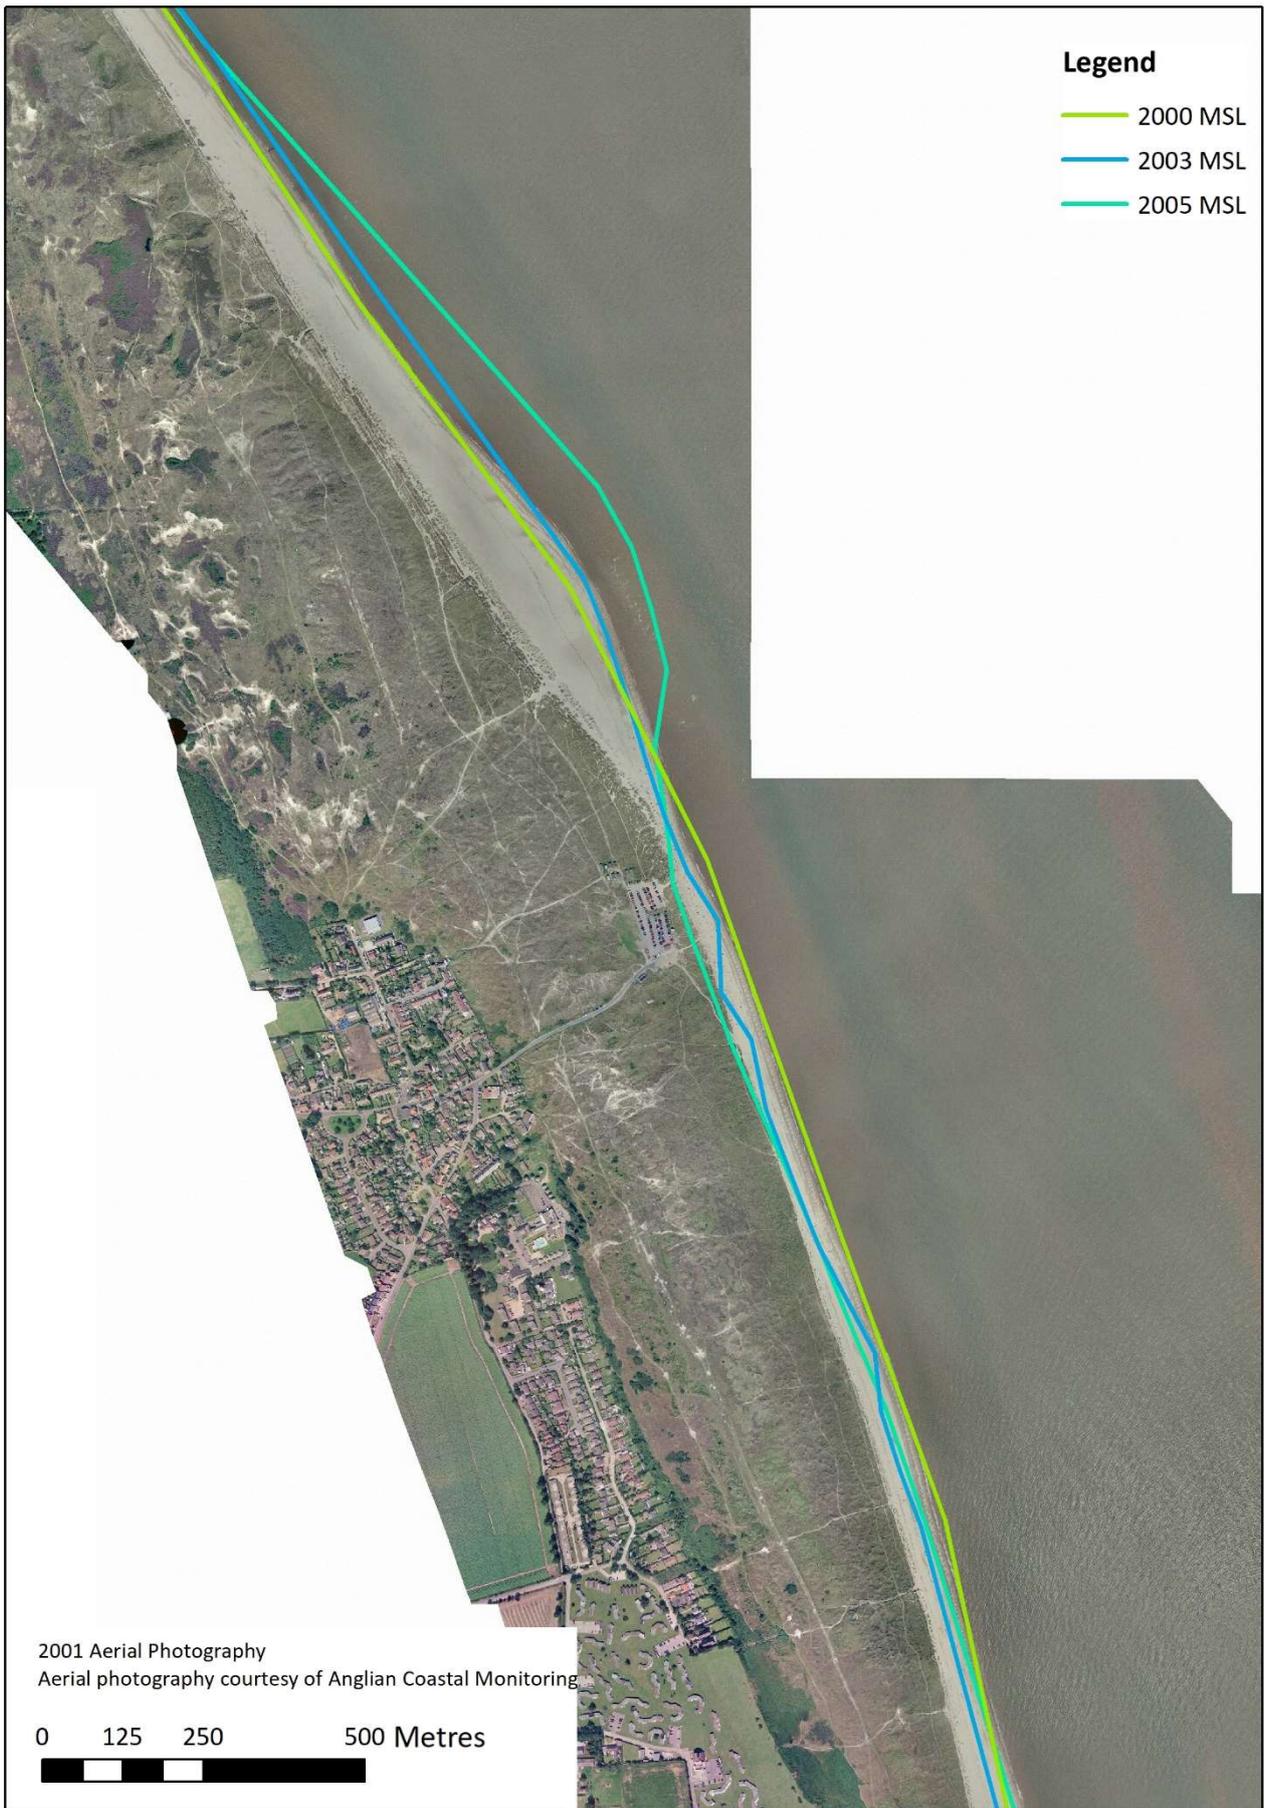
Figure 3 Extracted MSL points and interpolated lines for years 2000 – 2005.

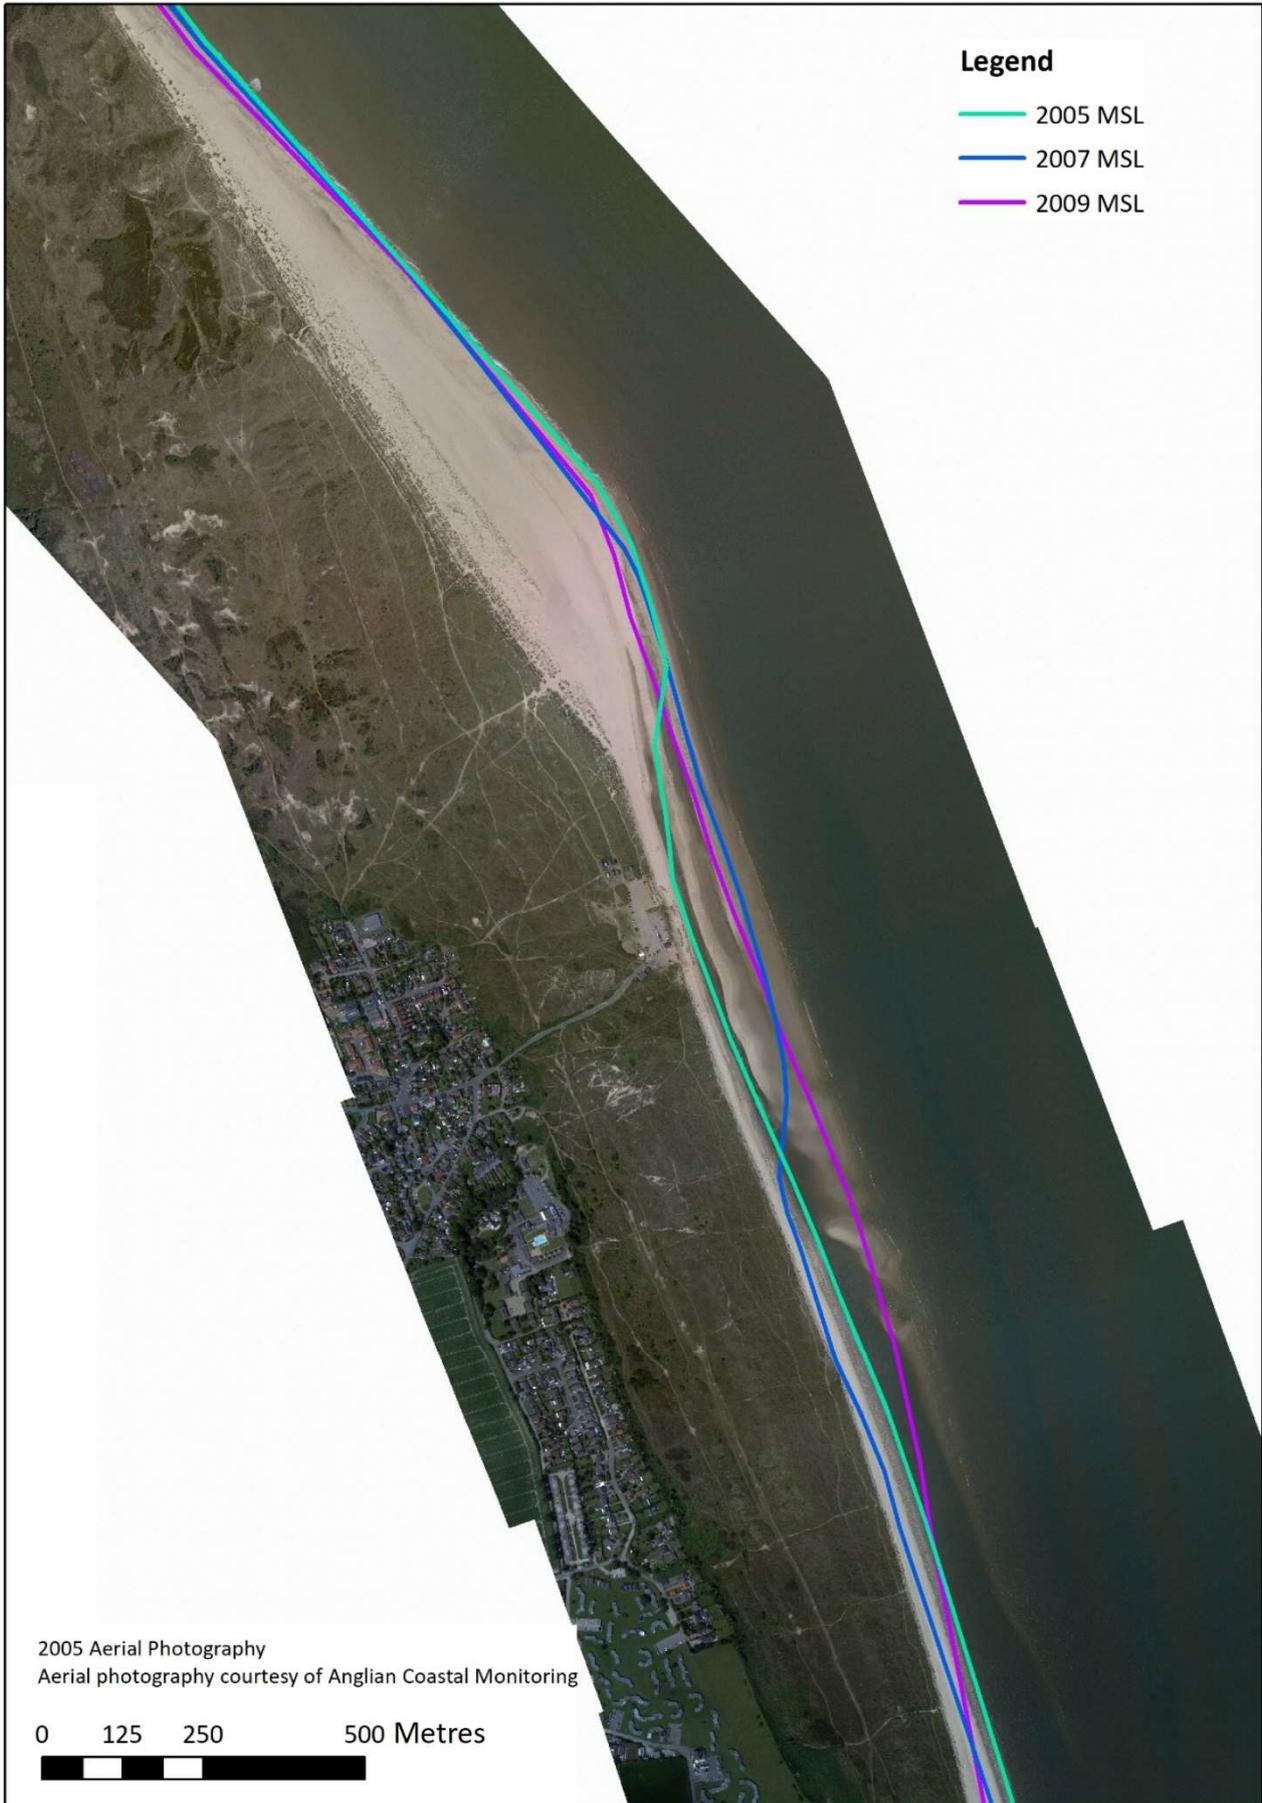
Figure 4 Extracted MSL points and interpolated lines for years 2005 – 2009.

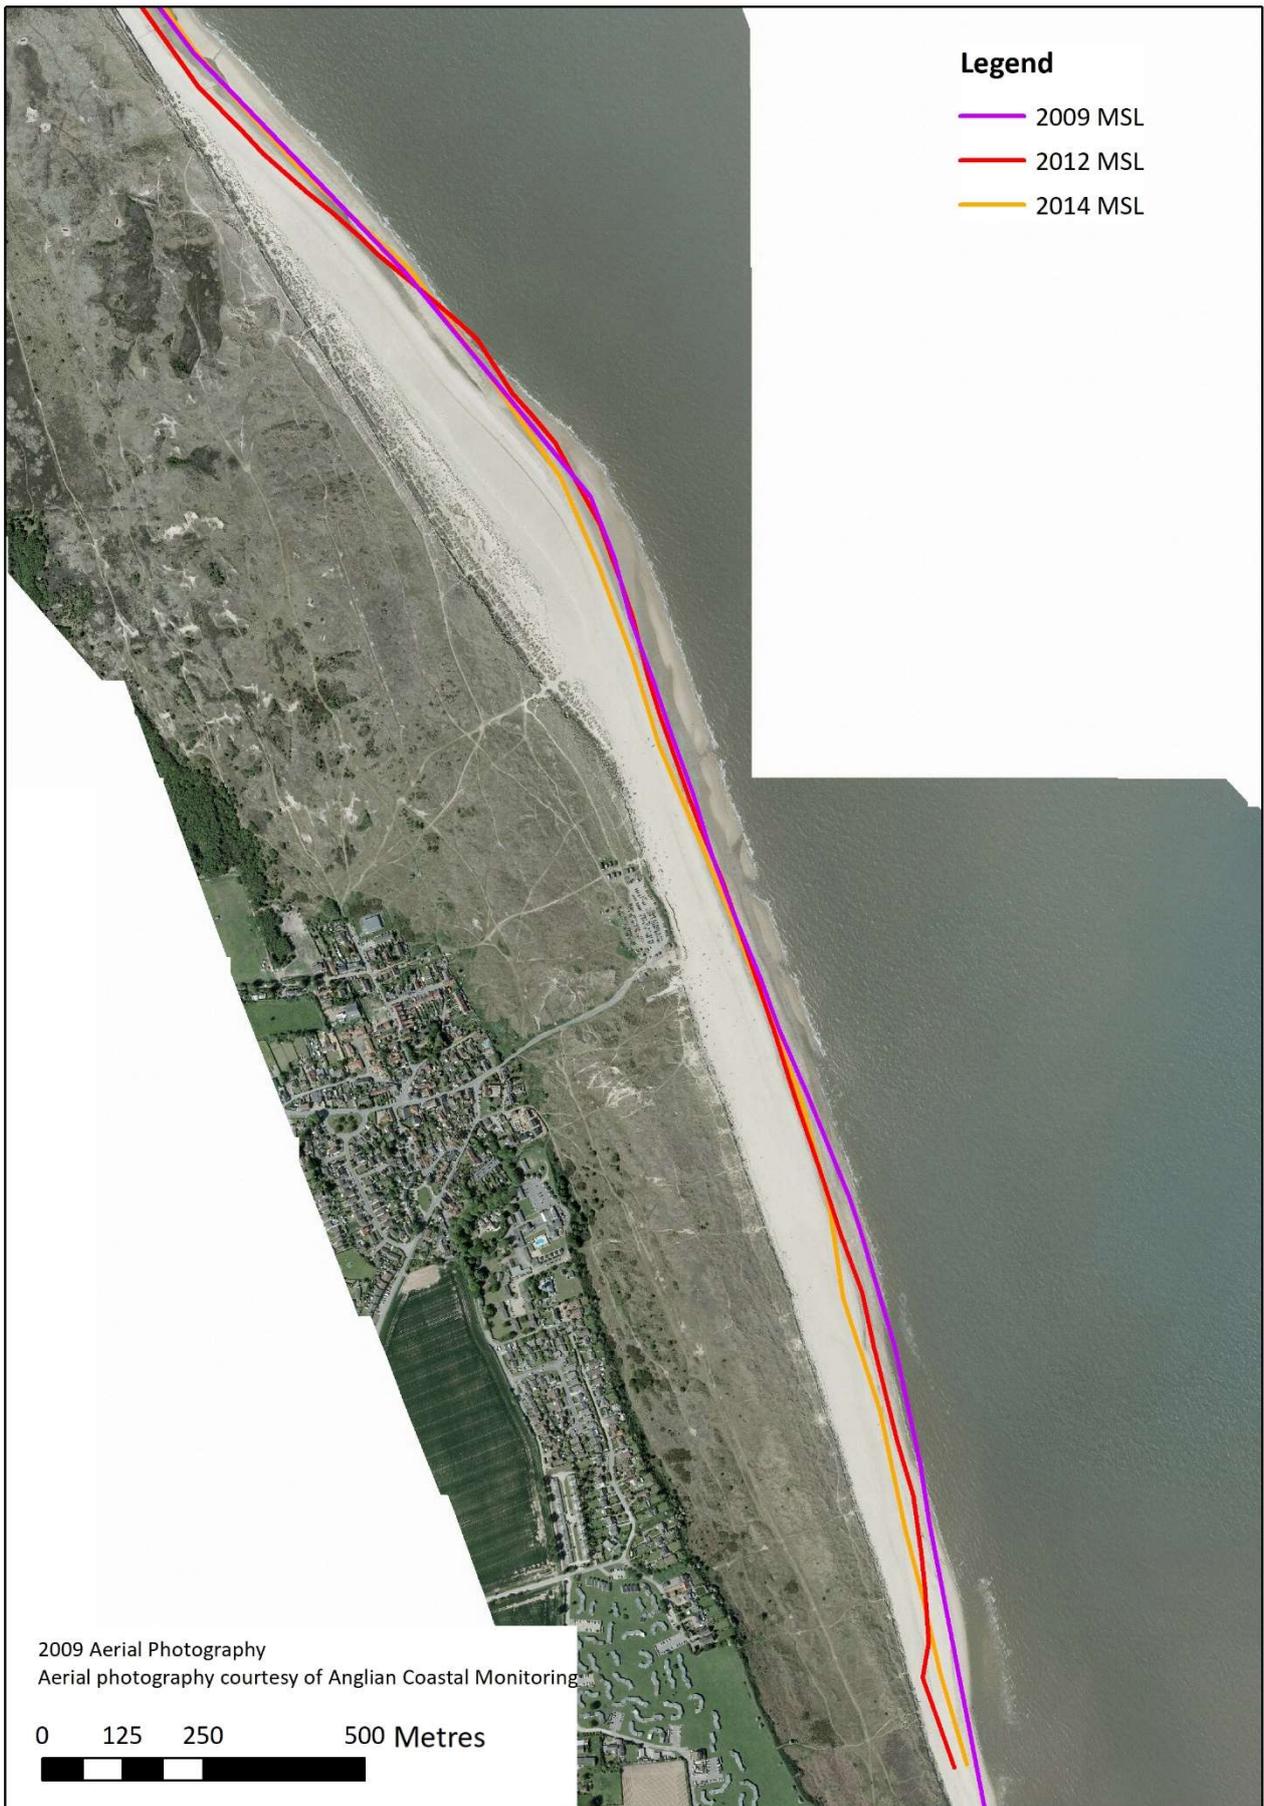
Figure 5 Extracted MSL points and interpolated lines for years 2009 – 2014.
