GREAT YARMOUTH
BOROUGH COUNCIL

Environment Committee

Venue: Supper Room

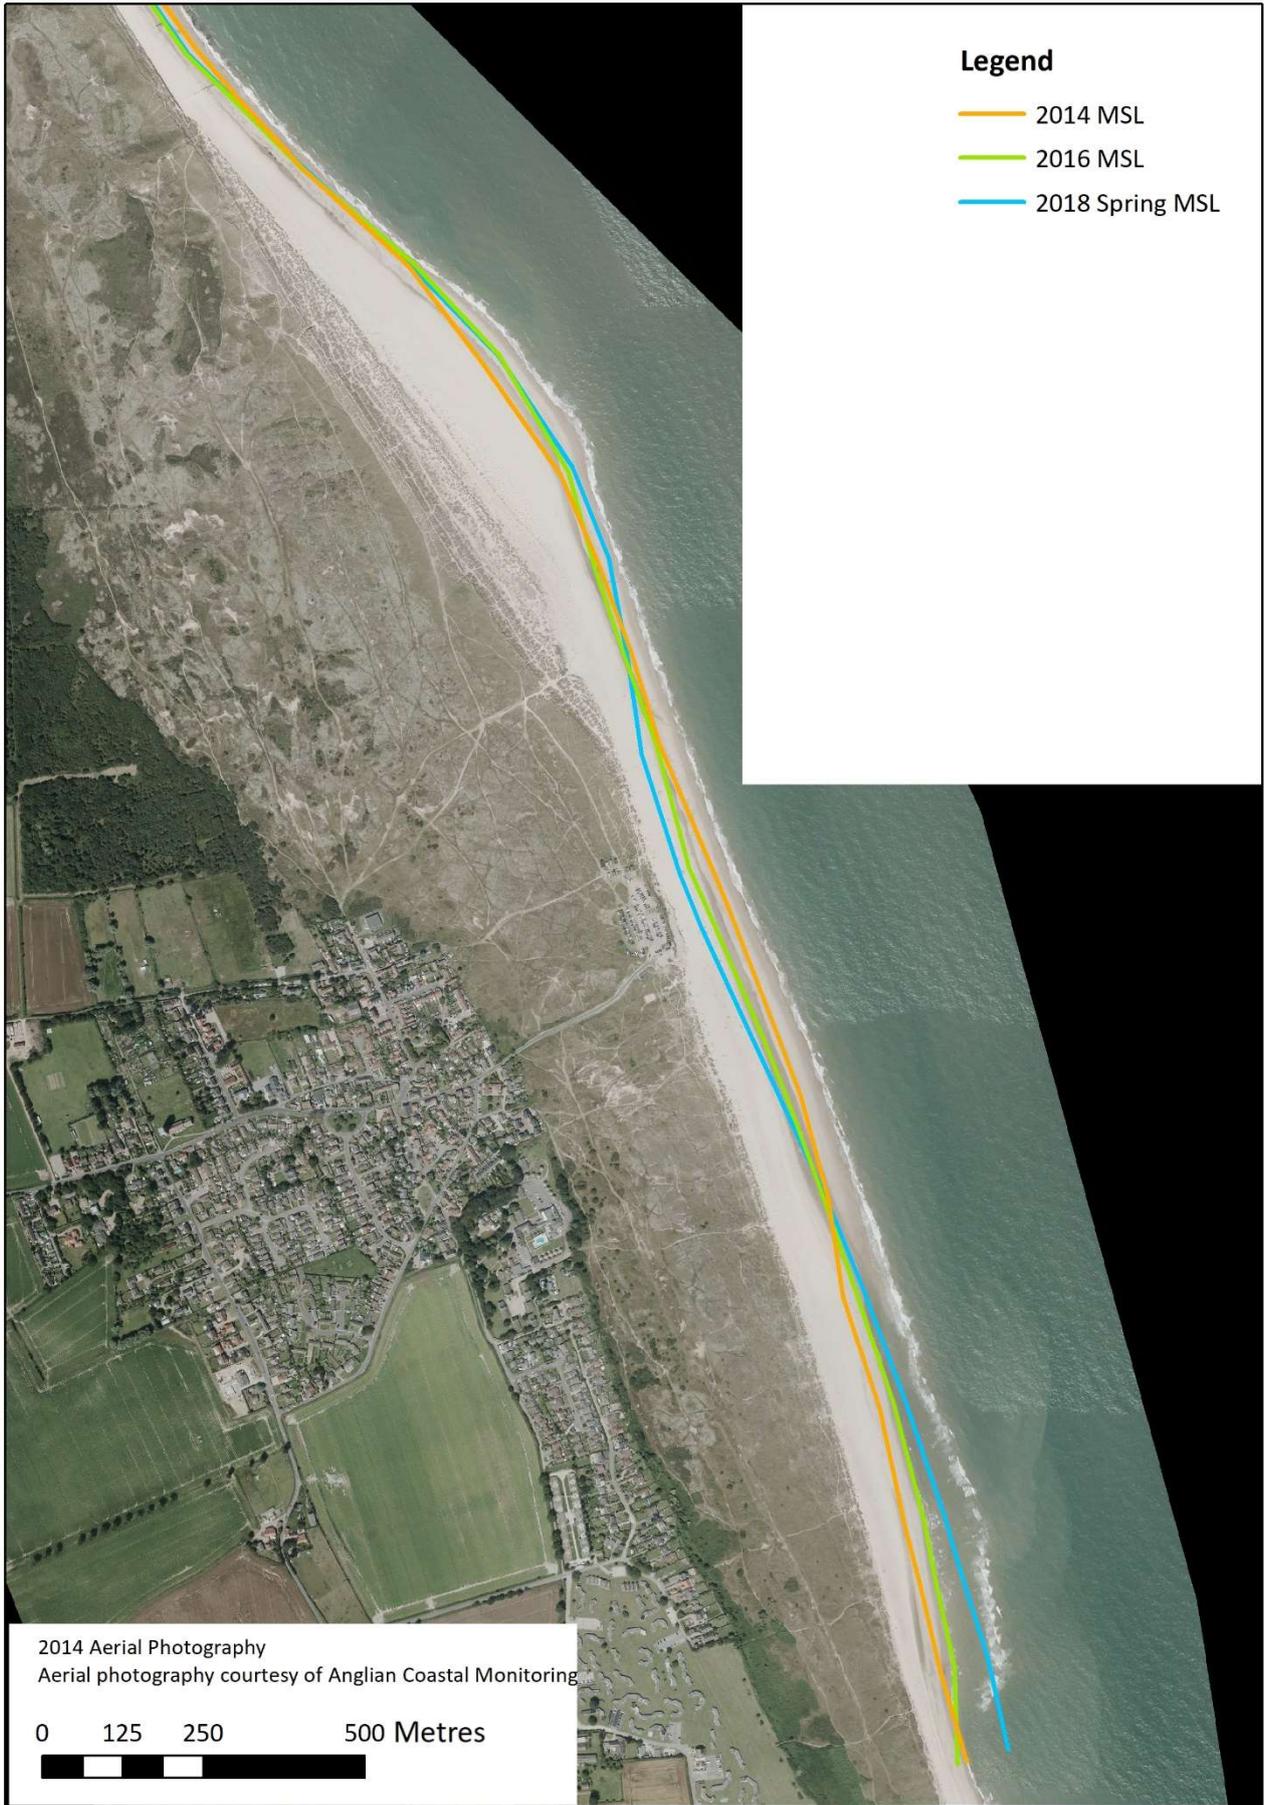
Figure 6 Extracted MSL points and interpolated lines for years 2014 – 2018.

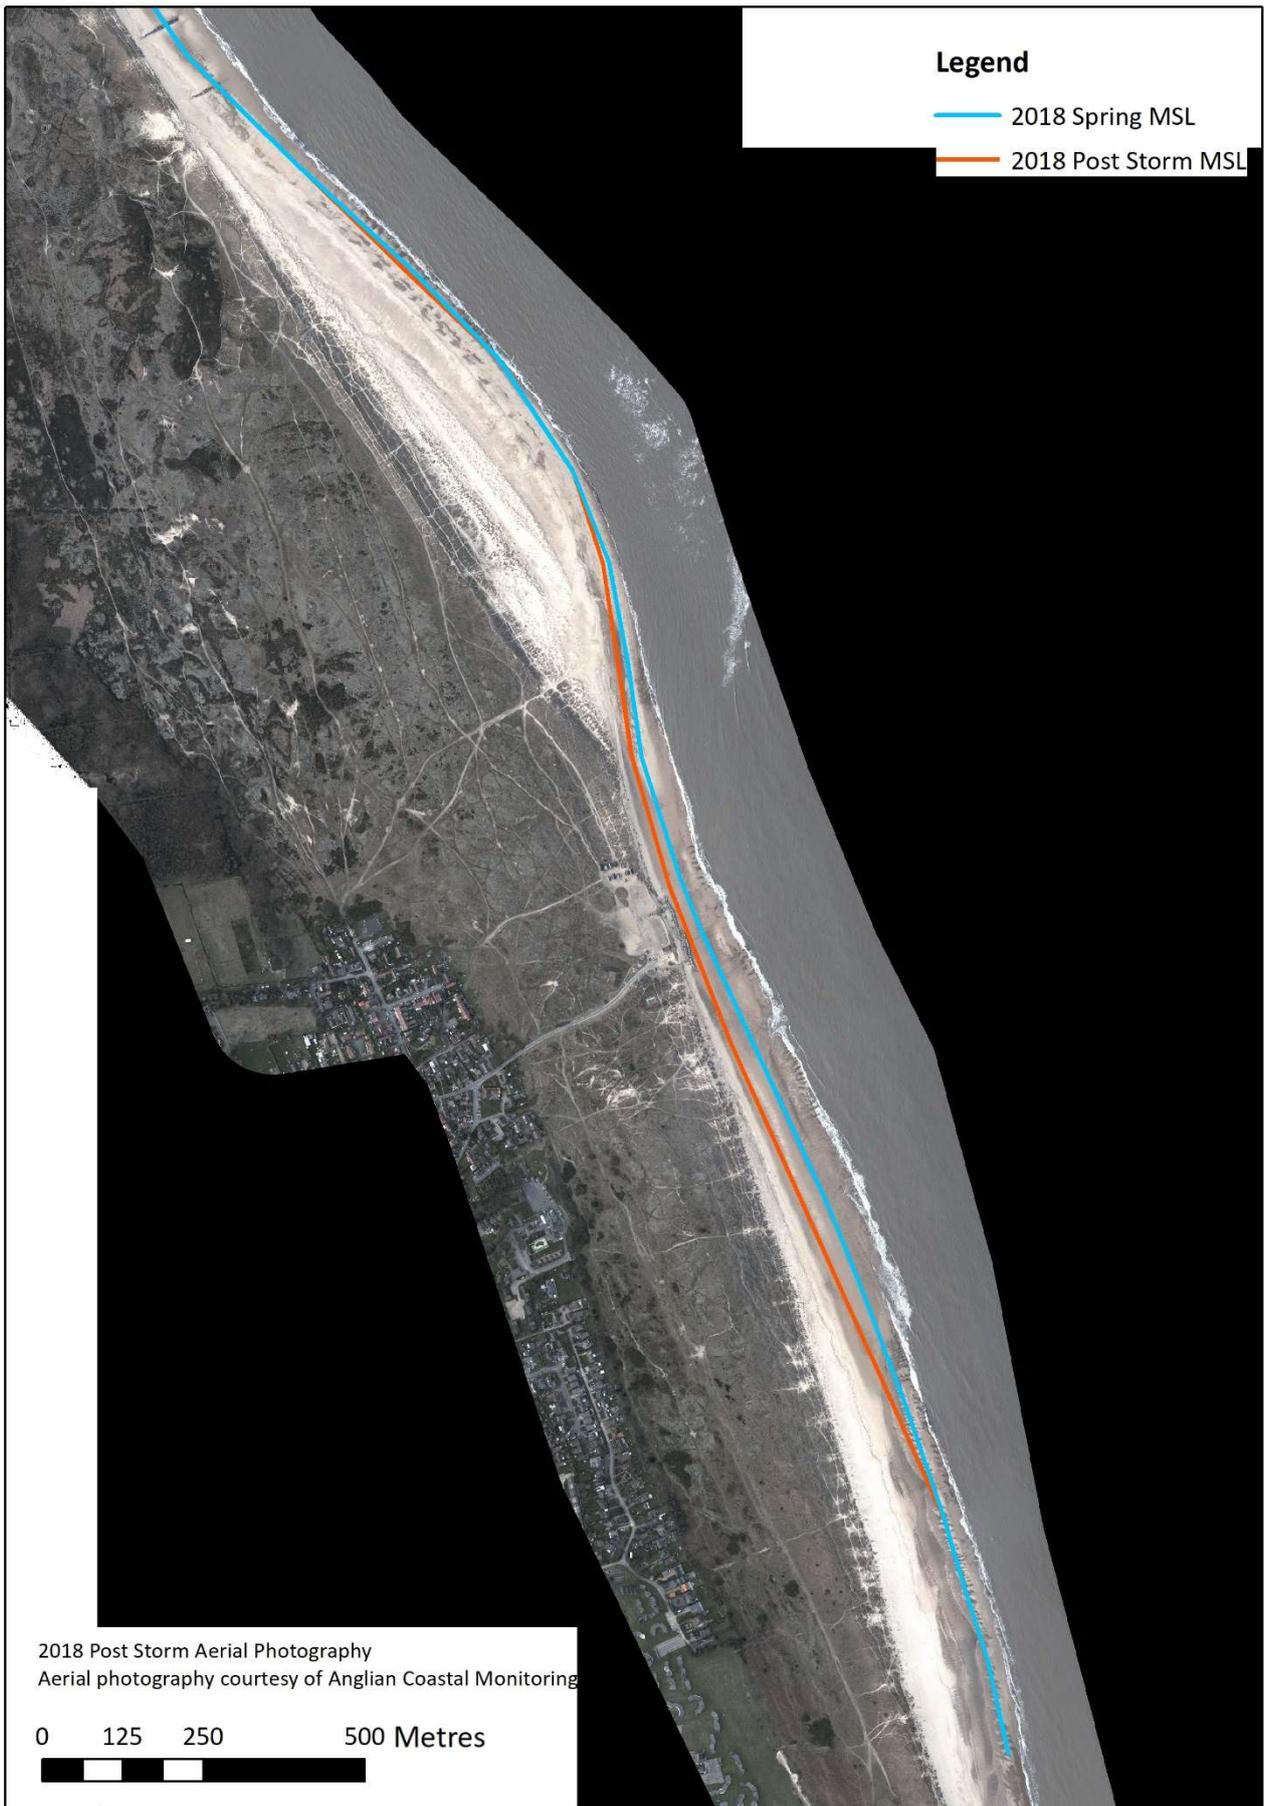
Figure 7 – Extracted MSL points and interpolated lines for Spring 2018 – 2018 Post Storm.

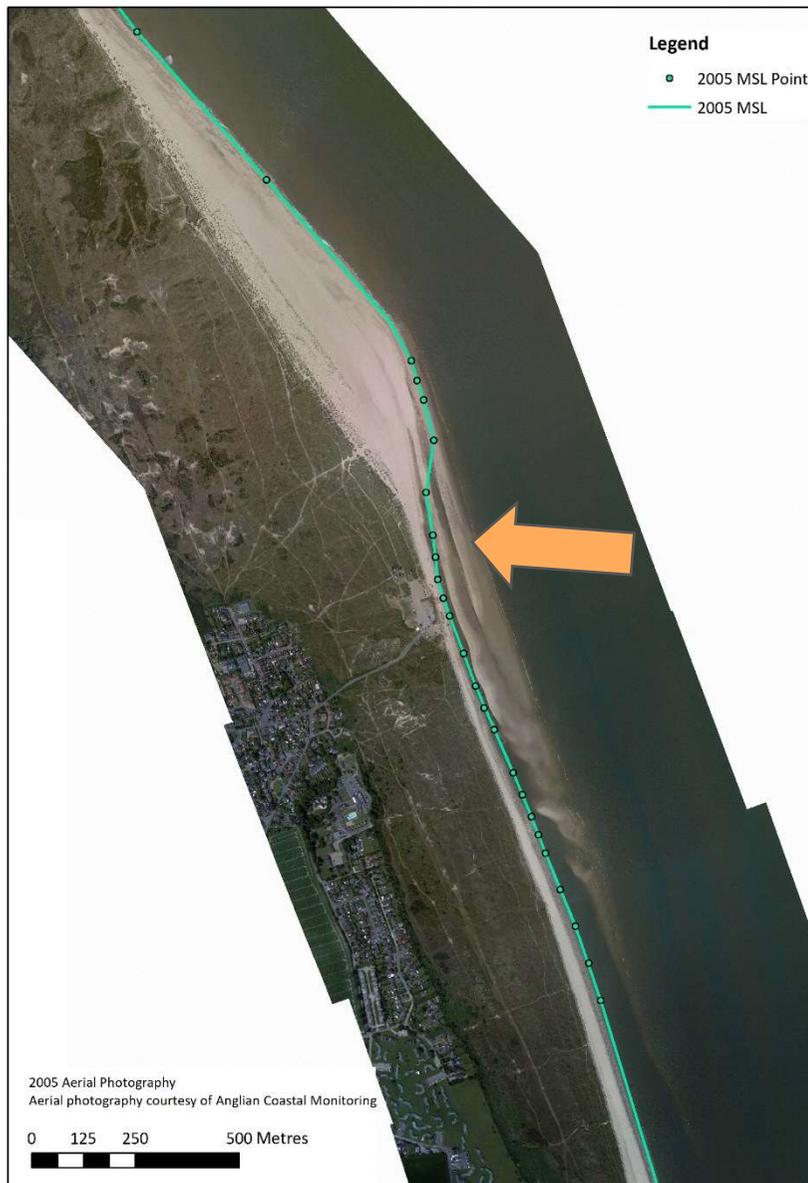
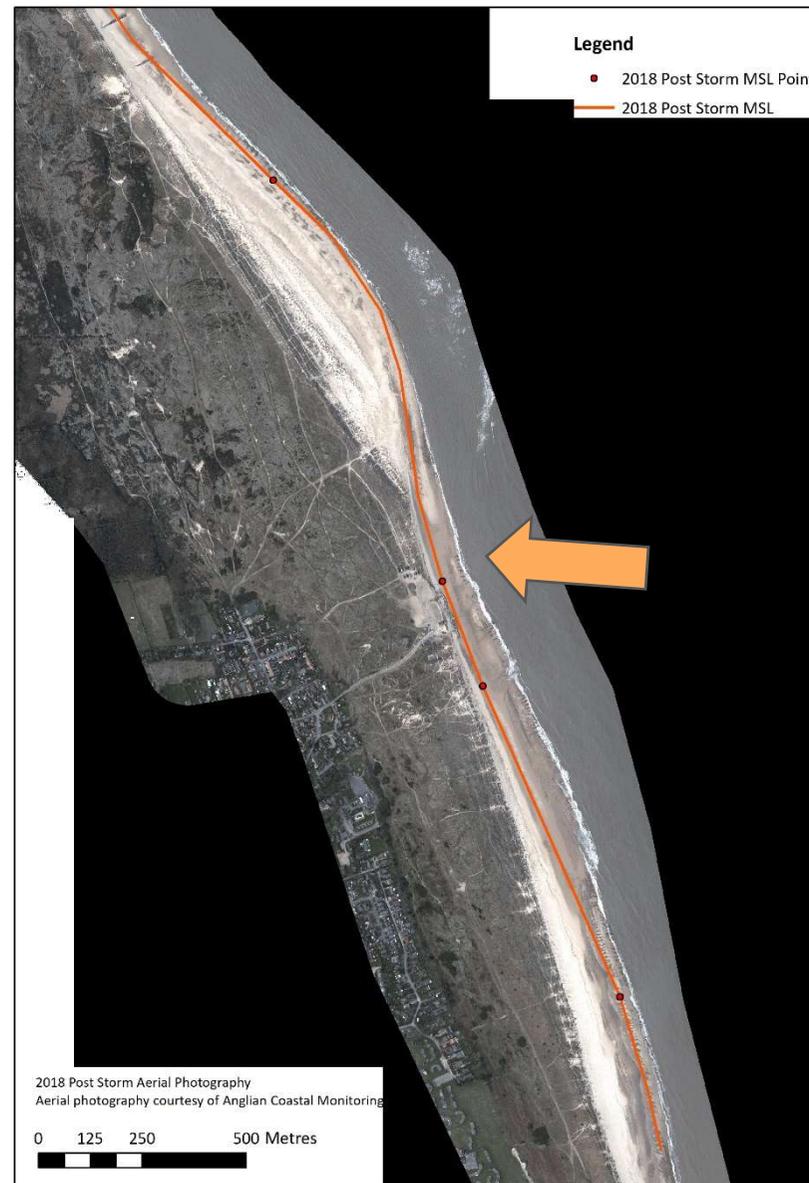
Figure 8 Similarities and differences between the shape of Winterton ness in 2005 and 2018. Orange arrows indicate the re-orientation of shoreline as the area to the south of the ness eroded.

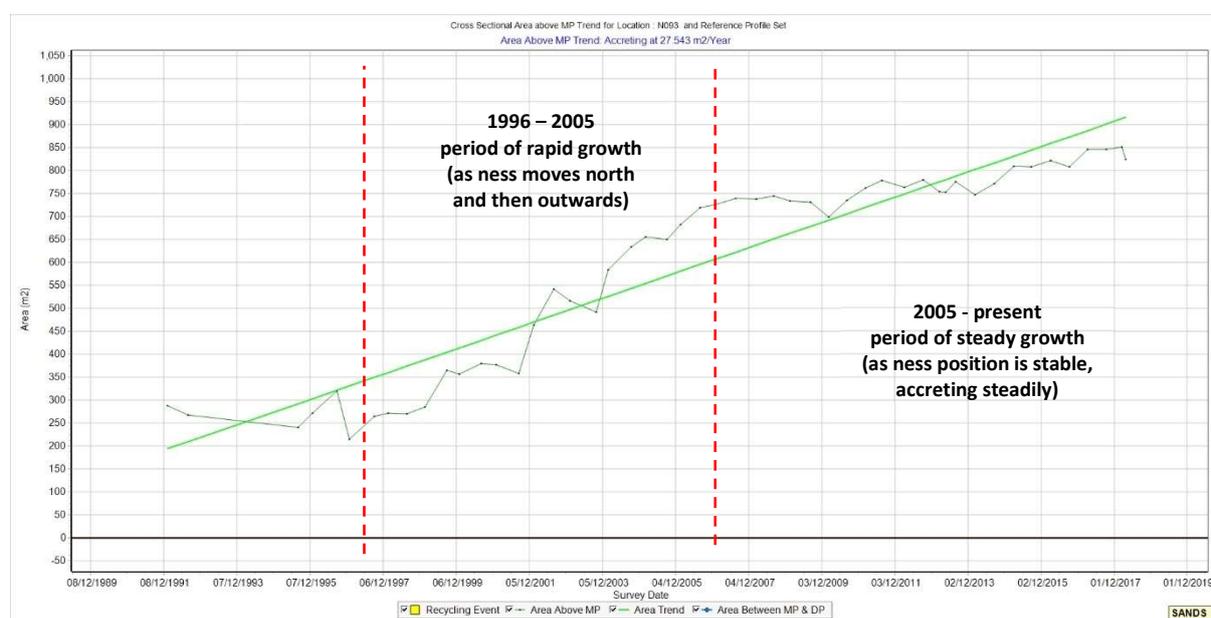
Figure 9 Profile N093 - Cross sectional area over time (1992 - 2018)

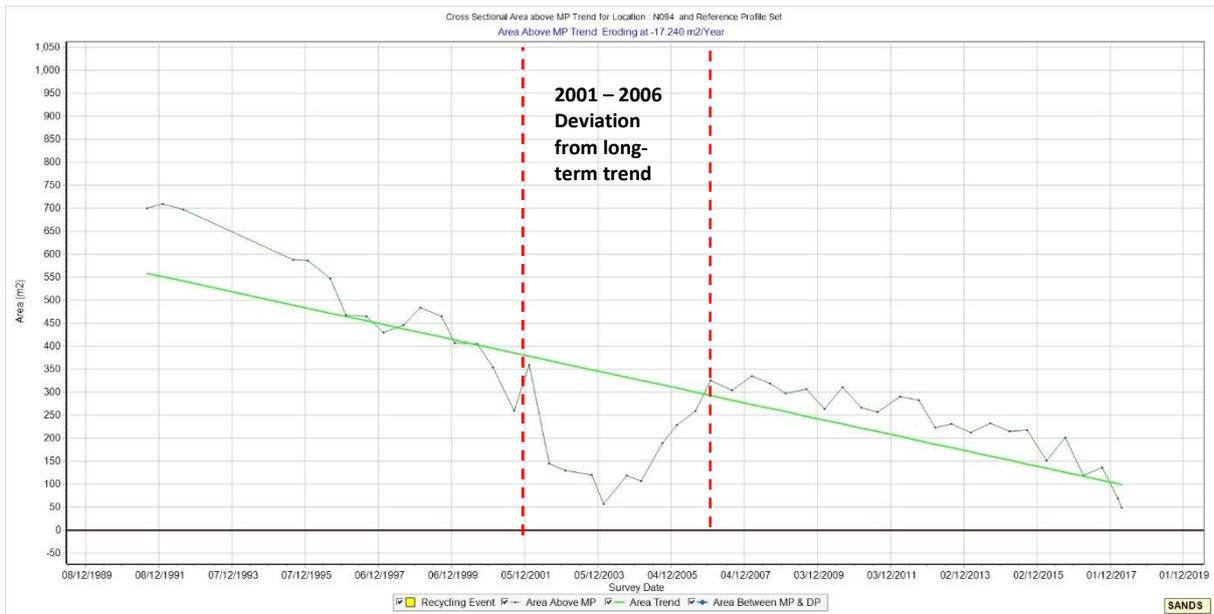
Figure 10 Profile N094 - Cross Sectional Area over time (1992 - 2018)

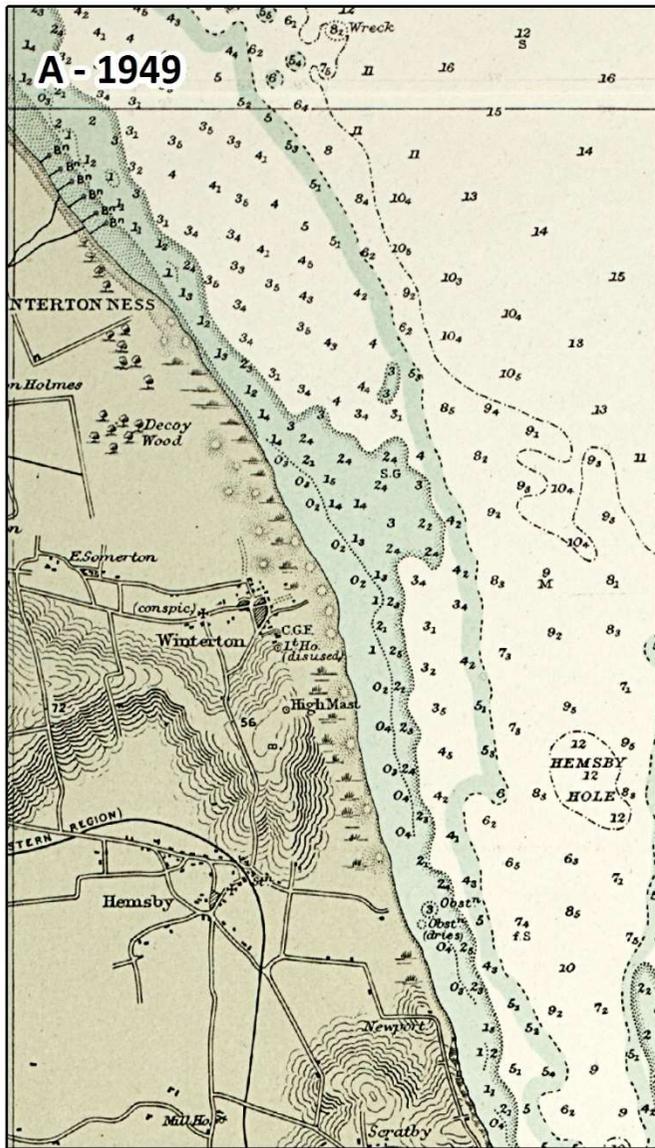
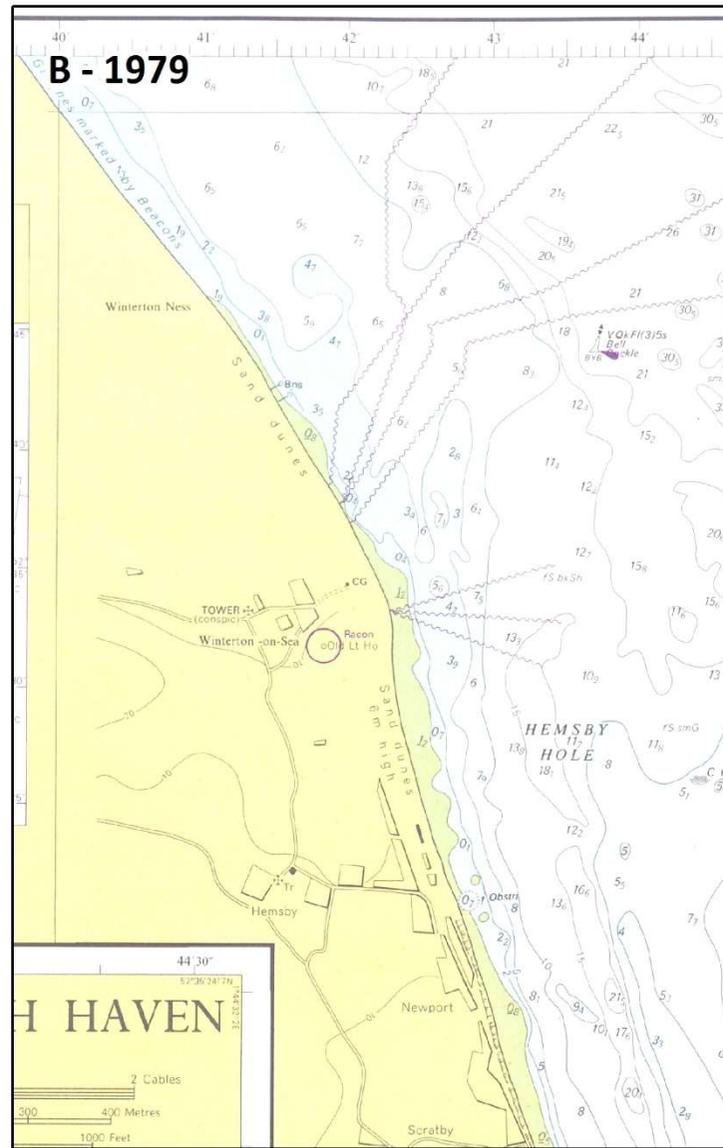
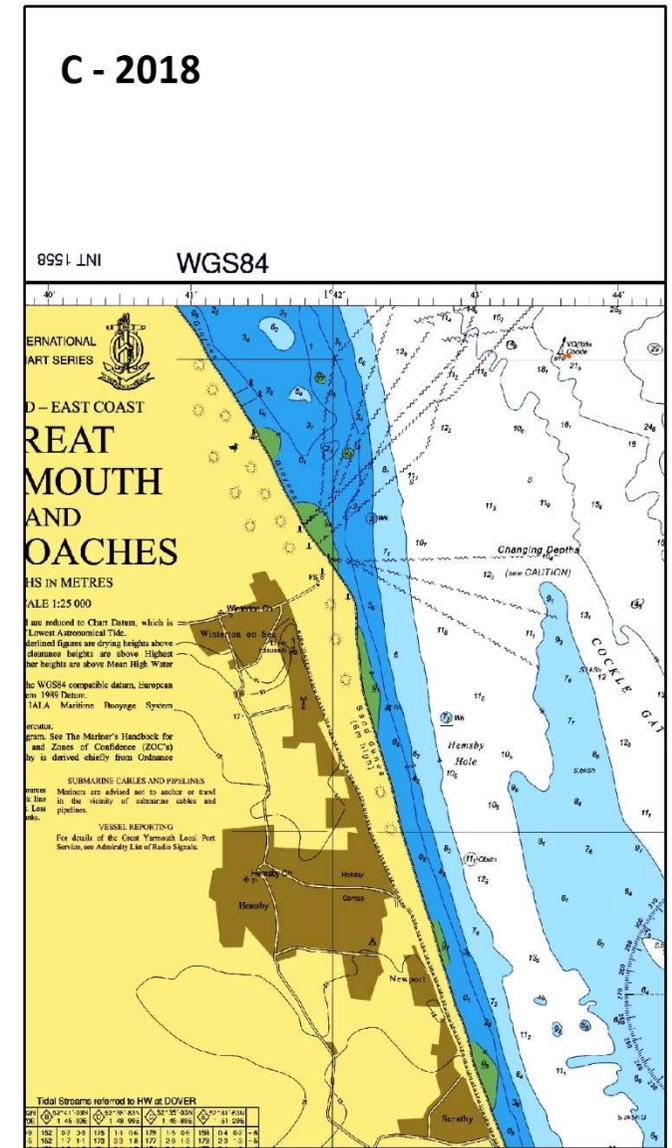
Figure 12 Winterton Ness Admiralty Charts © Crown Copyright and/or database rights. Reproduced by permission of the Controller of Her Majesty's Stationery Office and the UK Hydrographic Office (www.GOV.uk/UKHO).

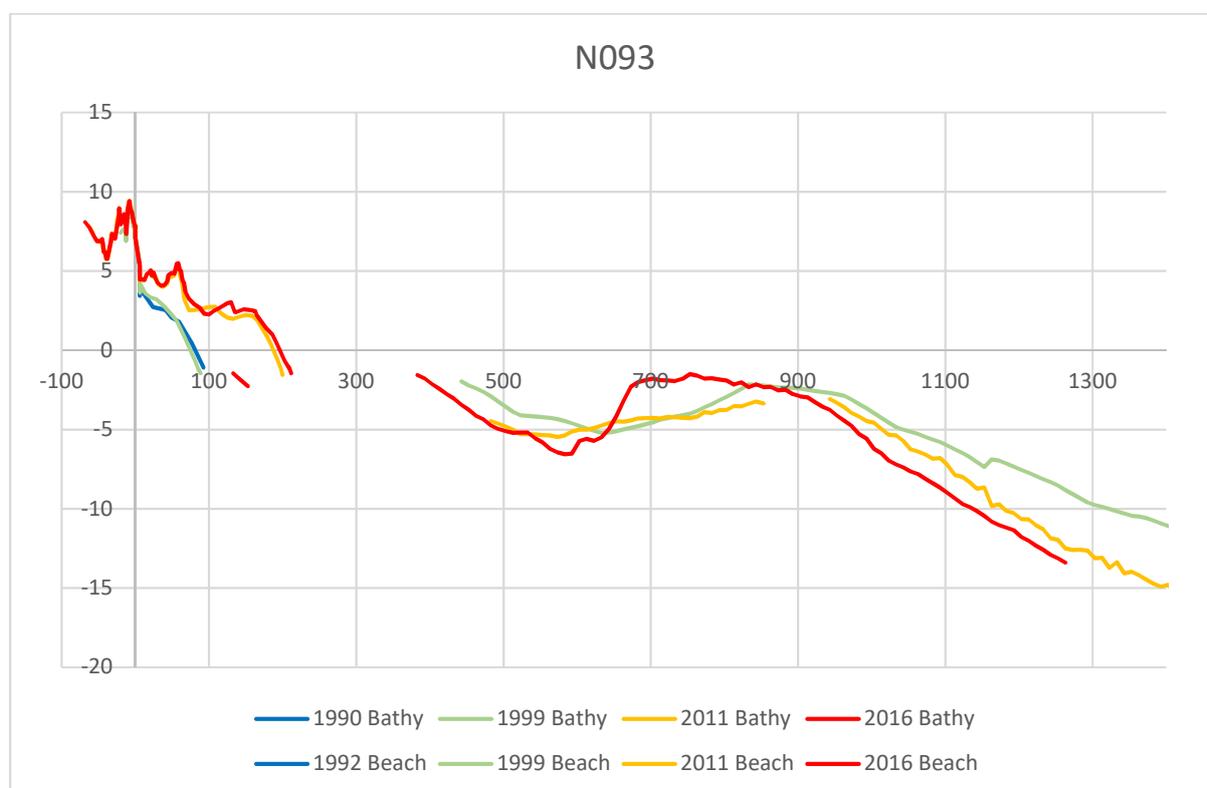
Figure 13 Beach profile data Profile N093 with additional bathymetry (sea floor) data extracted from MCA surveys. Note: the vertical axis is in metres above Ordnance Datum.

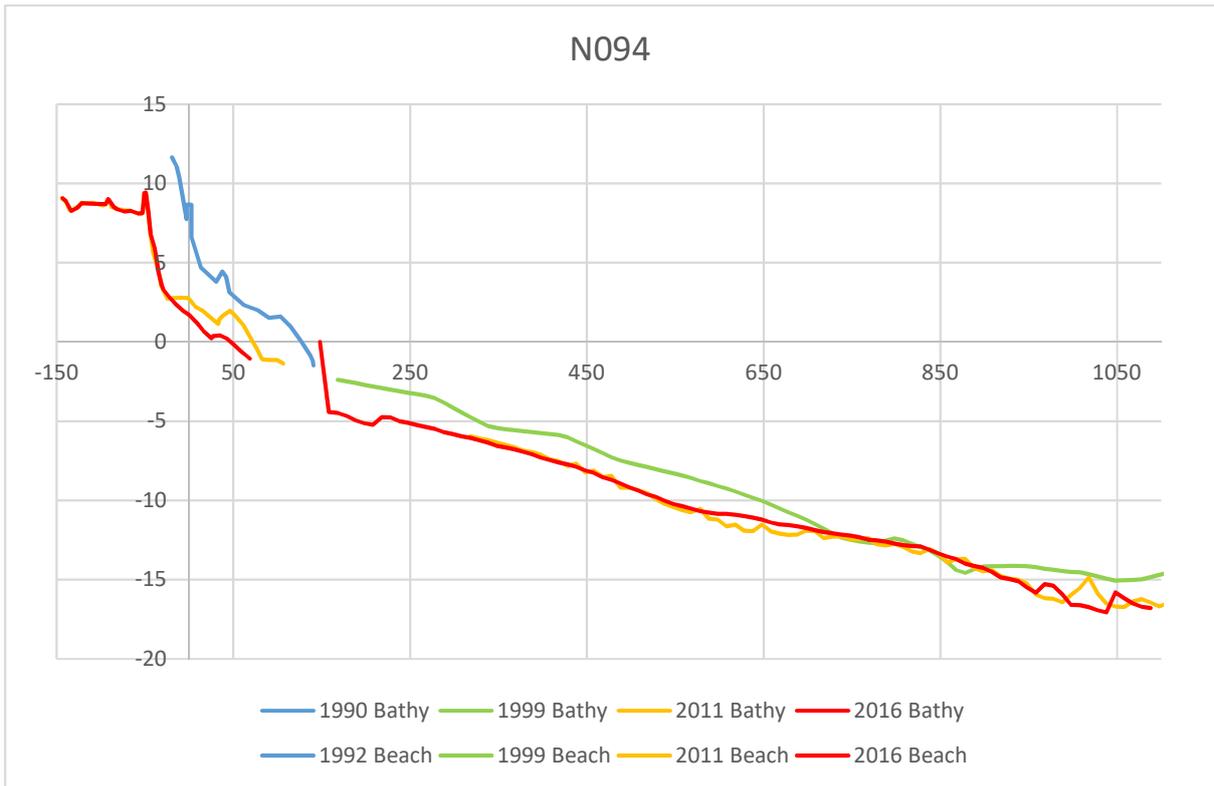
Figure 14 Beach profile data Profile N094 with additional bathymetry (sea floor) data extracted from MCA surveys. Note: the vertical axis is in metres above Ordnance Datum.

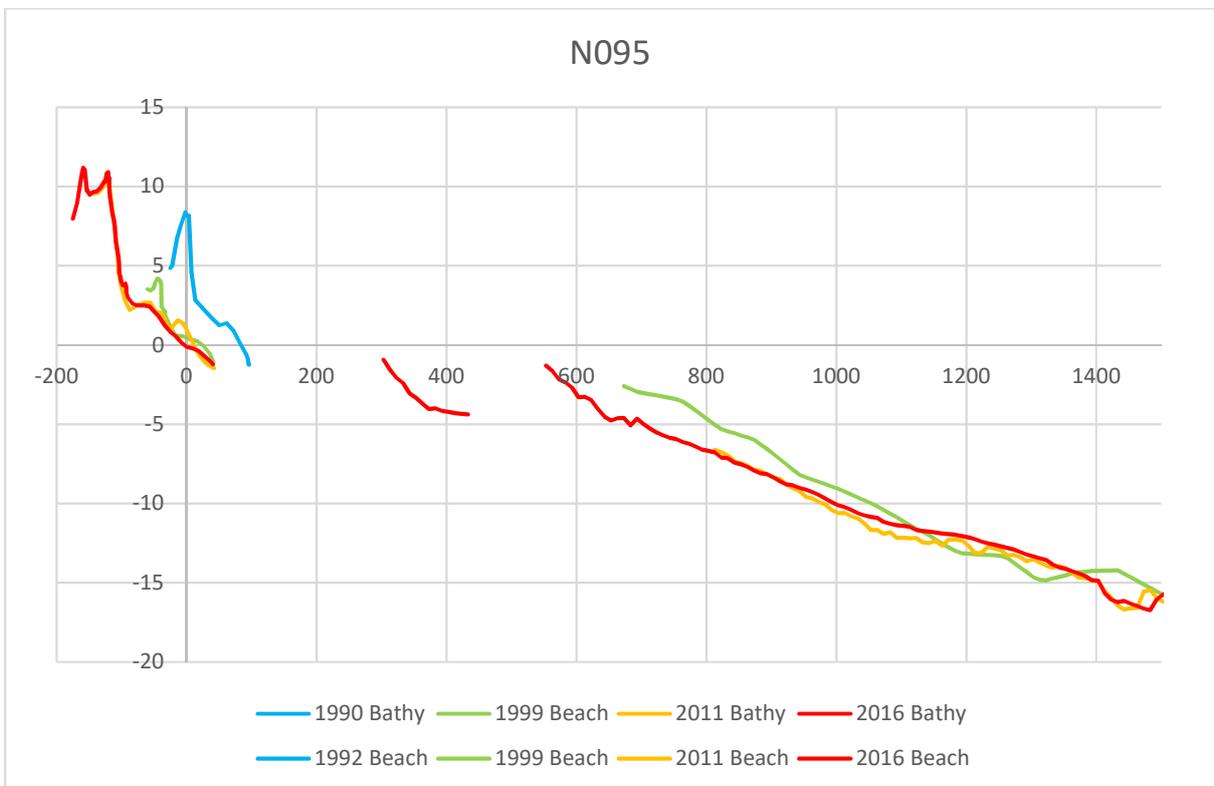
Figure 15 Beach profile data Profile N095 with additional bathymetry (sea floor) data extracted from MCA surveys. Note: the vertical axis is in metres above Ordnance Datum.

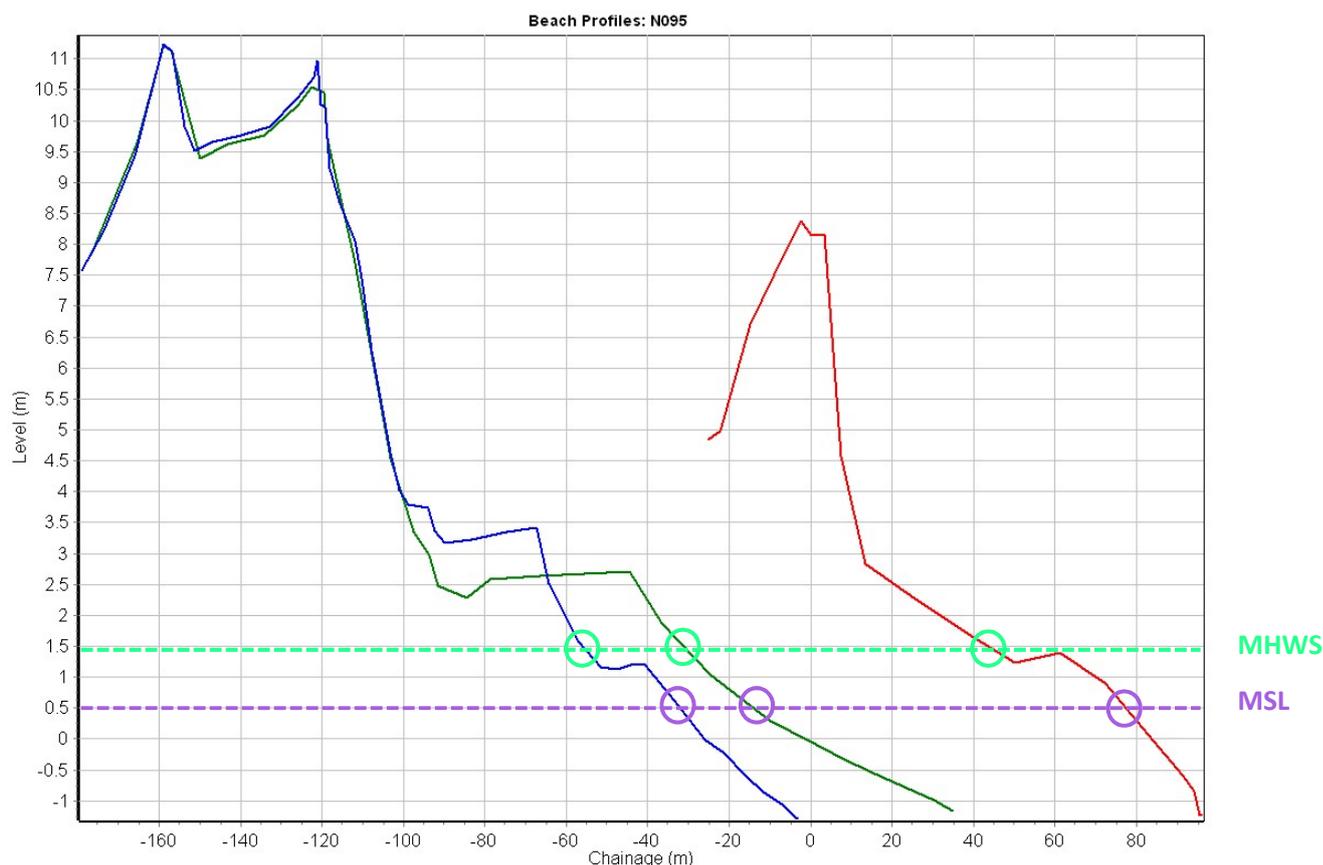
Figure 16 Extraction of chainage point at Mean Sea Level (purple points) and Mean High Water Springs (green points) from beach profile data. Chainages were extracted for the 1992/1997 (red), 2013 (dark green) and 2018 (blue).

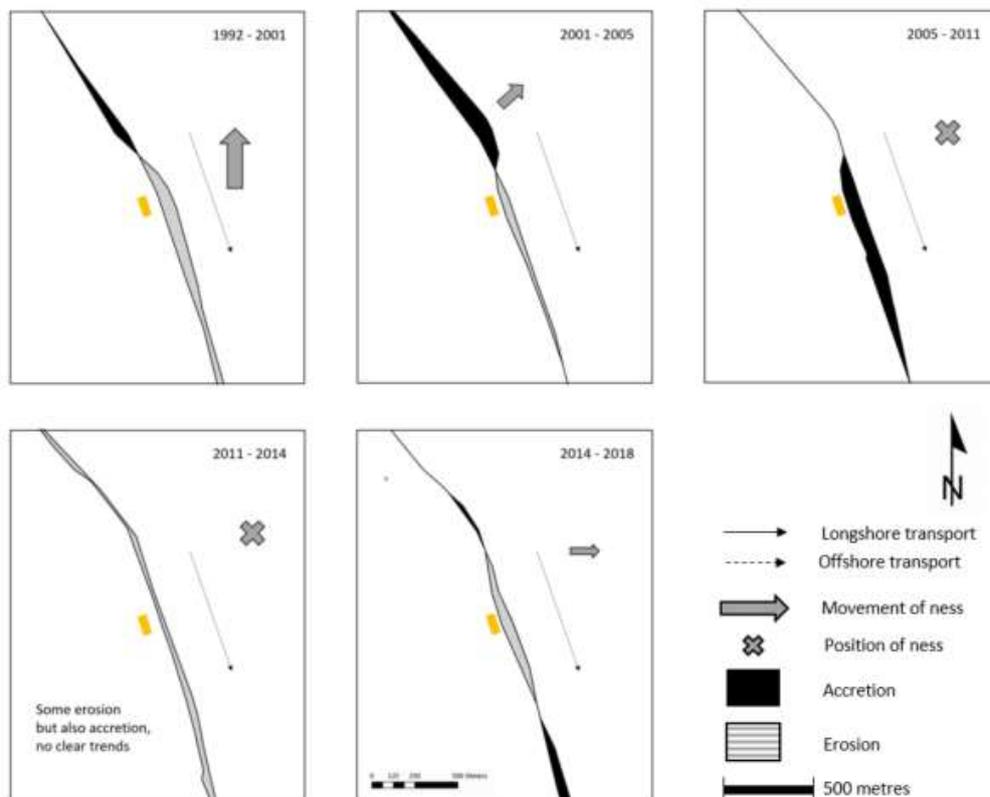
Figure 18 Conceptual summary of changes at Winterton Ness during the period 1992 – 2018. The yellow rectangle indicates the position of the car park for reference.

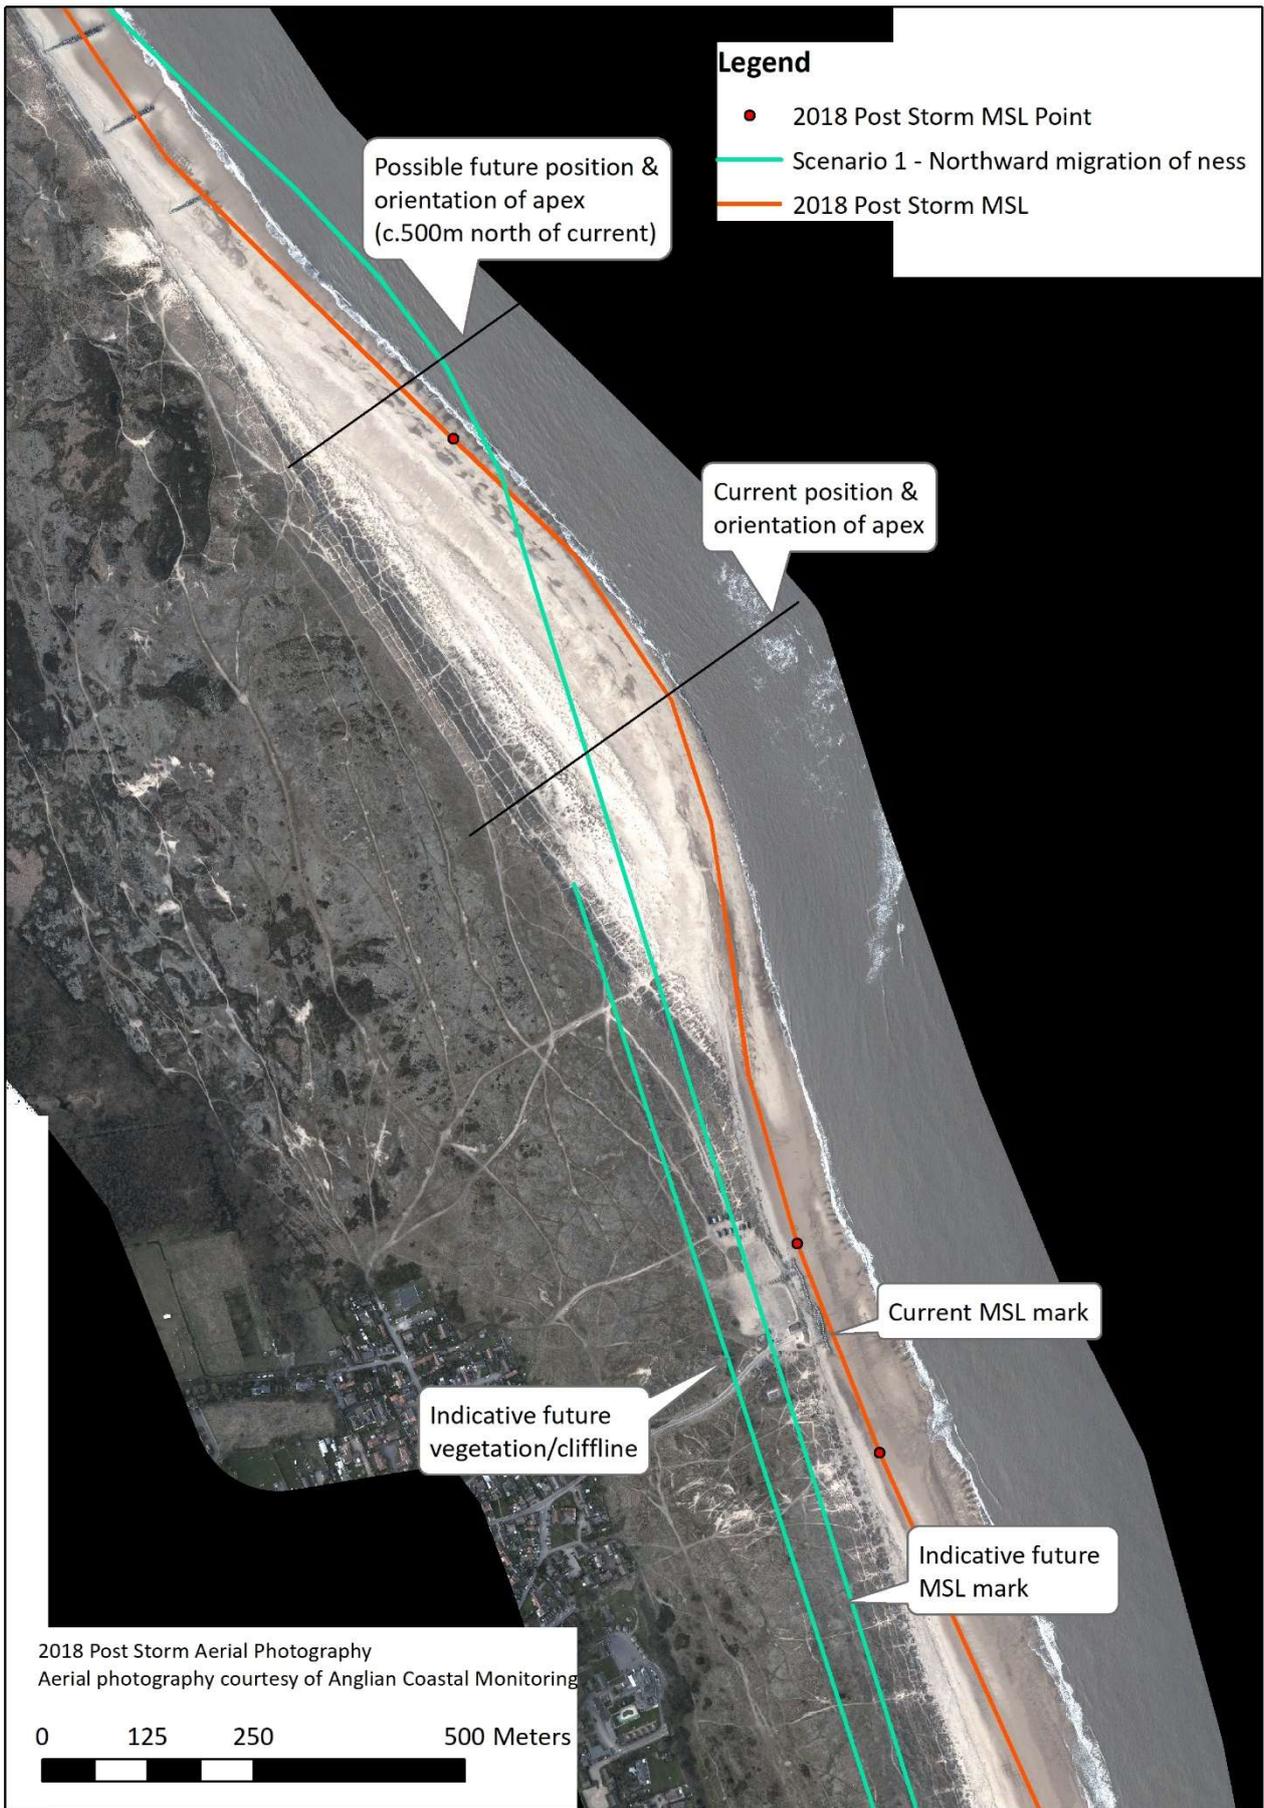
Figure 19 Scenario 1 – Northward migration of the ness (20 year projection).

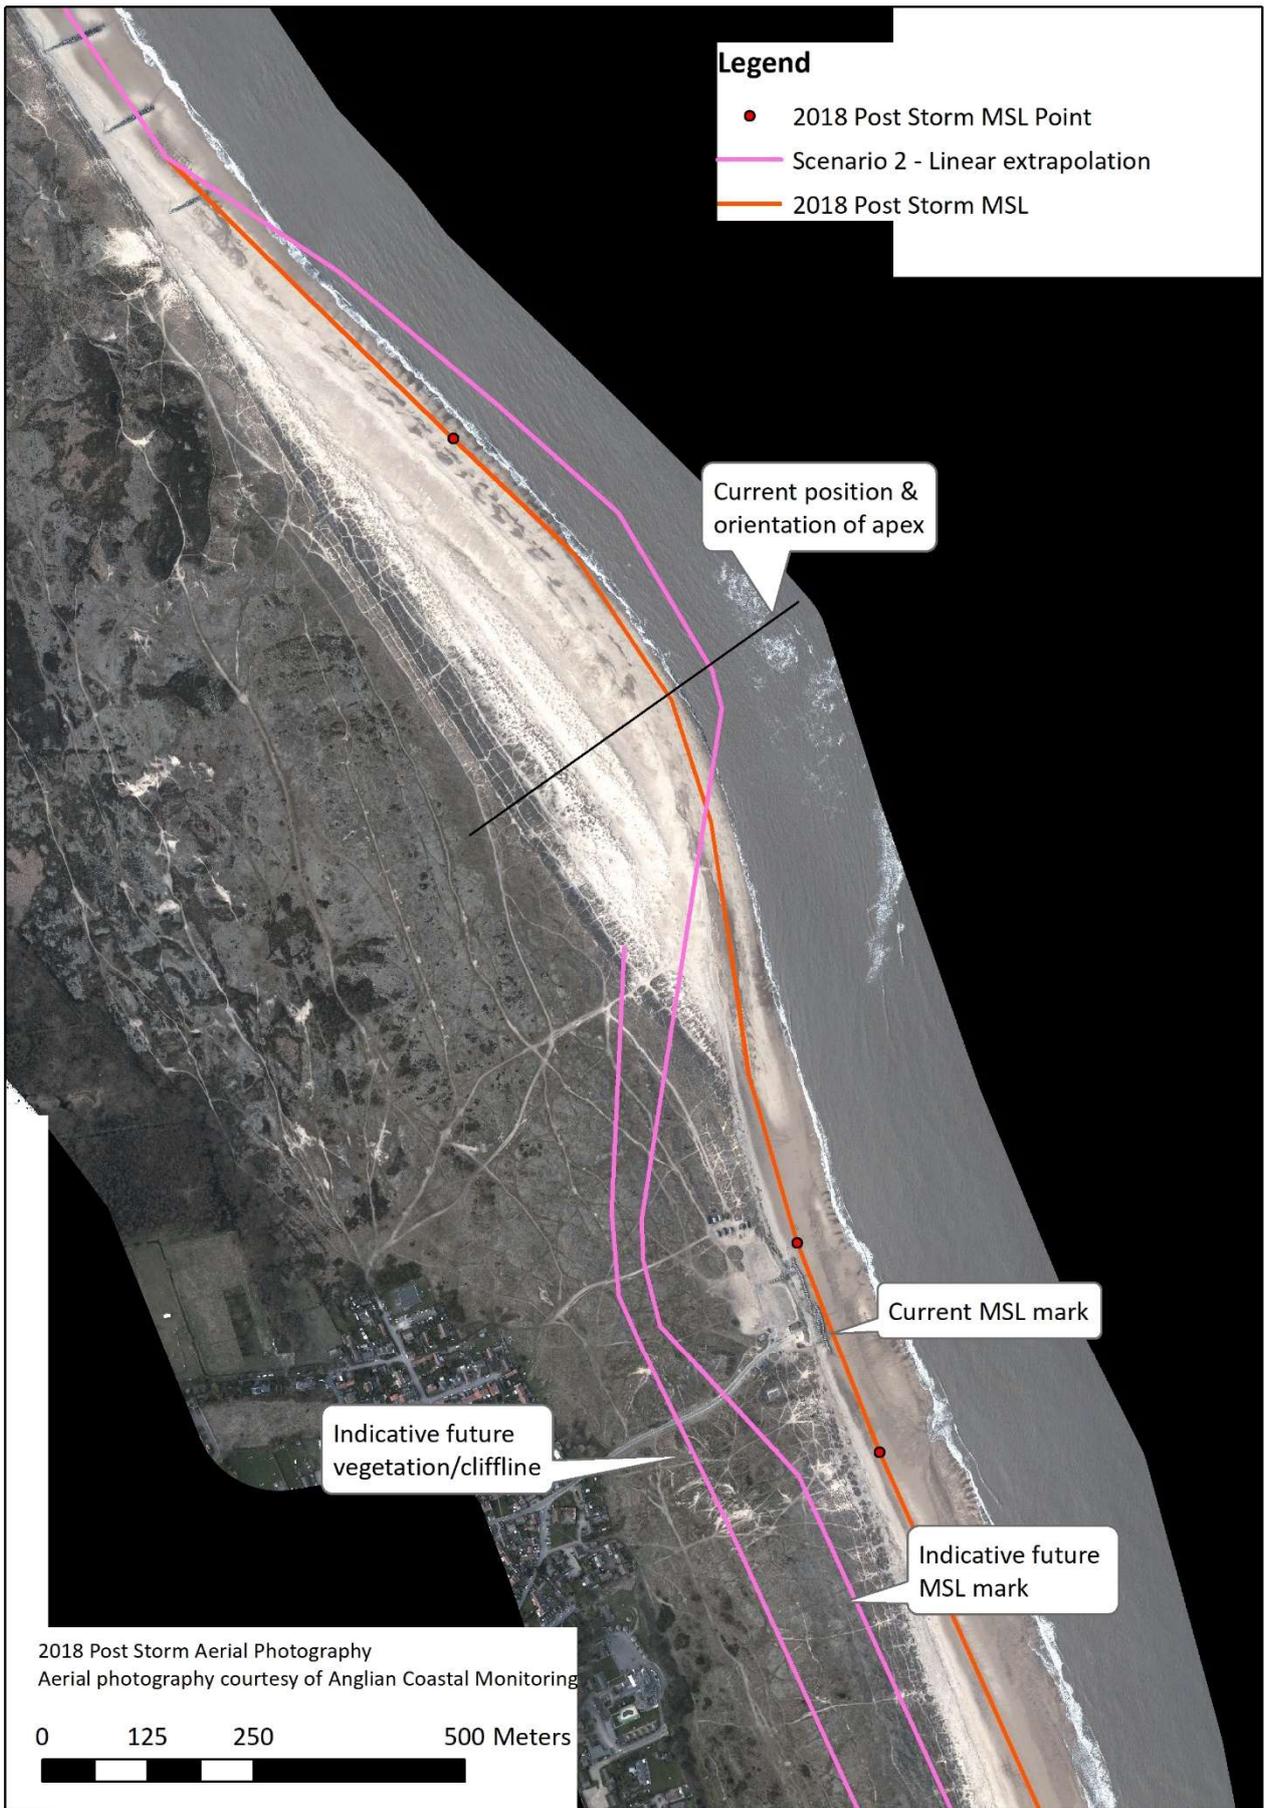
Figure 20 Scenario 2 - linear extrapolation of current trends alongside current MSL mark (20 year projection).
