Report Title: Haven Bridge Public House

Report to: Scrutiny

Great Yarmouth Borough Council (GYBC) appointed Technicus Consulting on 15th February 2024 to conduct a visual-only, non-invasive, external structural survey of the fire damaged Haven Bridge Public House (PH) on Bridge Road, Cobholm. The purpose of the survey is to report on the structural condition of the building, and the expected preliminary scope of structural repairs and remedial works needed to return the building to a wind and watertight condition. We understand this report will then be used to assess the likely remedial works costs to assist with valuing the property, following which GYBC may consider submitting a Compulsory Purchase Order (CPO) to acquire the dilapidated property.

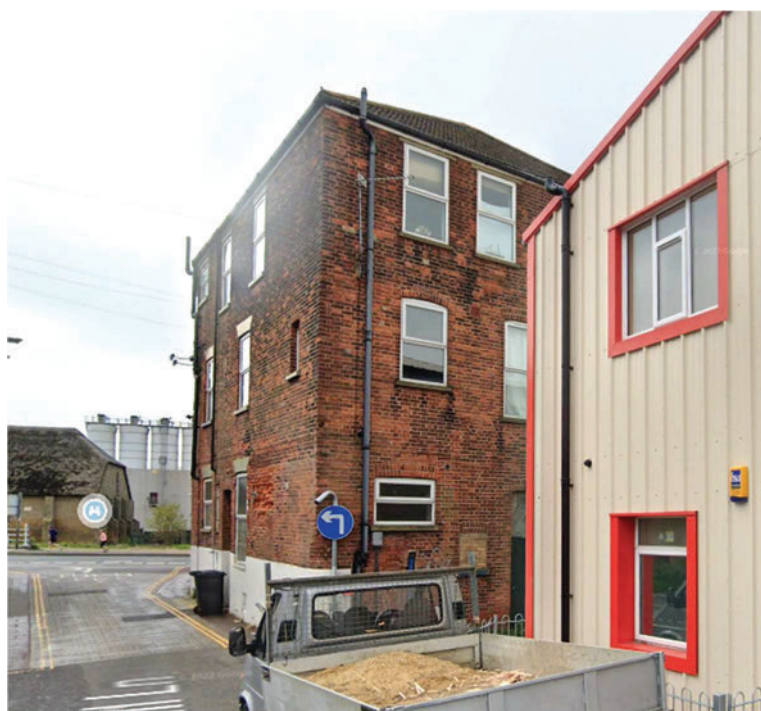
Figure 2 – 2018 View of Haven Bridge PH From Steam Mill Lane Prior to Fire Damage

The building has also been subject to remedial works in the form of installation of lateral restraint tie rods and pattress / restraint plates to laterally restrain the east facing flank wall panel at first and second floor levels. These remedial works are visible from Steam Mill Lane and can be seen in Figure 3 below.
