Subject: COASTAL STRATEGY FOR WINTERTON TO GREAT YARMOUTH

Report to: EMT 29th September 2016 Environment Committee 12th October 2016

Outline of coastal conditions and bases of requirements for Coastal Management review for Winterton to Great Yarmouth

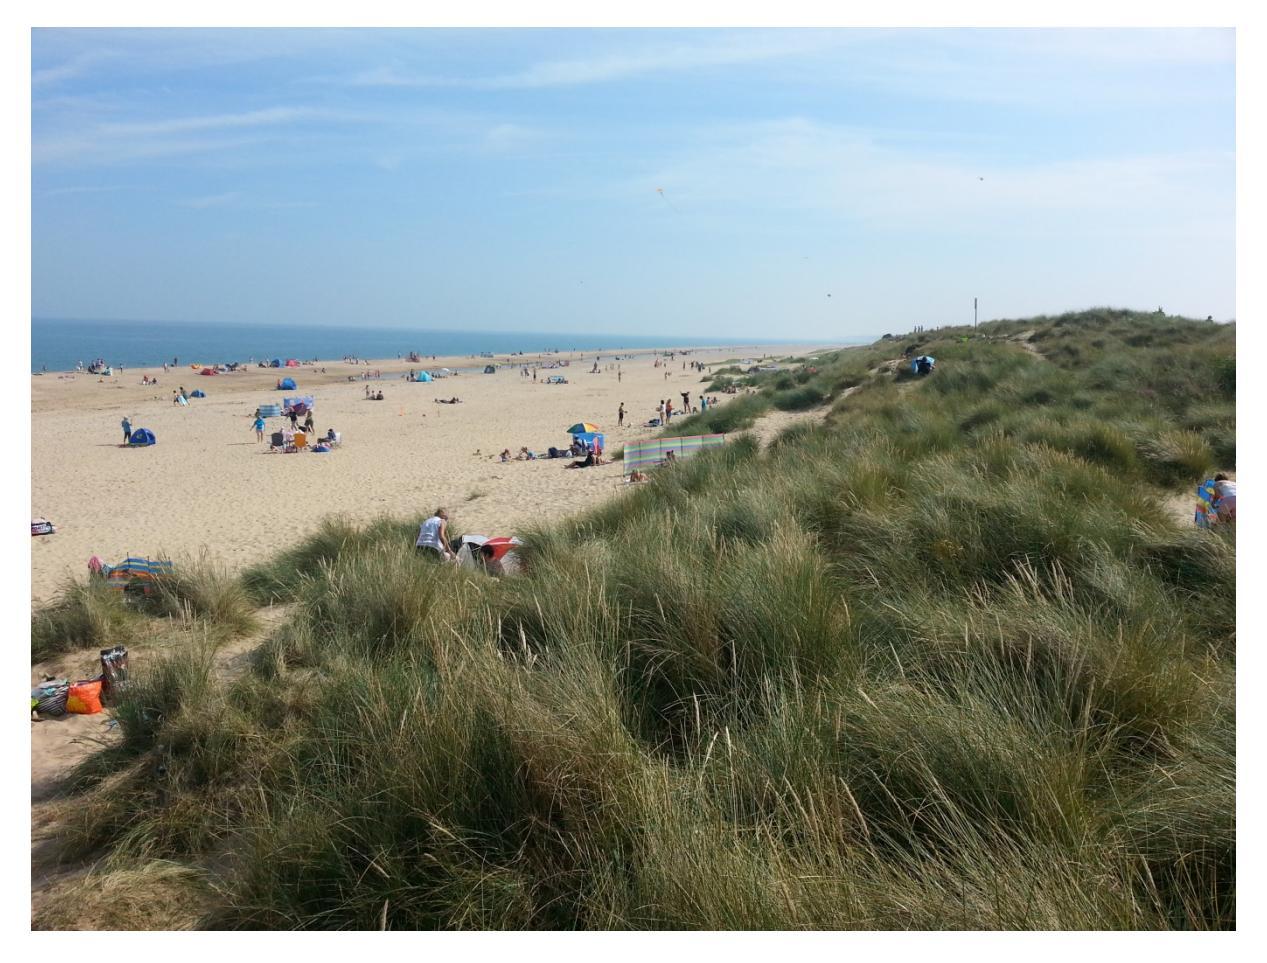
Winterton dunes summer 2016

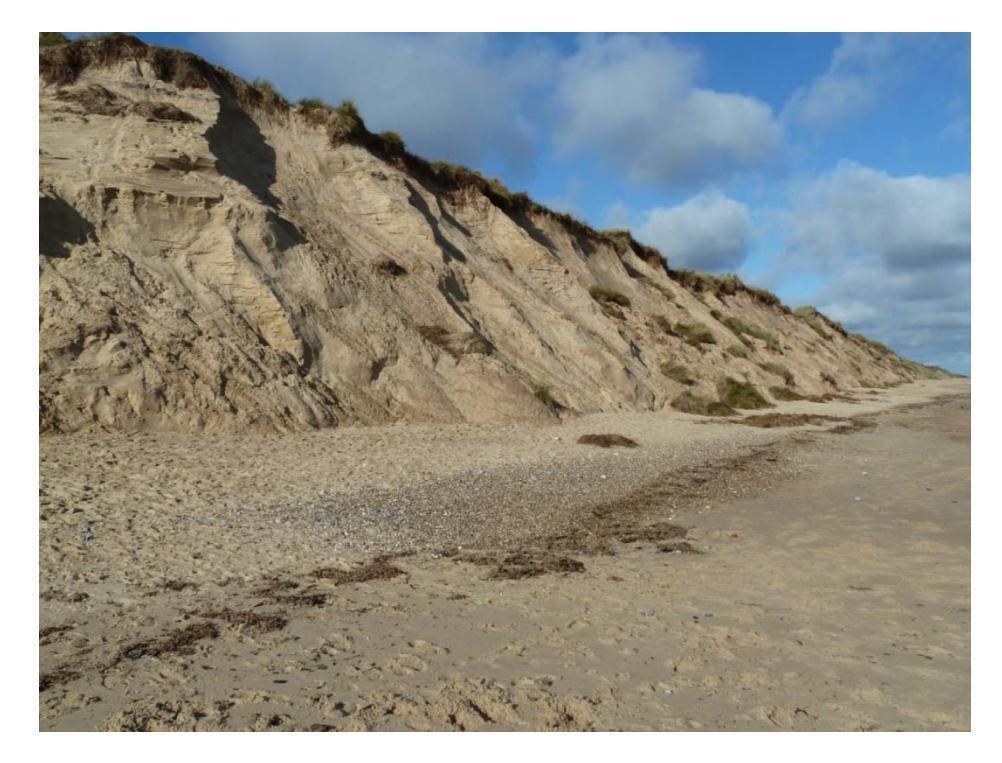
Since this review there have been occasional, and separate localised erosion to the south of Winterton Ness, Hemsby dunes and other areas south. This erosion has been limited to the seaward face of the front dune system and has left the slope, at certain locations, at an unsustainable angle. See below.

Winterton dunes (south end) north of Hemsby

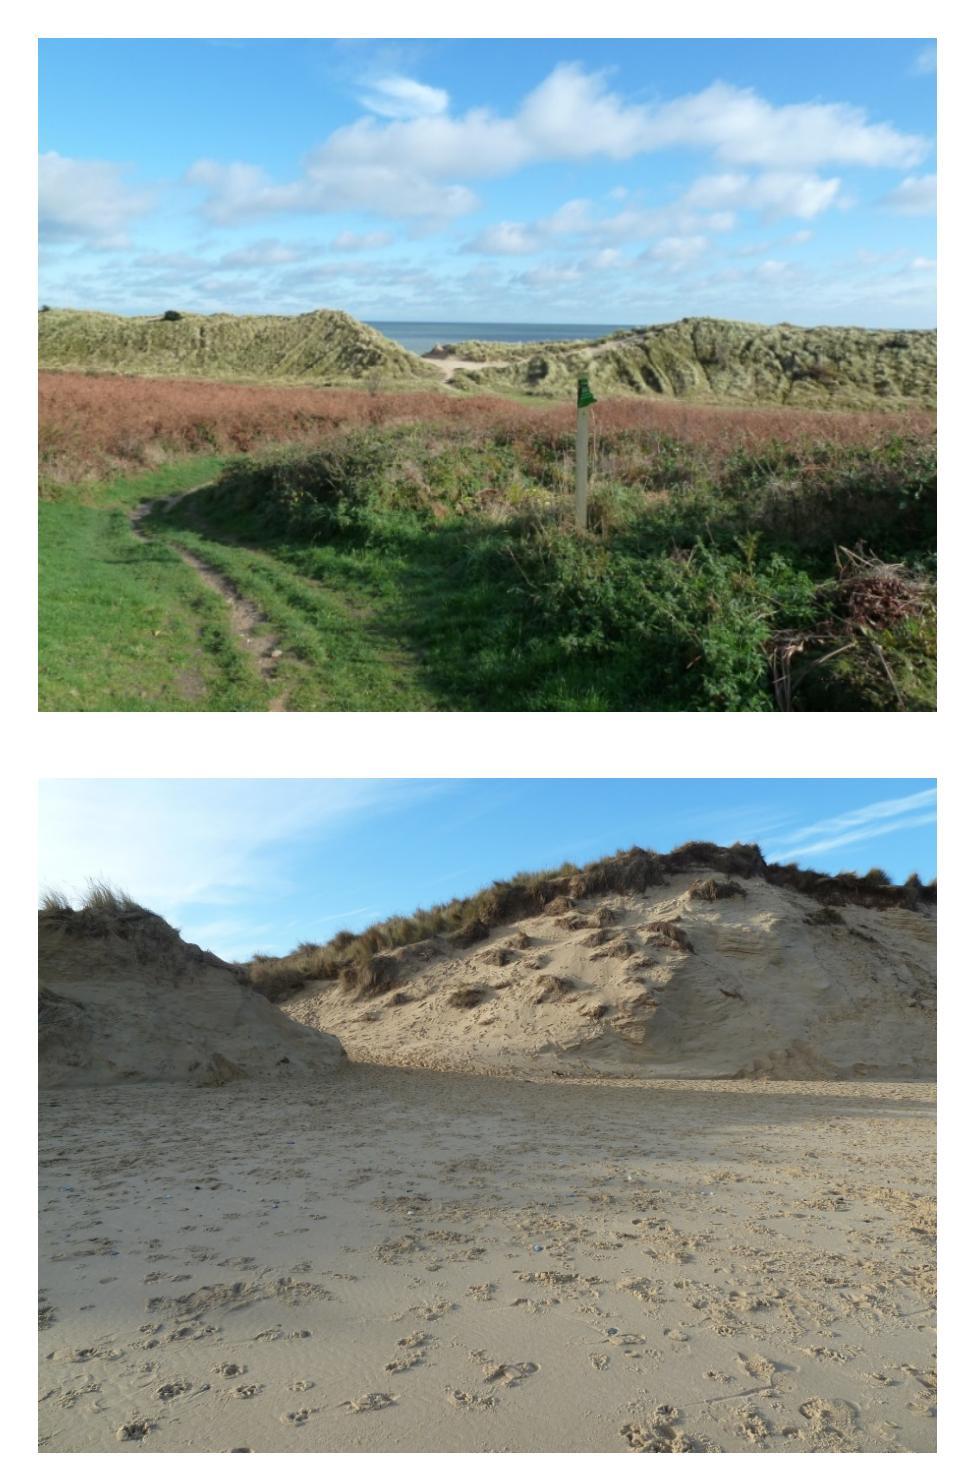
Seaward view of access point north of Hemsby (Long Beach Estate)

There is some local concern that the sea will break through at this point and flood the valley behind. The ground levels within the valley are at approximately +3m to +7m AOD and therefore it would require an extreme event to place water into this area and once this had passed the water would recede. At this time there is no risk of flooding to the properties along this length of coastline although some of the buildings constructed within the dunes at Hemsby could be subject to the consequences of erosion.

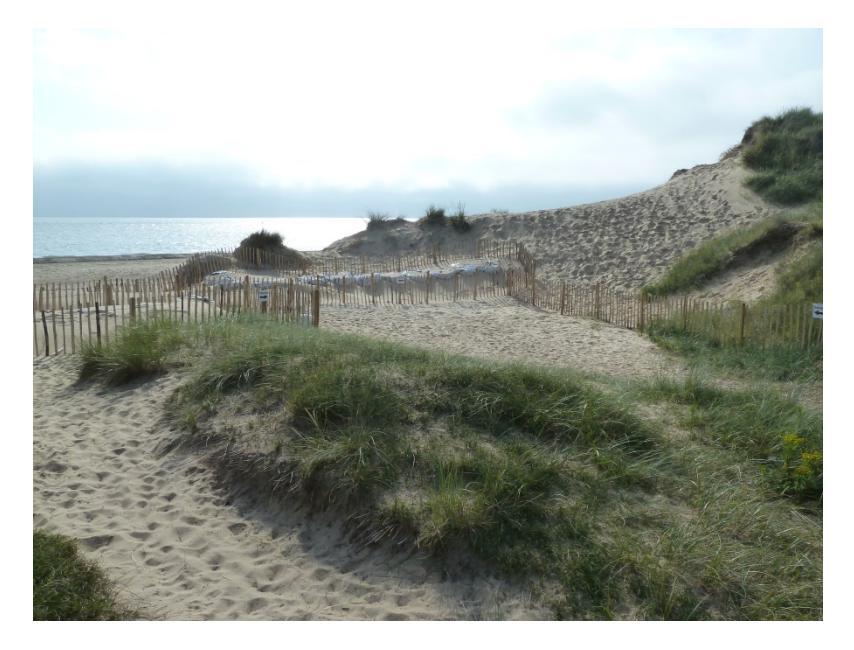
Following a meeting with the Environment Agency (EA), Natural England (NE) and Great Yarmouth's Coastal Manager it was agreed that minor works could be considered in this location. In this case cleft chestnut fencing has been used as a method of reducing sand erosion, caused by foot traffic, by controlling the pathway through the dune and to encourage the deposition of windblown sand.

At Hemsby it has been agreed to use a similar method and carry out works, with the help from the local community, to help maintain the dunes by trapping windblown sand at the base of the dunes.

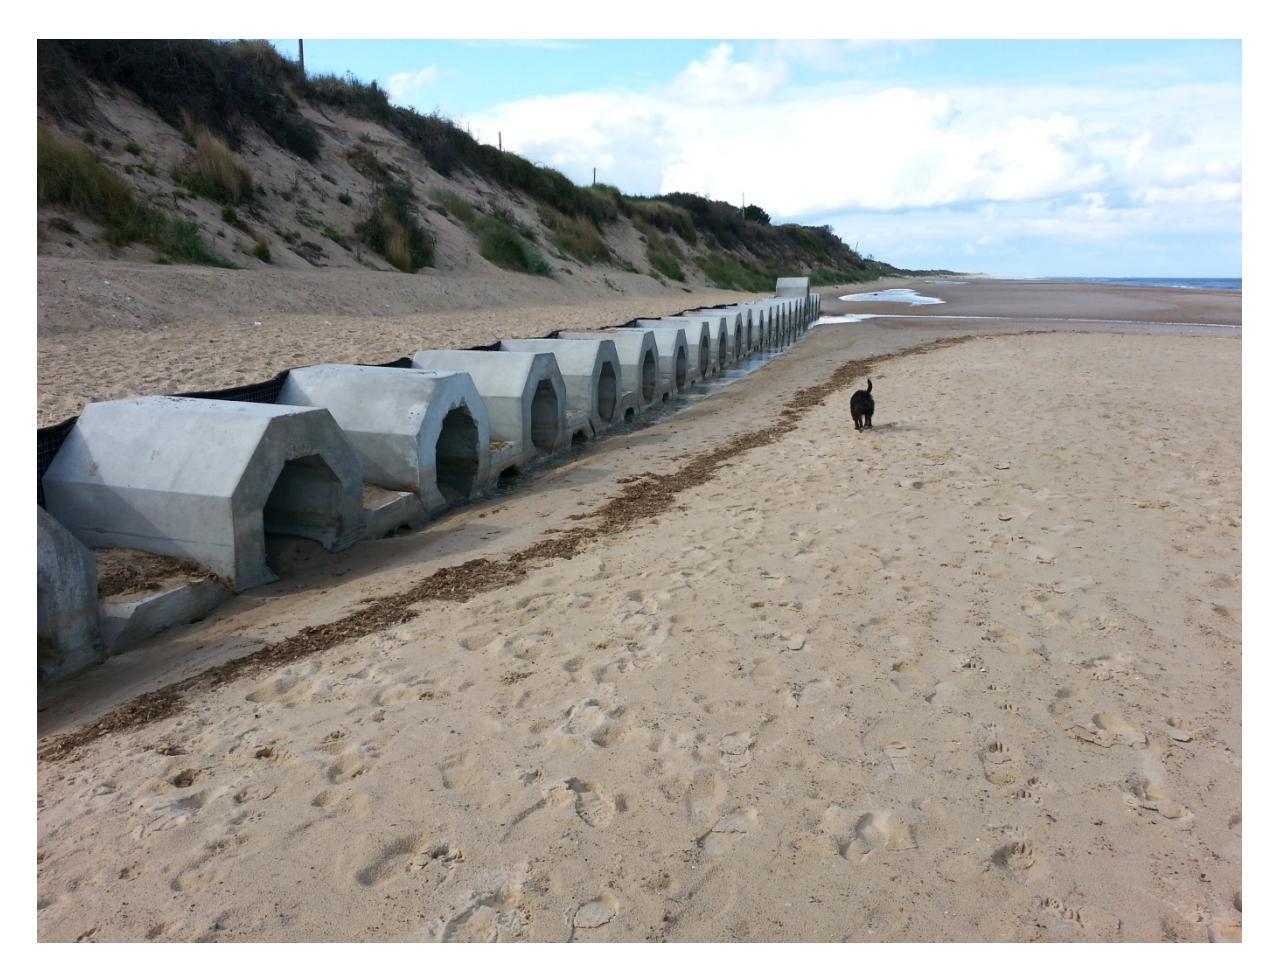
Following a series of adverse sea events during 2013, and culminating in the tidal surge of 5th December 2013, this area of coastline suffered significant change to beach levels and cliff alignment. This last event received wide publicity and The Save Hemsby Coastline (SHC) group received public donations to their fund. This fund, together with a grant from Norfolk County Council and support from GYBC, enabled the group to deliver sections of dune protection designed to limit the effects of erosion.

Hemsby Concrete "OctoBloks" commissioned by SHC

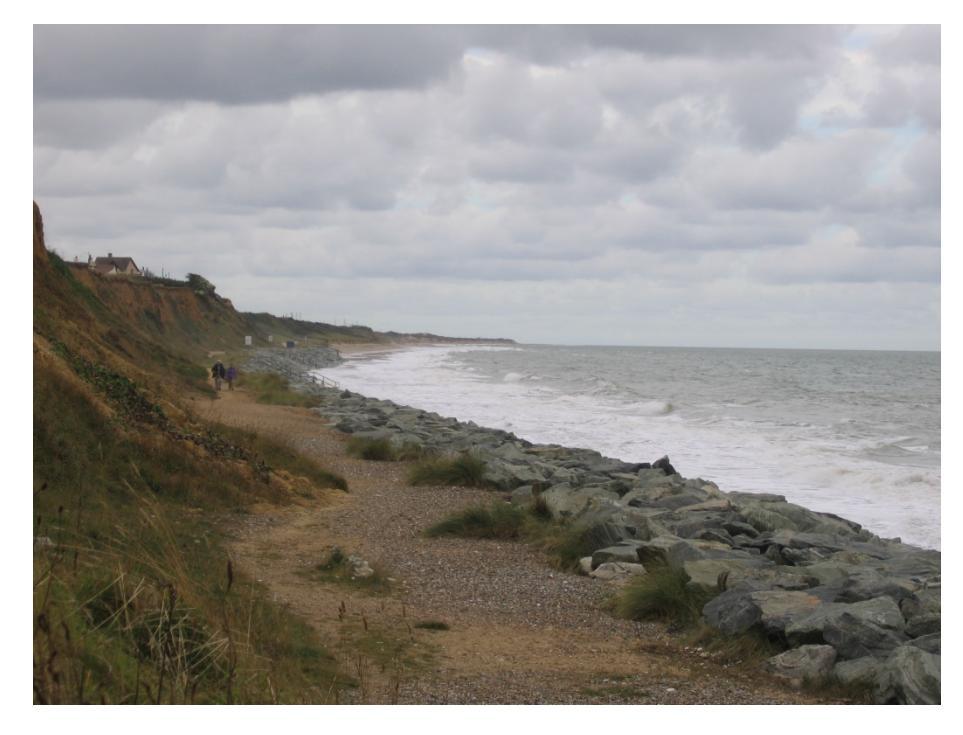
The first defence constructed by GYBC in c1996 is a rock berm fronting California cliff area. The cliffs at this location were being undermined by wave action during very high tide and storm conditions. Follow this undercut of the cliff toe there would be a sheer failure and the cliff line would retreat. The rock berm greatly reduced the impact of the waves on the cliff and has reduced the rate of cliff erosion. This defence is constructed above mean high water and does not trap sediment from the littoral drift process.

California rock berm

Following this successful intervention and community concerns relating to erosion elsewhere, a scheme to extend the rock berm northwards was proposed. In 2007 GYBC carried out a pre-feasibility study to ascertain if this would work, would be acceptable to Natural England, Environment Agency and could be funded. Although the project was technically viable it would not meet the funding criteria in use at that time. There was a willingness to prepare a scheme and submit for approval in the understanding that funding may become available in the future.

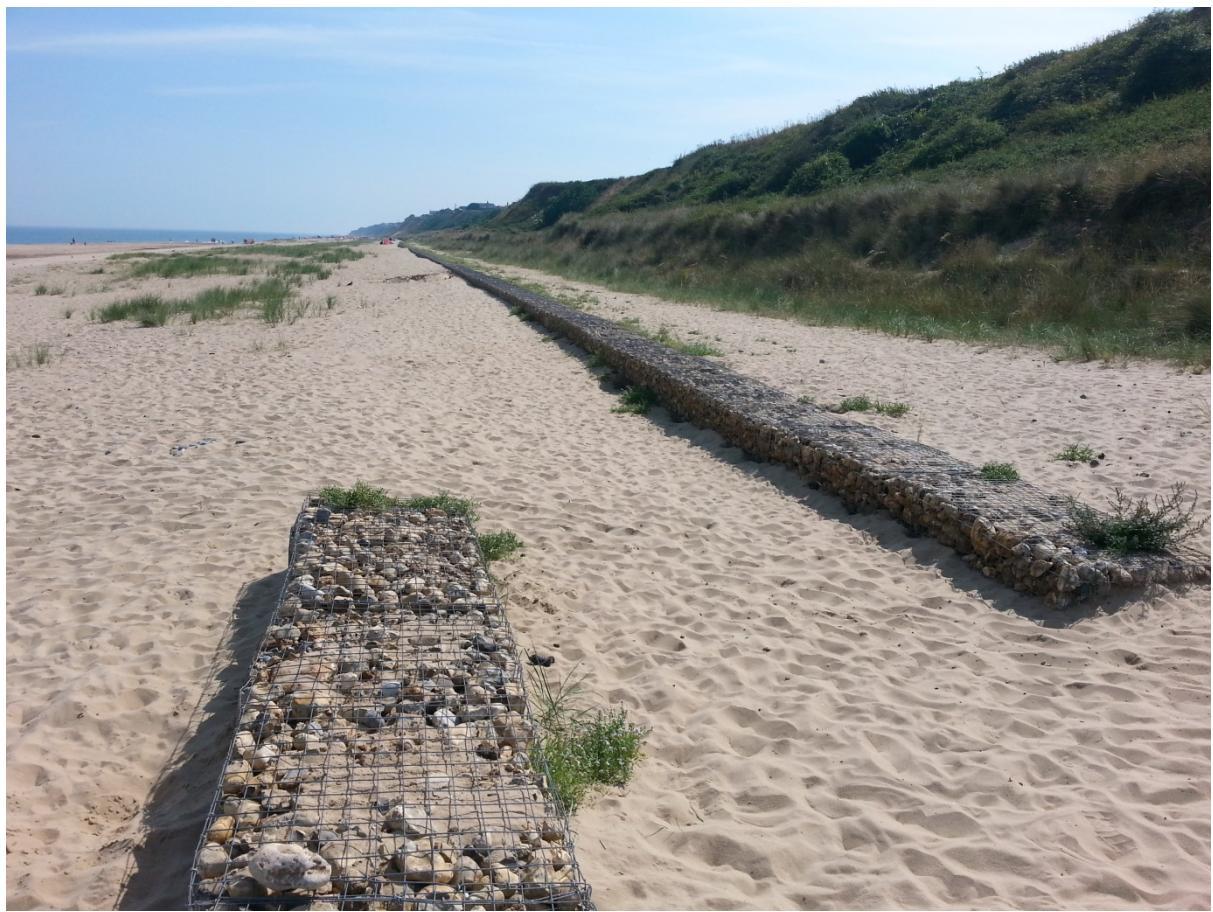
The rock berm scheme was redesigned in 2014 to produce a more cost effective construction and using a mix of alternative partnership funding, has allowed this defence works to be carried out in 2015/16.

Scratby top of gabion cages summer 2016

This scheme has been designed with an intended life of 20 years to give the community time to consider coastal change and options for the future management of the coast.
